First Release: March 21, 2014	Revised:
Prepared by: Phillip C. Pierce ¹	
Title: Evaluation and Rehabilitation of Historic Covered Bridges

The evaluation and rehabilitation of historic covered bridges (covered bridges) requires appreciation of, and experience with, the nuances of complex timber structures subject to moving loads. This bulletin provides guidance on the myriad of issues involved with this work.

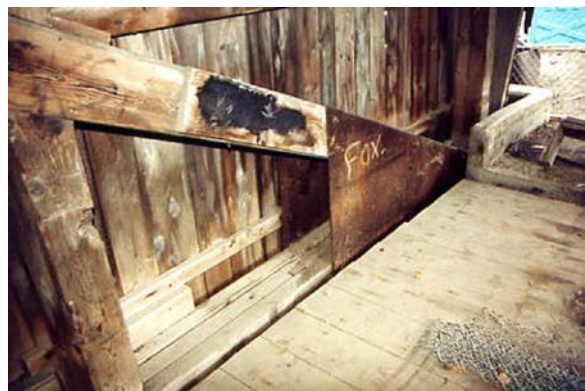
- Steel plates that have been added – they are notorious for hiding deterioration of timber behind the steel plates. You will probably be unable to remove them for inspection, but if you are involved with a rehabilitation project of a bridge having such plates – beware! =>

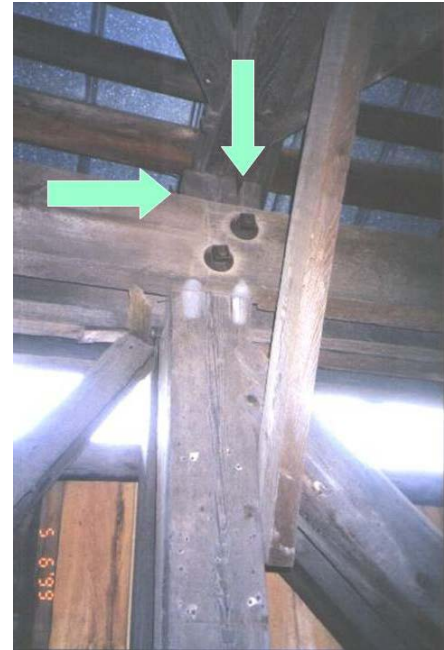
- Splits of the top of heavily loaded posts – potential indication of shear failure. Posts without “check braces” opposite the main diagonals are especially susceptible to such failure. =>

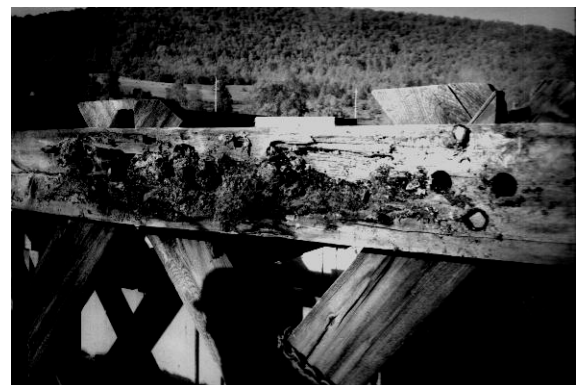
- The extensive area of mating surfaces of Town lattice trusses in particular, are also notorious for hiding deterioration from view – in this case, the mating surfaces were found to be nearly completely removed by a nesting rodent after removal of an outside element. The remaining thin shell of material of the two chord elements might escape notice during a visual examination. =>

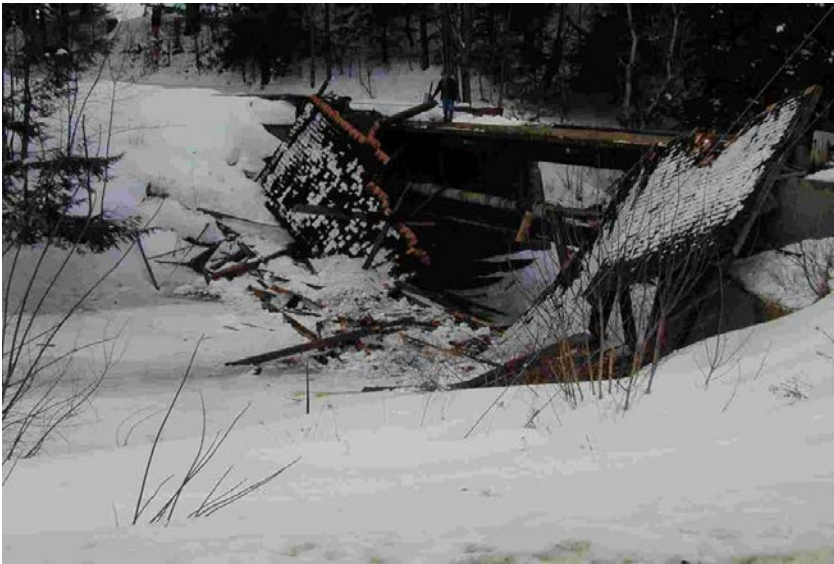
Power House Bridge in Johnson, VT – oops (due to snow)

Conventional (non-covered) bridges are not designed for **snow loading** since snow is plowed off preventing combinations of full snow load and full design live loading. Therefore, AASHTO bridge specifications do not address snow loading. However, covered bridges located in colder climates are subject to snow loading atop their roofs that must be considered in combination with vehicular loading. The most commonly used and widely adopted reference for snow loading is ASCE/SEI 7 Minimum Design Loads for Buildings and Other Structures (ASCE 7).⁸ It is an appropriate reference to use for the prediction of snow loading on a covered bridge.

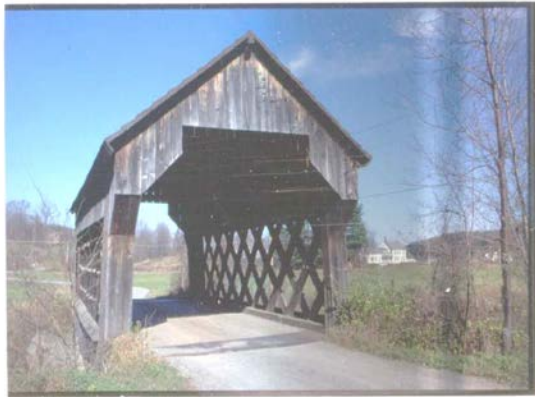
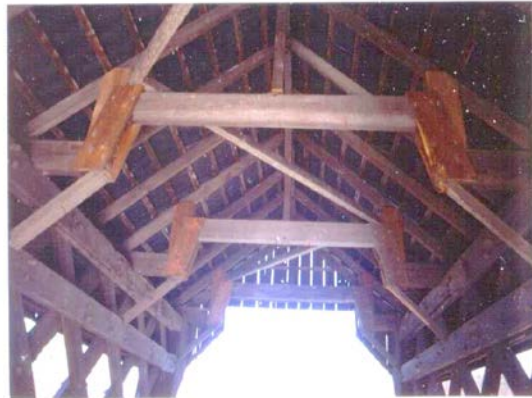
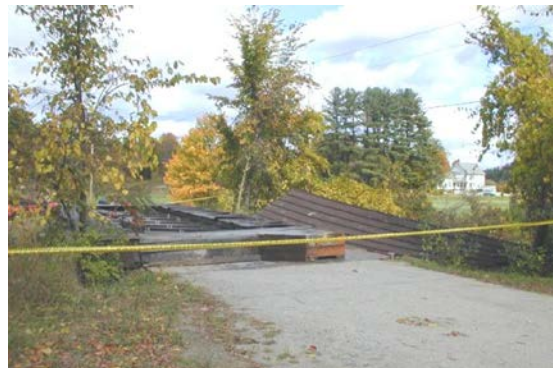
Unknown bridge to farmer's field

Farmer tired of his wagons hitting the tie beams

Oops – farmer doesn't live here anymore, following that little wind storm!

AASHTO specifications provide basic wind load provisions, but they are excessively conservative with respect to covered bridges. Guidance provided in ASCE 7 is much more refined and widely used for wind loading. As noted earlier, the evaluation of wind loading is based on the bracing system of the bridge transmitting the force of the wind to the substructure units (abutments for single-span bridges). Unlike more modern steel through-truss bridges that typically contain a top lateral system and heavy end portal system that conveys the wind loads of the top of the bridge to the abutments, covered bridges often do not have the same strong end portal system and rely more on intermediate knee bracing to convey some of the top wind loads down into the plane of the floor or lower lateral system. The floor systems of many covered bridges act as large, strong horizontal diaphragms to transmit forces the ends of the bridges. While the analytical evaluation process for wind loading is based on that load alone (i.e. no group load combination factor), it progresses with consideration of the duration of load factor as mentioned above.

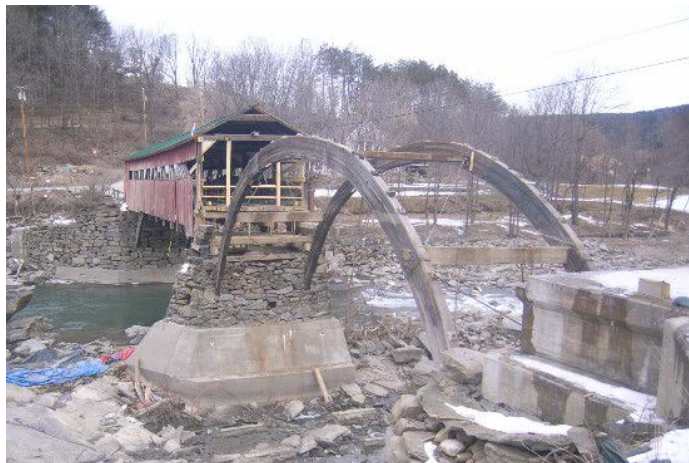
Taftsville Covered Bridge – rehab underway post Irene damage. A pair of the largest supplemental timber arches known to this author!

For those covered bridges supported by combination truss/arches (think Burr Arch – multiple kingpost truss with superimposed arch), the most difficult part of the analysis is convincing oneself which part (truss vs arch) supports what portion of the various loads. This conundrum has confounded every engineer tasked with evaluation of these combination structures. The most important part is to properly recognize the strength or weakness of the connections between the two vertical structures as well as the relative stiffness of them. This is one type of timber structure that truly warrants careful modeling in modern computer software, yet the results can at best only bracket the results. There are few articles about the analysis of specific truss/arch covered bridges. This writer is unaware of consensus among engineers involved in this work about general conclusions.

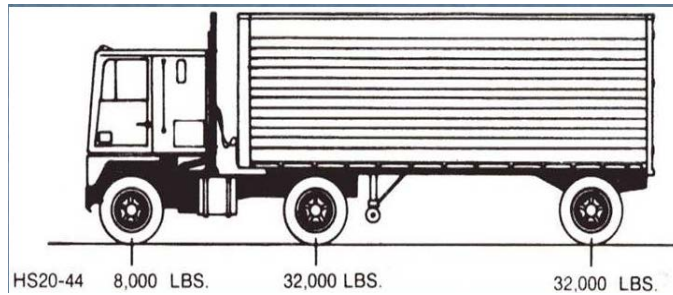
Now is this what really ought to be allowed to cross an historic covered bridge???

1. *Selection of “design” vehicle.* It is important that the design vehicle be appropriate for an extant covered bridge. The design vehicle should be as light weight as possible to minimize the potential need for replacement or strengthening of existing elements. Many rehabilitation projects have been based on two-axle vehicles having weights of three to eight tons.

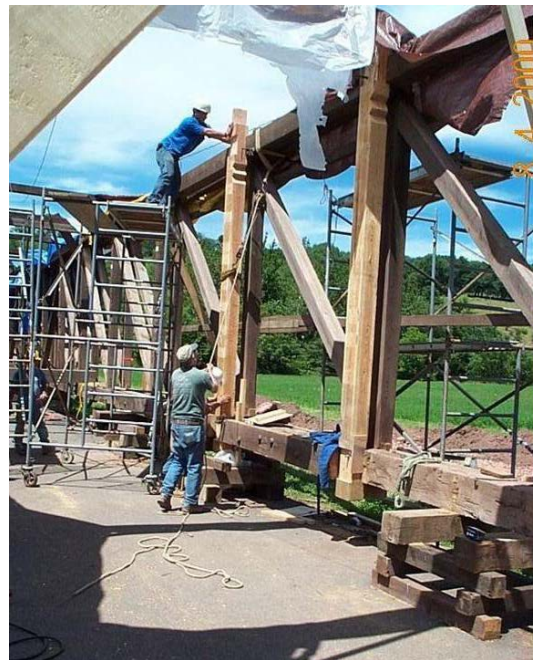
In-kind replacement posts – Hamden Covered Bridge, Delaware County, NY =>

3. *Truss or arch element rehabilitation.* The preferred approach is to replace damaged, deteriorated, or otherwise weak elements in-kind using connections that match the original construction. Non-wood elements are not preferred, but are occasionally required. The connections of non-wood elements into the fabric of the original wooden bridge should be carefully planned to avoid unnecessary damage to original material. Additionally, dissimilar materials can lead to internal moisture condensation that can lead to premature deterioration of wood, hidden from view.
