# TIMBER FRAMING

JOURNAL OF THE TIMBER FRAMERS GUILD

Number 87, March 2008

*Reproducing a Burned Steeple*

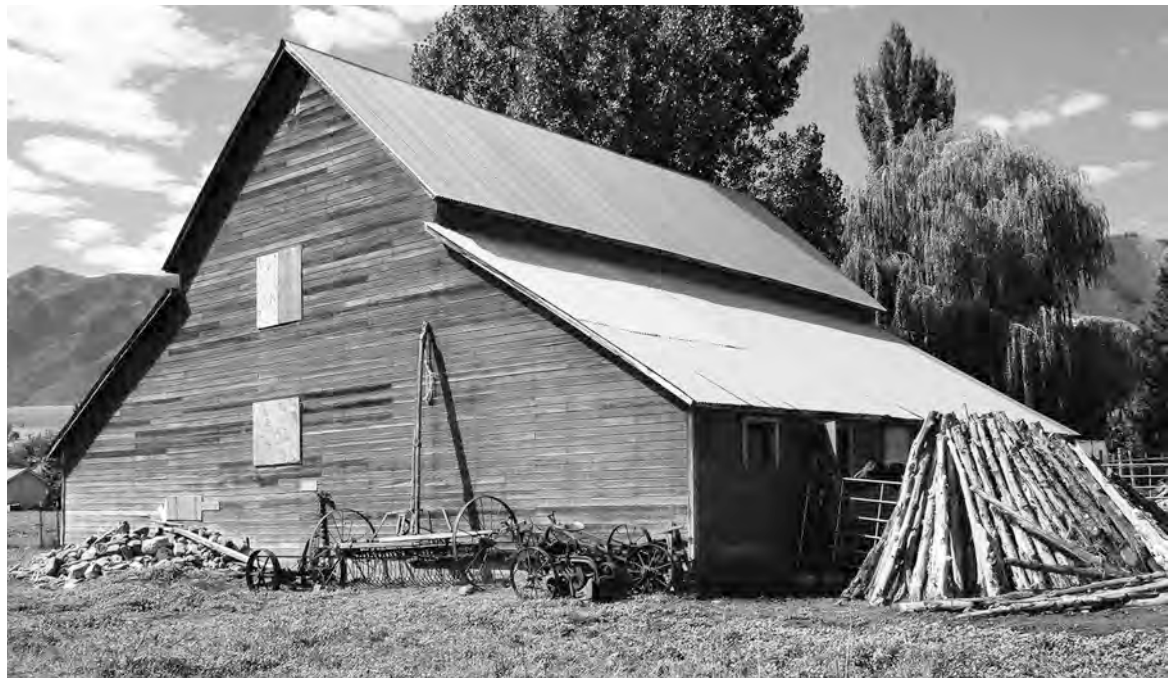
*Watkins barn, Mendon, Cache County, Utah, ca. 1922. Horizontal sheathing is atypical.*

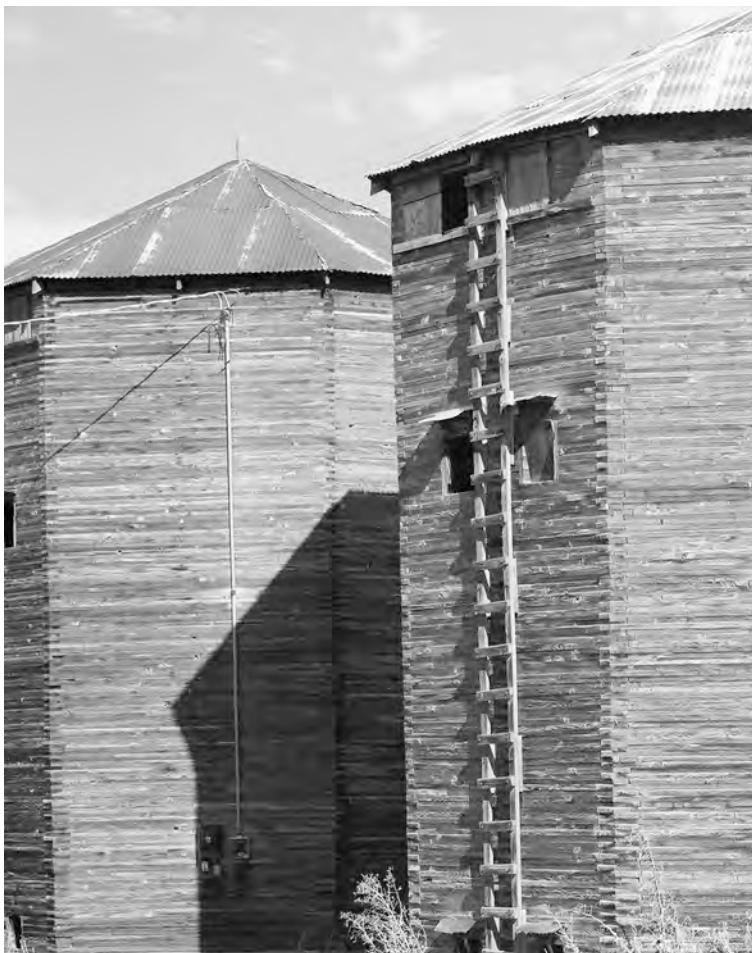
*Hans Sorenson's stacked 2x4 and 2x6 10,000-bushel hexagonal grain bins, Soda Springs, Caribou County, Idaho, ca. 1925.*

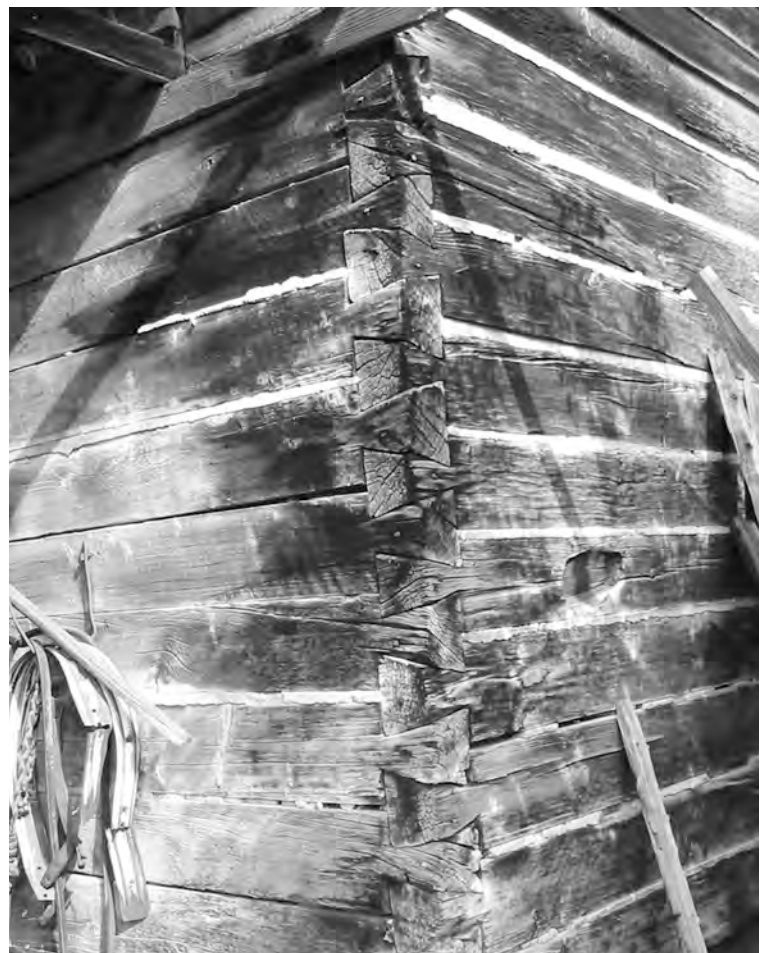
*Marion McBride's squared log dovetail chinked granary, Cache County, Utah, early 1900s.*

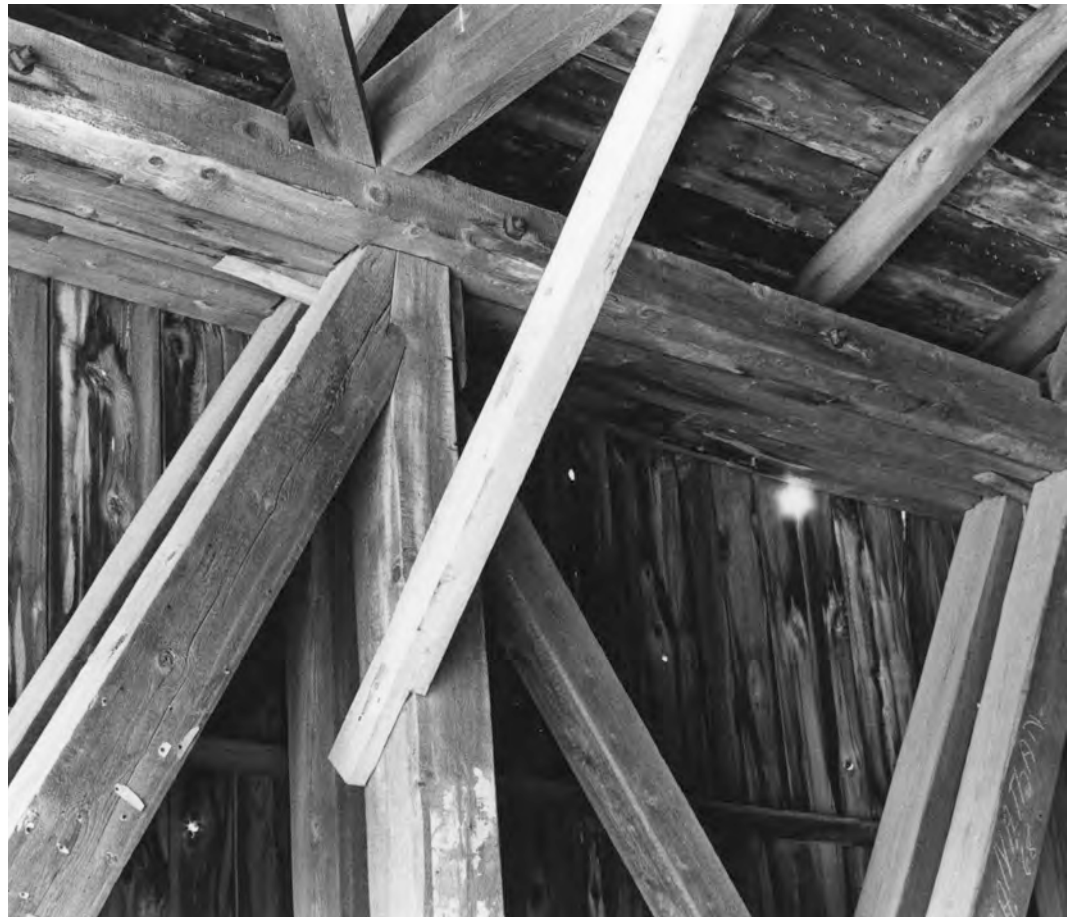
*Fig. 3. Framing details of Long truss. Thin ends of counterbrace prestress wedges poke out between braces. Behind the near post an additional wedge can be seen intended to snug up the housed joint, a detail often omitted. Low's Bridge shown, between Guilford and Sangerville, Maine, built in 1857 by Leonard Knowlton and destroyed by flood in 1987, when it was the extant Long truss most closely resembling the patent (though the colonel would have recommended more post-top relish). Jan Lewandoski built a new Long truss bridge here in 1990.*

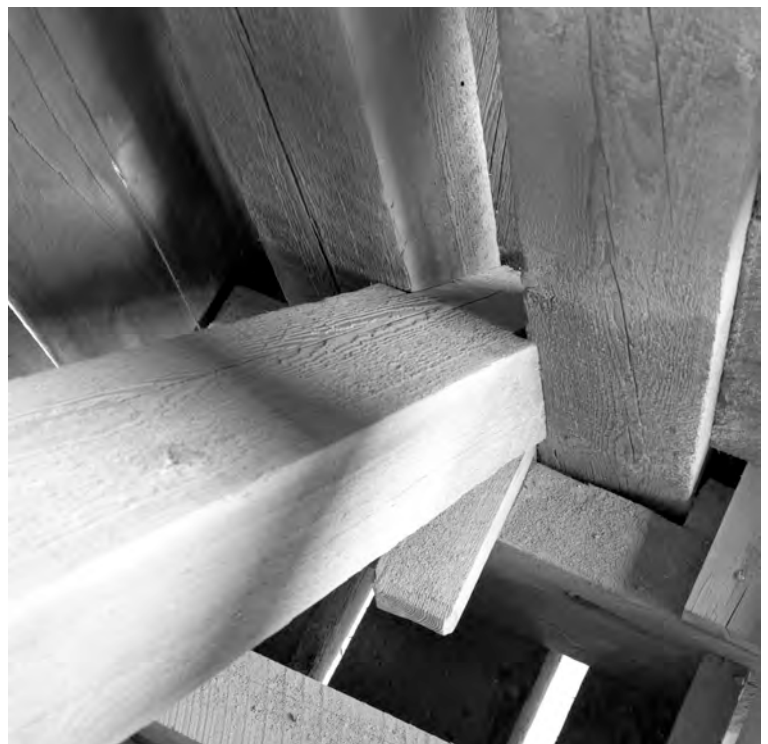
*Fig. 4. Counterbrace wedge at the bottom instead of the top. Blair Bridge, Campton, New Hampshire, built 1869.*

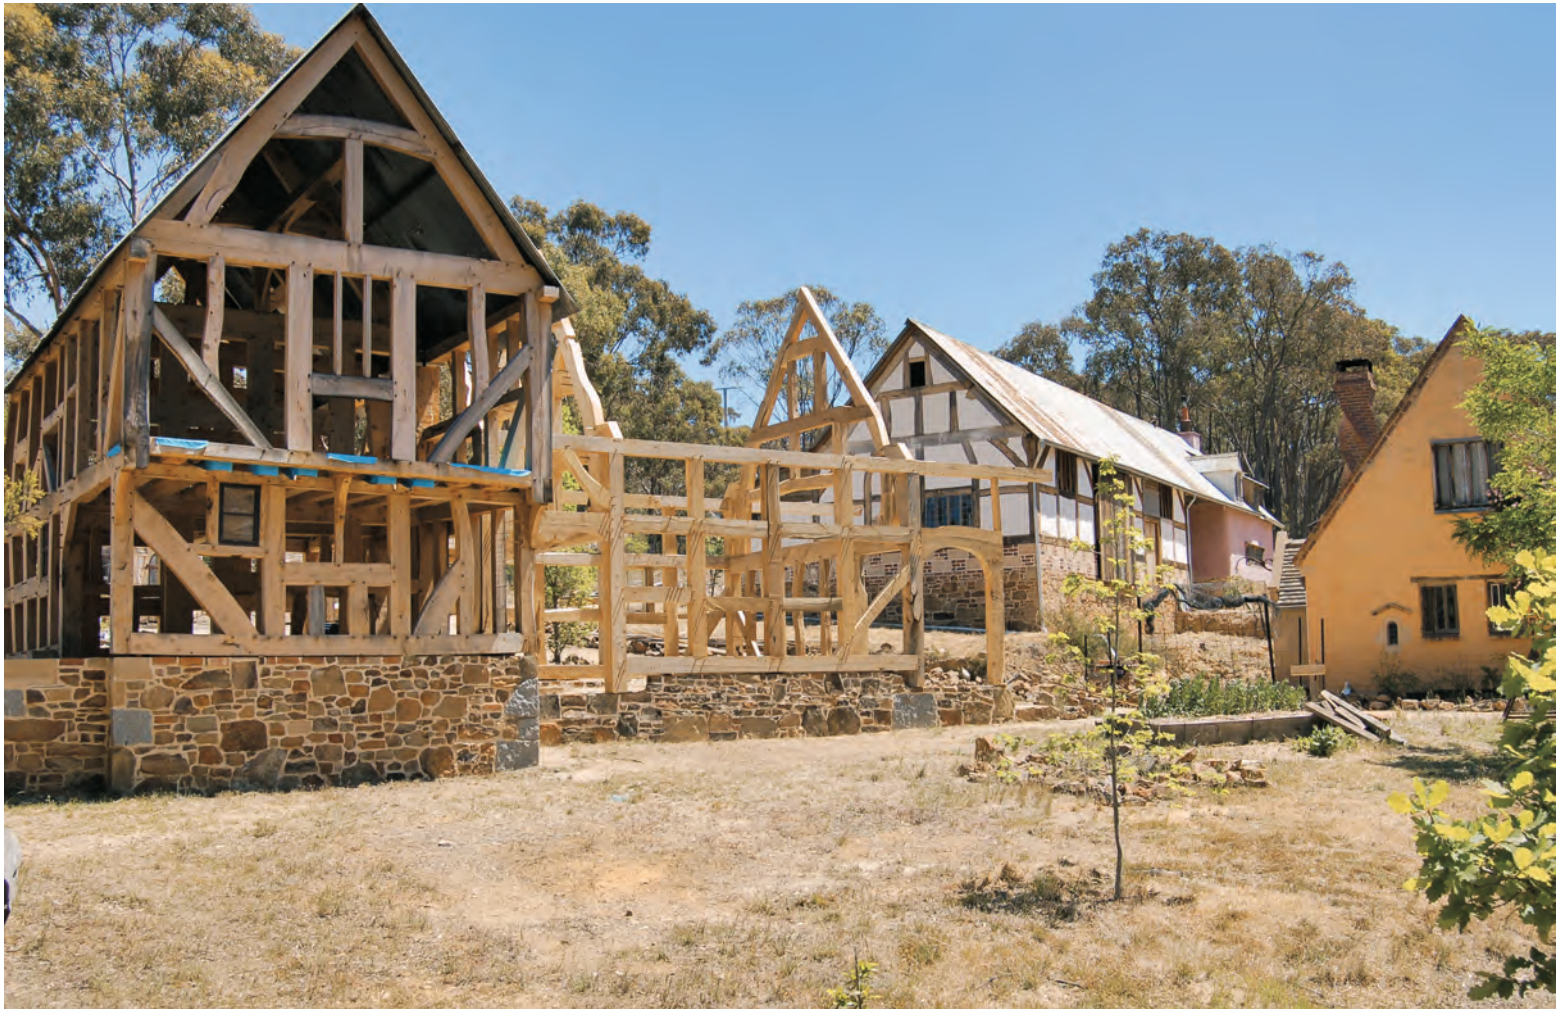
*Fig. 1. View of new work at Rob Hadden's ever-growing empire in Castlemaine, Victoria, Australia. Center right, barn and guest house completed in 2004. Far right, masonry-walled house with interior timber framing, completed in 2000. Note drooping jetty on gable end of new work.*

HAVING completed the timber-framed barn and guest house in 2004 (Fig. 1, center right), and having enjoyed a very short recovery period, I launched into the main house frame as a man on a mission. A project of this scale was always going to present serious logistical challenges, not the least starting with nowhere near enough timber or regular income to pay for building as well as living expenses. But my firm belief that what I need will somehow manifest itself has been vindicated. A network of people are on the lookout for timber on my behalf, including a number of arborists recruited for the cause and unanimous in their backing of my use of salvaged timber. Over the last two years I have accepted for use a large variety of species, including cypress pine (*Cupressus leylandii*), English oak (*Quercus robur*), elm (*Ulmus minor*, var. *vulgaris*), Lombardy poplar (*Populus nigra*), silver poplar (*P. alba*), golden poplar (*P. canadensis*, var. *serotina* aura), Himalayan cedar (*Cedrus deodara*) and Monterey pine (*Pinus radiata*); also, grey box (*Eucalyptus microcarpa*), red box (*E. polyanthemos*), hybrid box (*E. variety unknown*), yellow gum (*E. leucoxylon*) and English ash (*Fraxinus excelsior*). All this timber I transported using my trusty Toyota pickup and a trailer borrowed from my father-in-law.

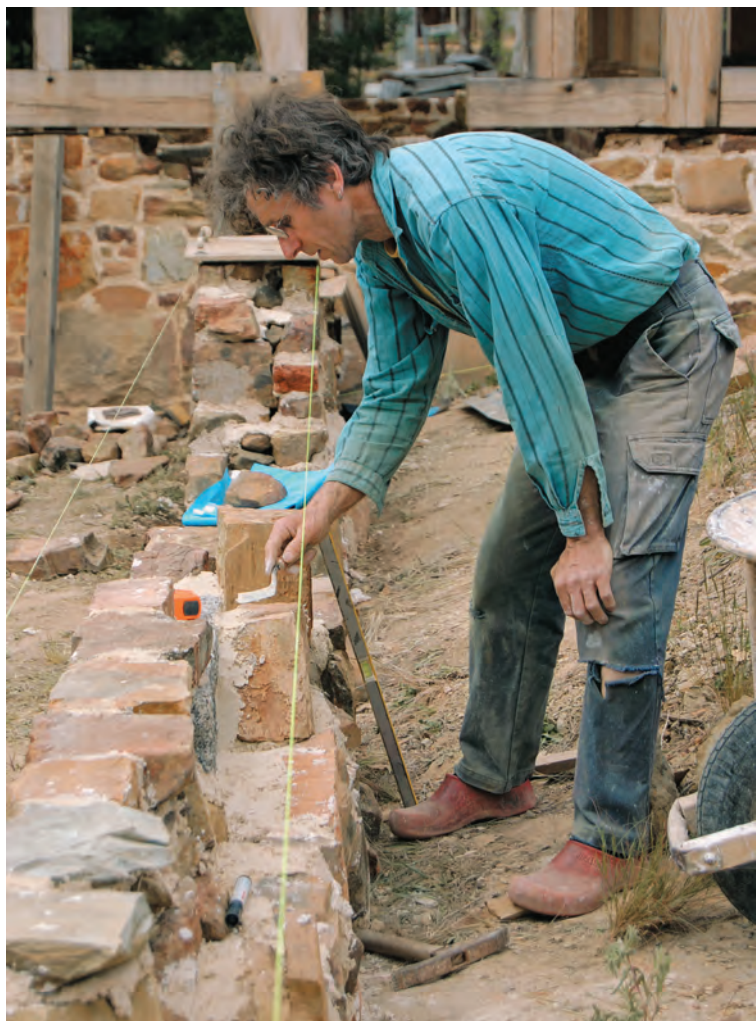
*Fig. 2. Author built lime-mortared stone foundation quickly with stone gathered from property.*

The rubble stone foundation I built two years ago in a frenzied two weeks using sandstone from our own property. The 12-in.-thick walls follow the natural slope of the land. The foundation extends from about 12 in. high at the south end to over 4 ft. at the north. This is very much standard-issue domestic random rubble masonry bonded with lime mortar (Fig. 2).

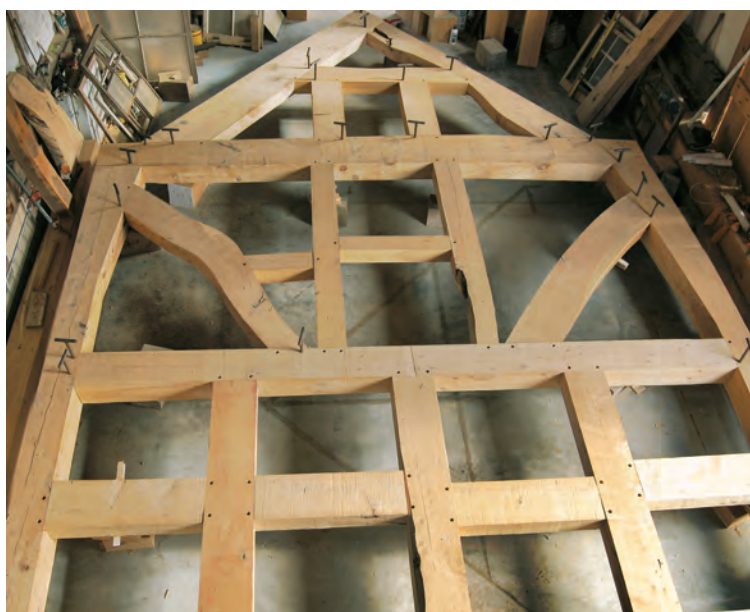
*Fig. 4. Crossframe in English Midlands style. Studs are 10x5 in.*

chiseled all the timbers for three crossframes (one shown in Fig. 4) and the jettied frame with its upper and lower parts (Fig. 1). There were no real dramas here except for the continual moving of the timbers in and out of the barn, which took up a lot of time.

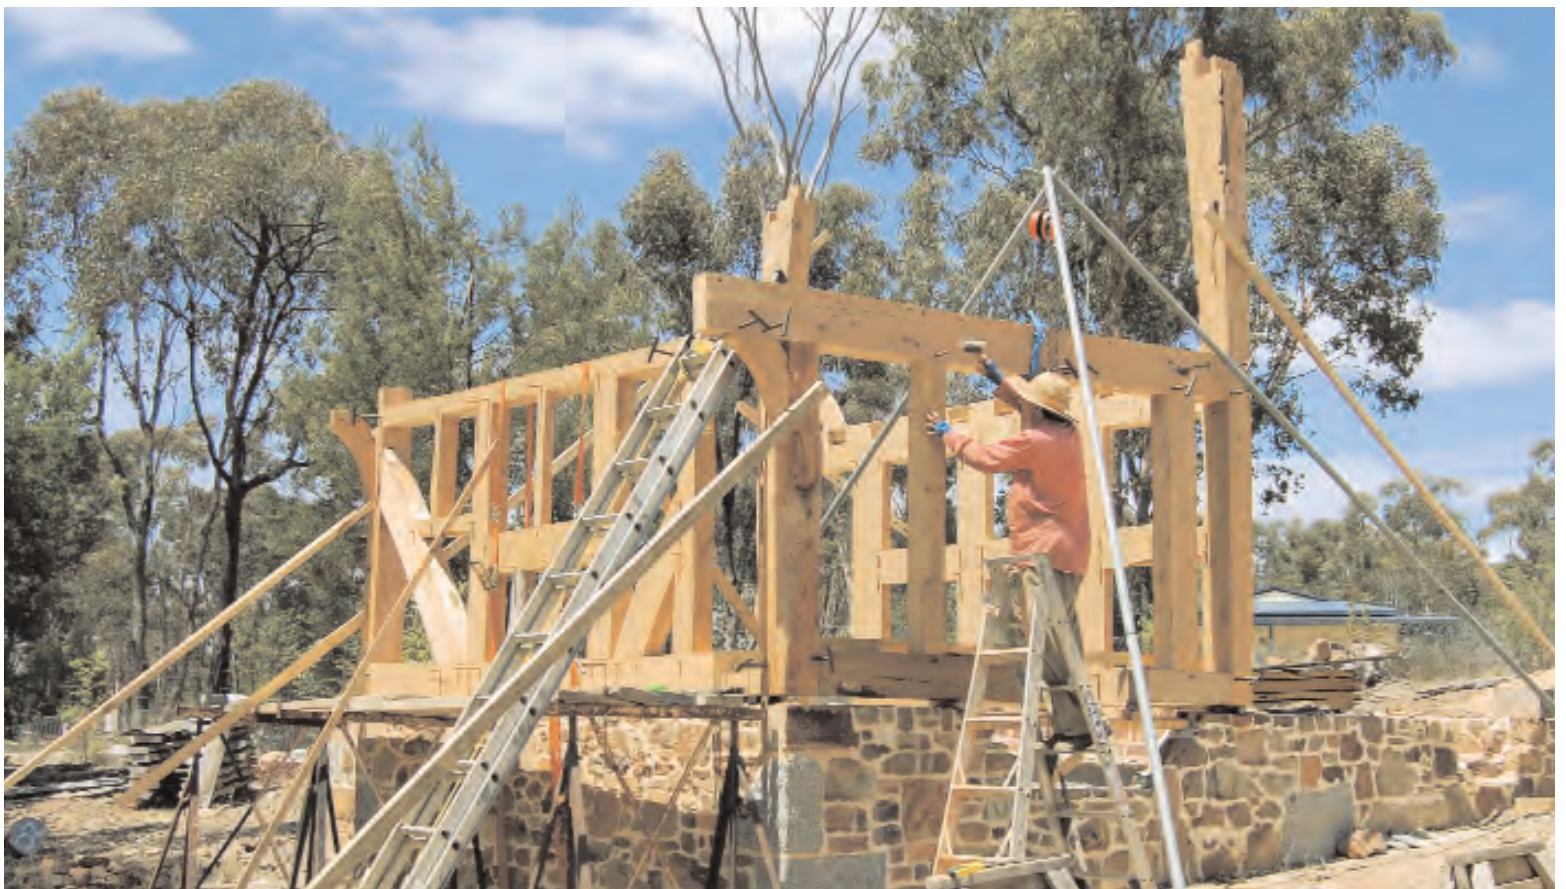
*Fig. 6. Author pegs off first wall girt, which passes corner post to form end support for jetty. Pipe tripod with block and chain raised the beam.*

was in place, the lengthwise 7x5 floor joists could be located in their respective mortises in the transverse floor girt (mortises still empty in Fig. 6). My joy at the success of raising crossframe two was short-lived. After placing the sill and corner posts for the lower frame of the jettied end, a brace on the left side wouldn't fit and all the studs refused to cooperate with the top plate. The cause appeared almost accidentally with a casual glance along the sill plate's datum line. The timber had bowed over an inch, taking all with it, moving in the heat over a few months. Pulling at it with ratchet straps did not improve the situation and mild panic set in as I envisioned the whole frame-raising stopped dead in its tracks. In the end, the only remedy was to saw the sill halfway through in two places and winch the middle section down slowly until I could engage the pegs in the stud tenons. Metal plates housed in place out of sight and secured with galvanized bolts bridge the cuts.

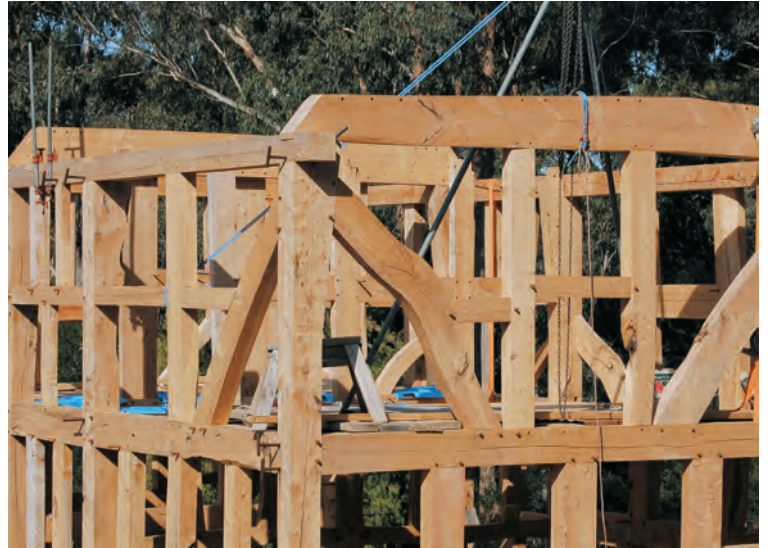
*Fig. 8. Shear legs tied off to wall, last tie beam raised over top plates.*

The piece-by-piece assembly moved along smoothly with interrupted sills, wall studs and girts raised by hand and the crane lifting crossframes three and four into place. With the aid of my trusty shear legs, Toni and I hauled up the top plates and assembled their respective 3-ft.-long stop-splayed scarfs. A temporary floor of thick plywood reduced any danger to ourselves during these operations. It was, altogether, now starting to resemble a house frame. We hauled up the large tie beams in two stages as the hoist chain could not reach two stories. We slid the ties along the plate to their respective locations and then lifted them onto the teazel tenons of the posts (Fig. 8).

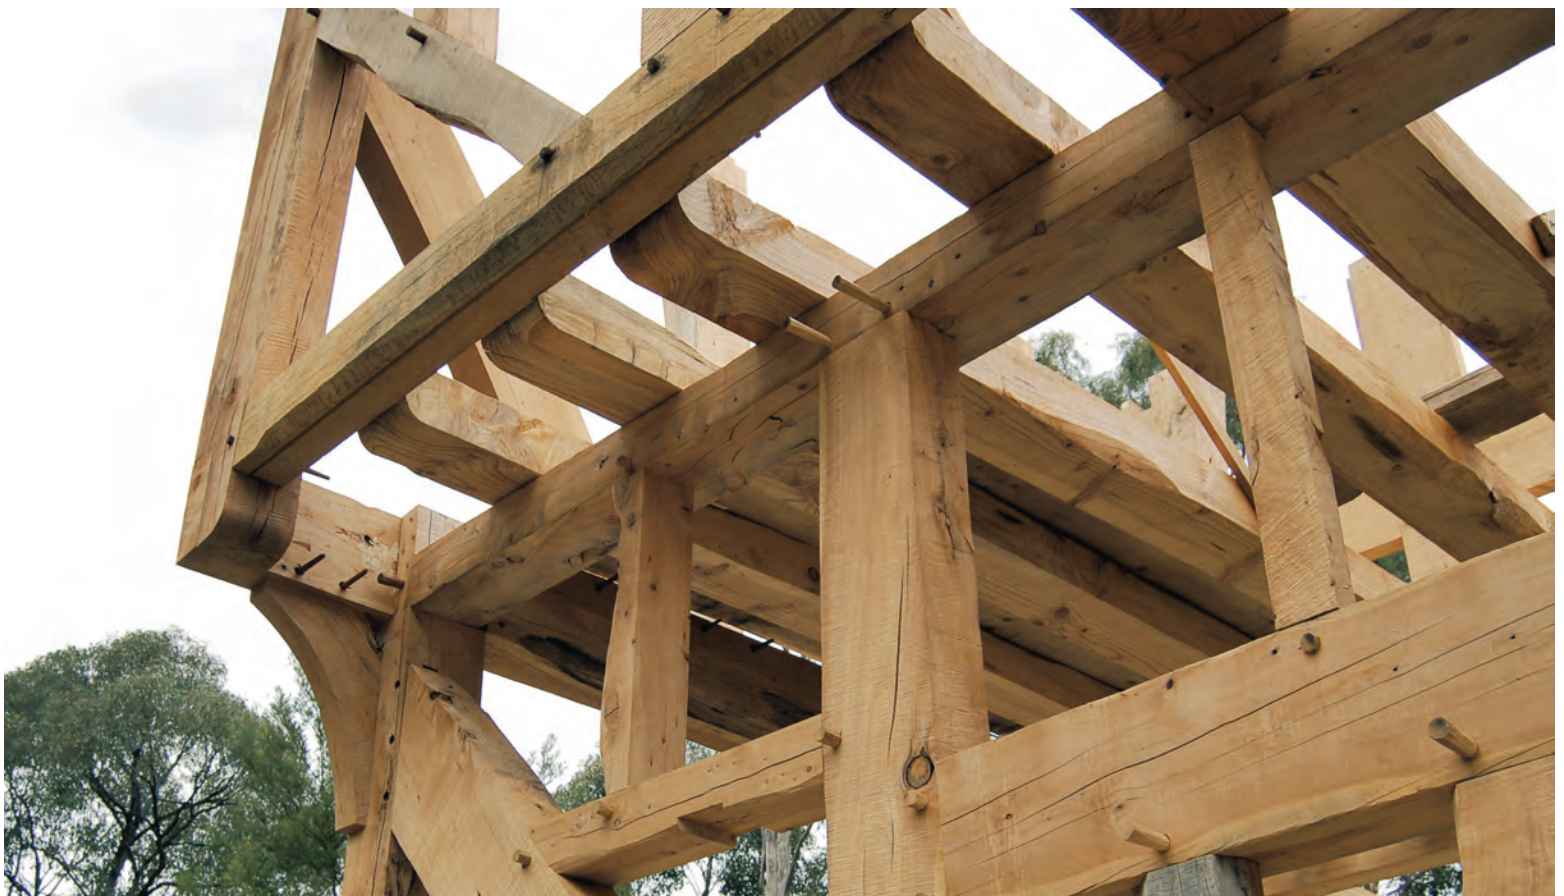
*Fig. 7. Jetty bressummer rabbet shelters ends of 7x5 pine floor joists. Note distinct drip groove in underside. Tenons of wall girts support end posts.*

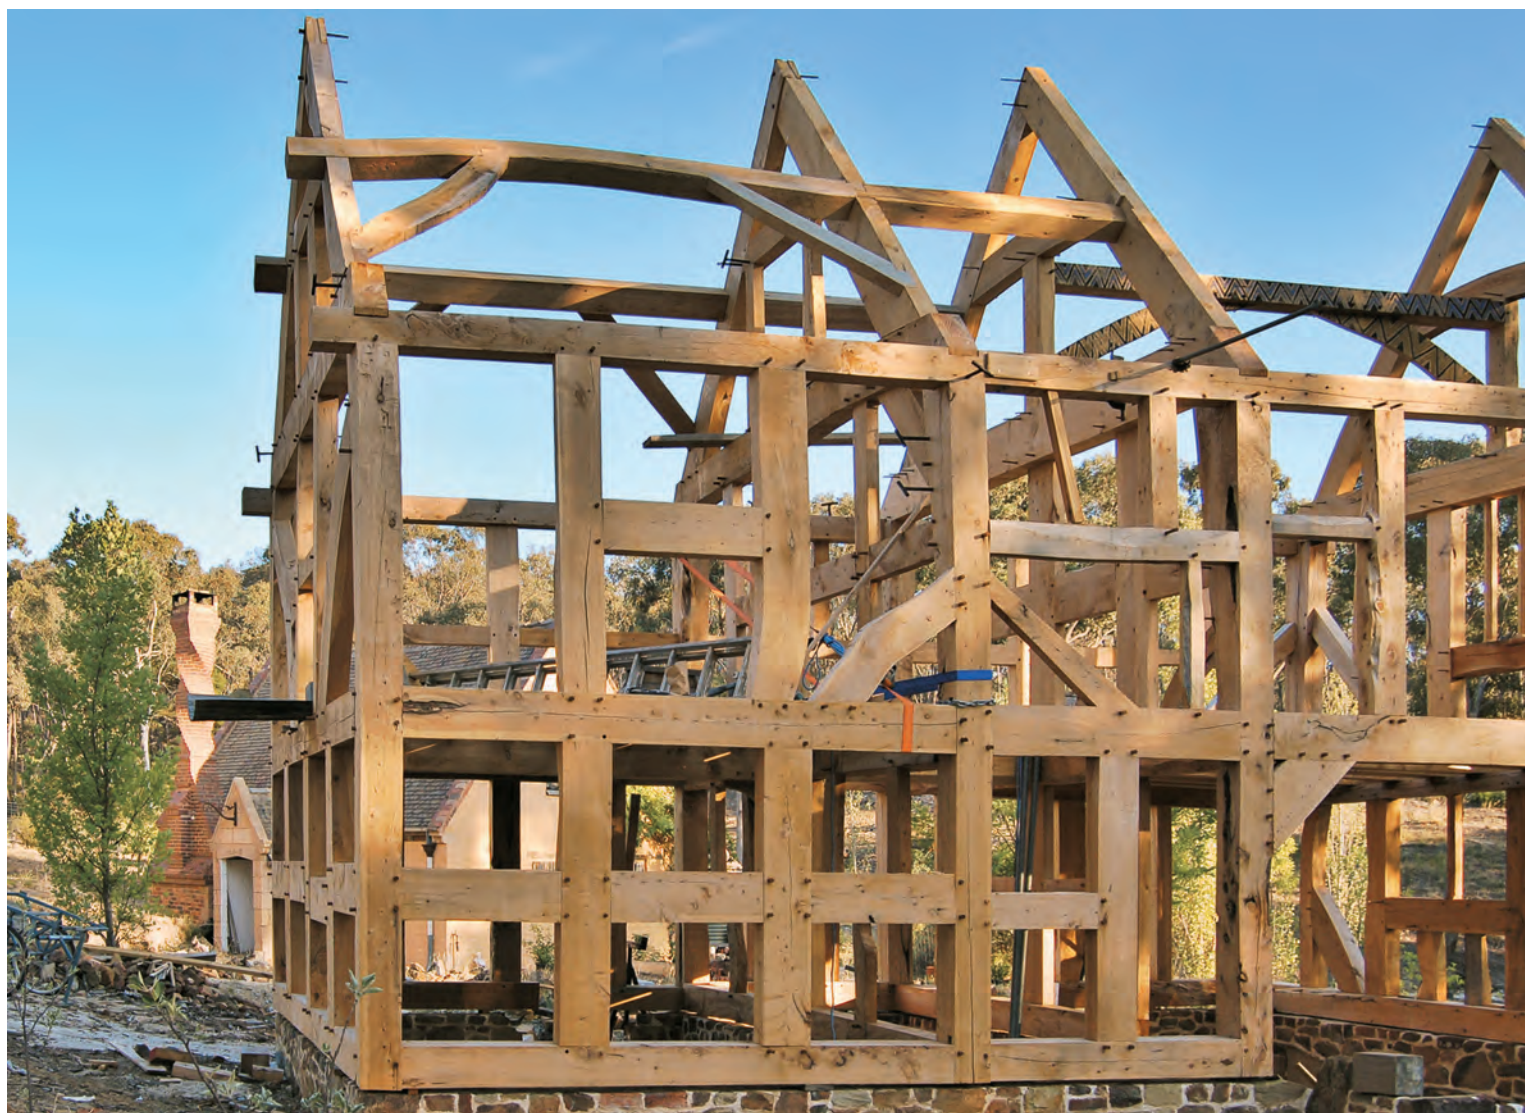
*Fig. 9. Main frame complete, with straps and chain for troublesome crossframe three post left in place. Purlins lock to each other or to a rafter; wind braces are taper-lapped to rafters and purlins. House in background with twisted chimney dates from 2000.*

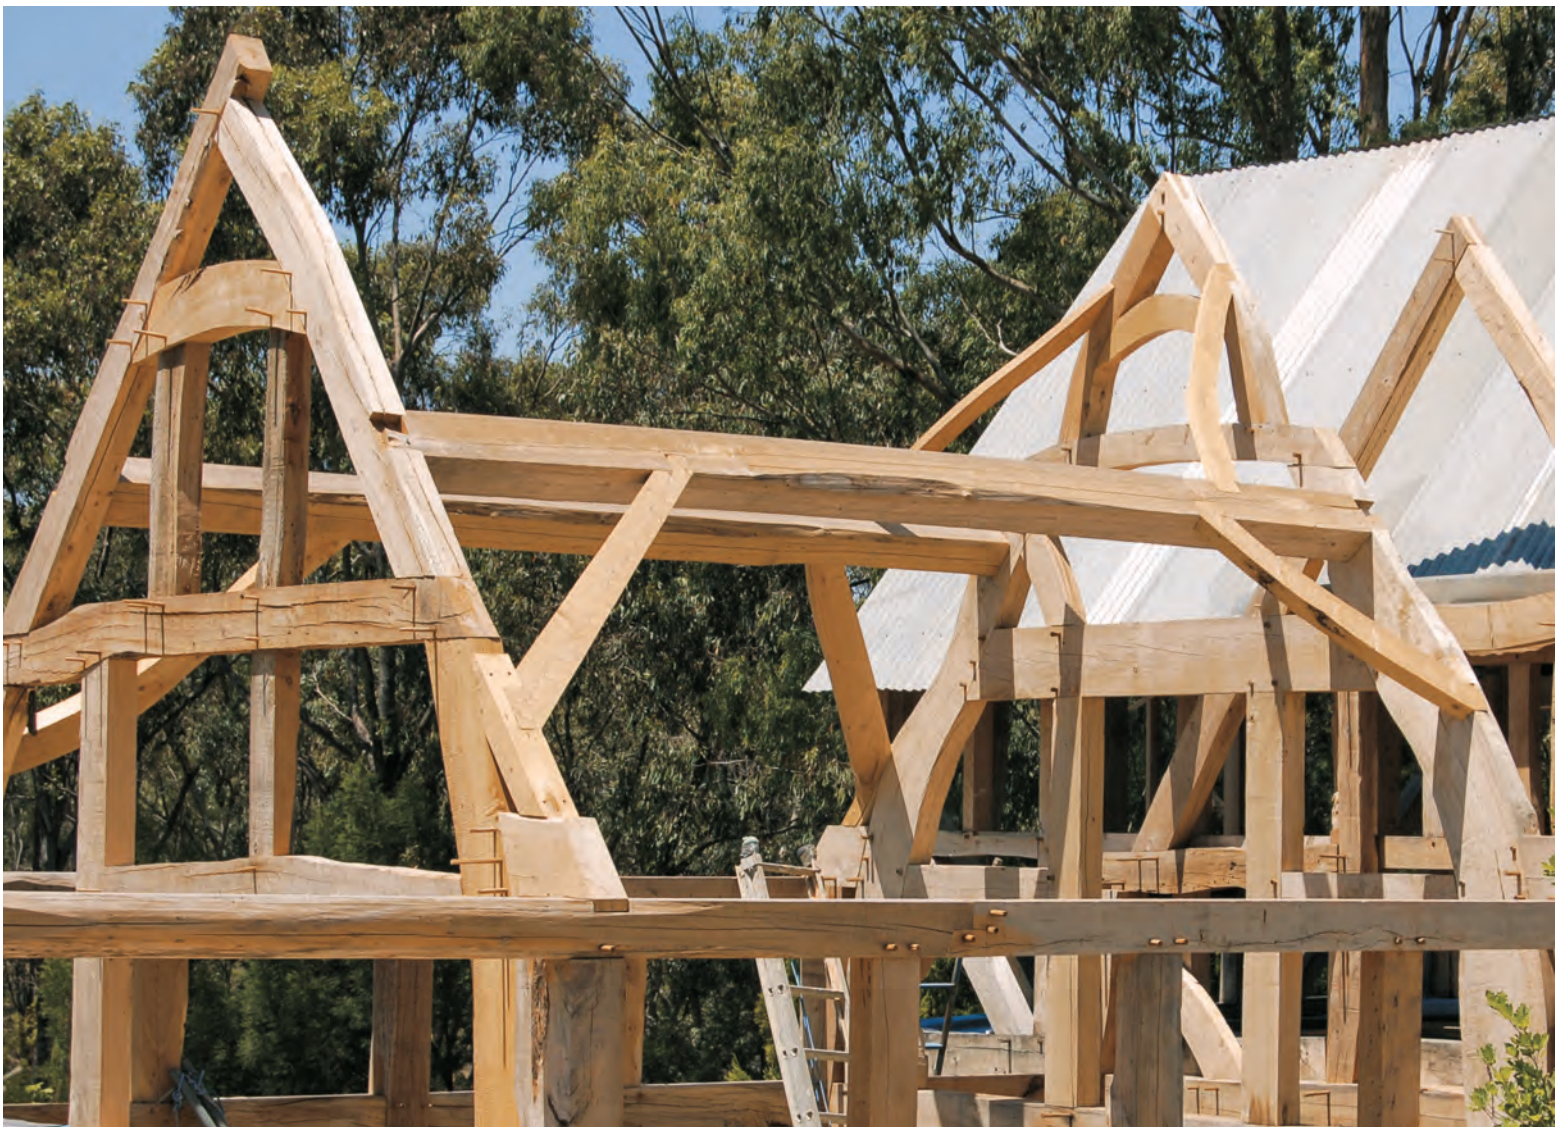
*Fig. 10. Framing of the ell continues. Note two tiered-cruck, spur acting as truncated tie, short bridled scarf in plate (three pegs) and lap-jointed wind braces. Additional crucks will rise to the left. The whole will be cob-walled and lime-plastered.*

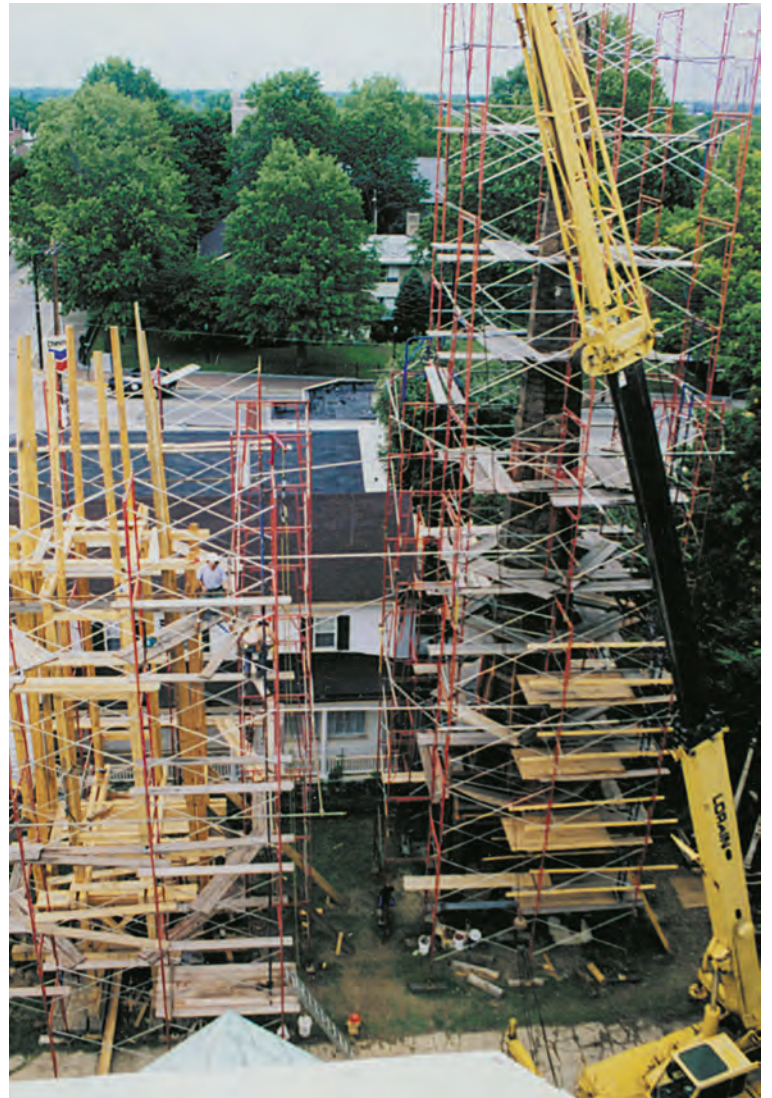
*Fig 1. Perfect original spire frame on right, totally replaced middle stages on left, awaiting lift onto Salem, N. J., Presbyterian Church, 1854, out of sight at right.*

At the Salem, New Jersey, Presbyterian Church (1854), the middle stages rotted, requiring complete reframing, while the healthy spire required only recladding (Figs. 1–3). At Christ Church, Philadelphia, built 1753, the wood sills laid upon the lower brick portion of the tower, as well as the feet of some of the great octagon lantern posts, rotted alarmingly by 1771, and the church's builder and designer Robert Smith was called back to repair it. Given the immense size and good condition of the steeple above, it was left in place (somehow supported on jacks, probably in successive segments) while the rotted timber was removed and replaced by built-up plank. Smith scarfed on new bottoms to the belfry posts as needed, and replaced with plank several of what he

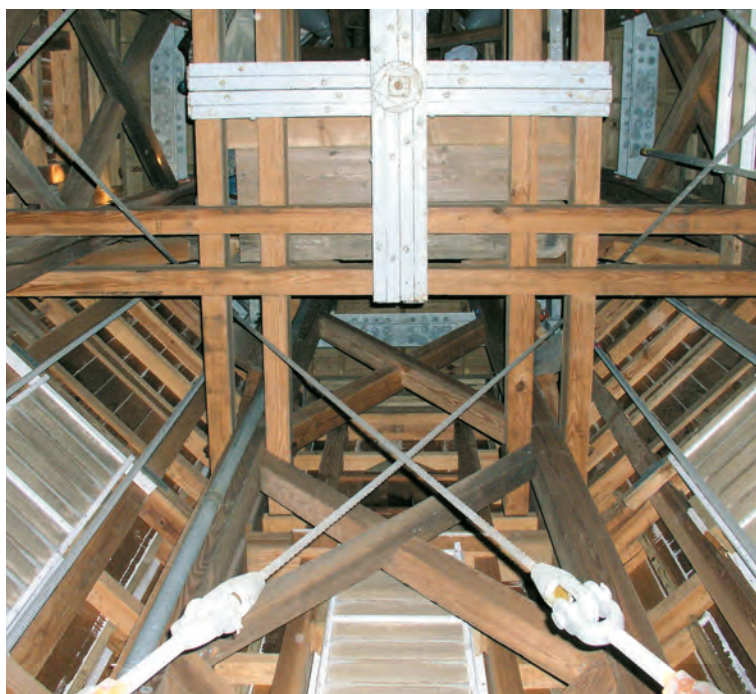
*Fig. 3. Restored middle-stage framing (octagonal stage, Fig. 2) of steeple at Salem. Tall spire above is tied down via long central bolt terminating at laminated crossing that bears up against partners in middle stage.*

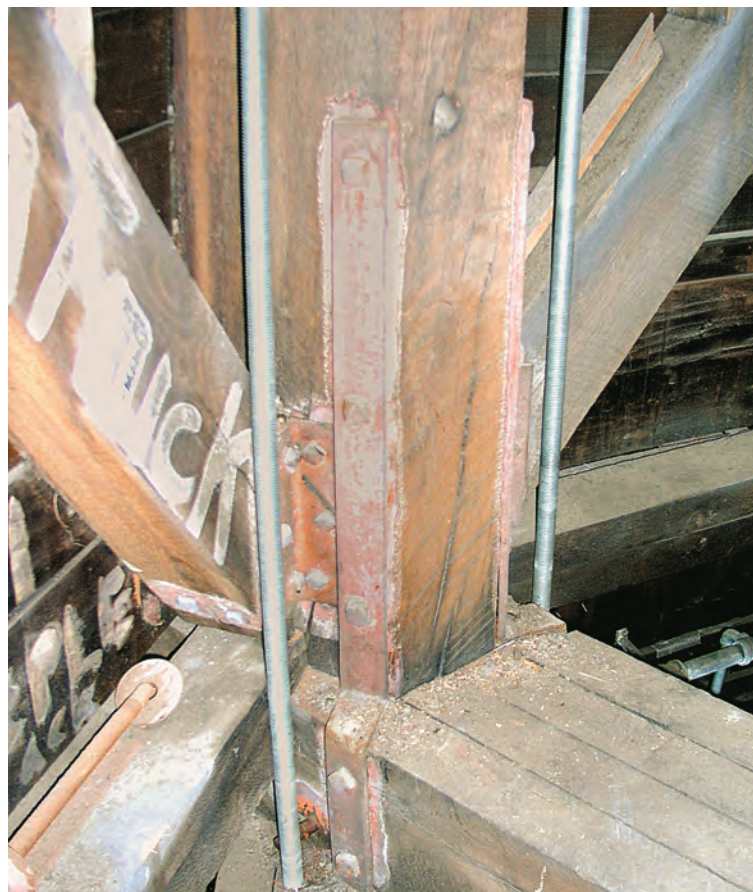
*Fig. 5. Laminated beams replaced rotted material at Christ Church in 1771. Iron straps appear to be original, rods 20th-century.*

called hammer beams, cantilevered members designed to carry the upper posts within the perimeter of a lower square tower. The spire, the ultimate stage of this rescued steeple, escaped water and decay but was destroyed by fire and rebuilt in 1908 (Figs. 4–5).

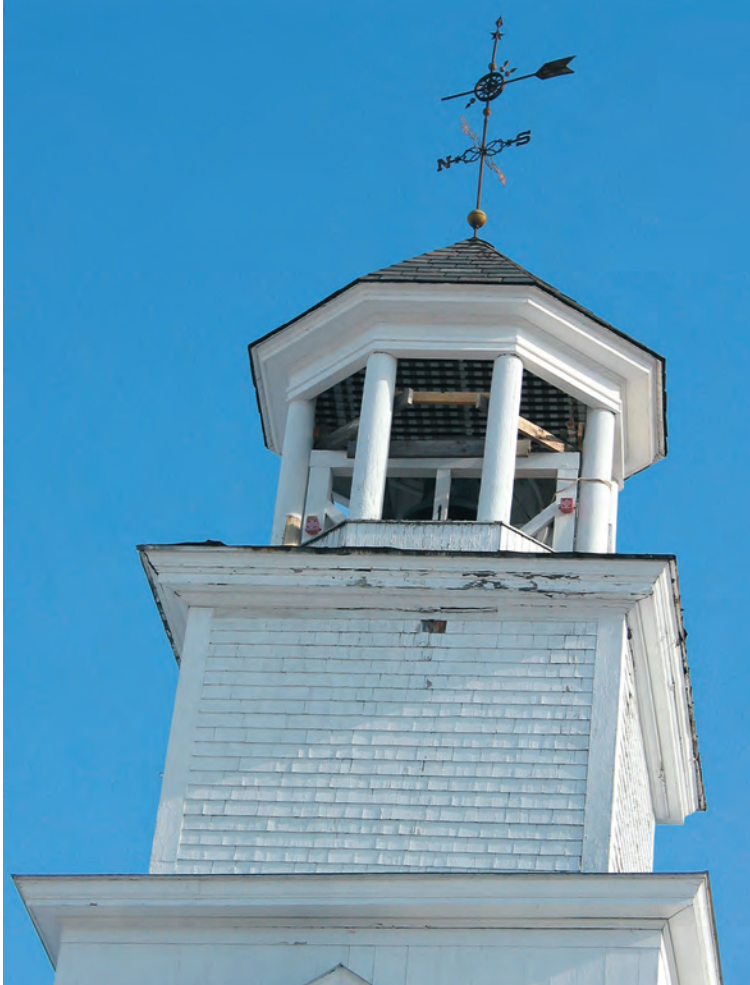
*Fig. 6. Decay in posts and supporting beams led to significant distortion of steeple at the South Woodstock, Vt., Community Church, 1836.*

At the South Woodstock, Vermont, Community Church (1836), the combination of rotted sleepers and tower posts and a rotted and deflected first truss chord caused the modest steeple to tilt out of plumb 7 in. on one axis and 5 in. on the other (Fig. 6). The steeple was restored by dismantling its conveniently telescoped and lodged stages (see TF 85).

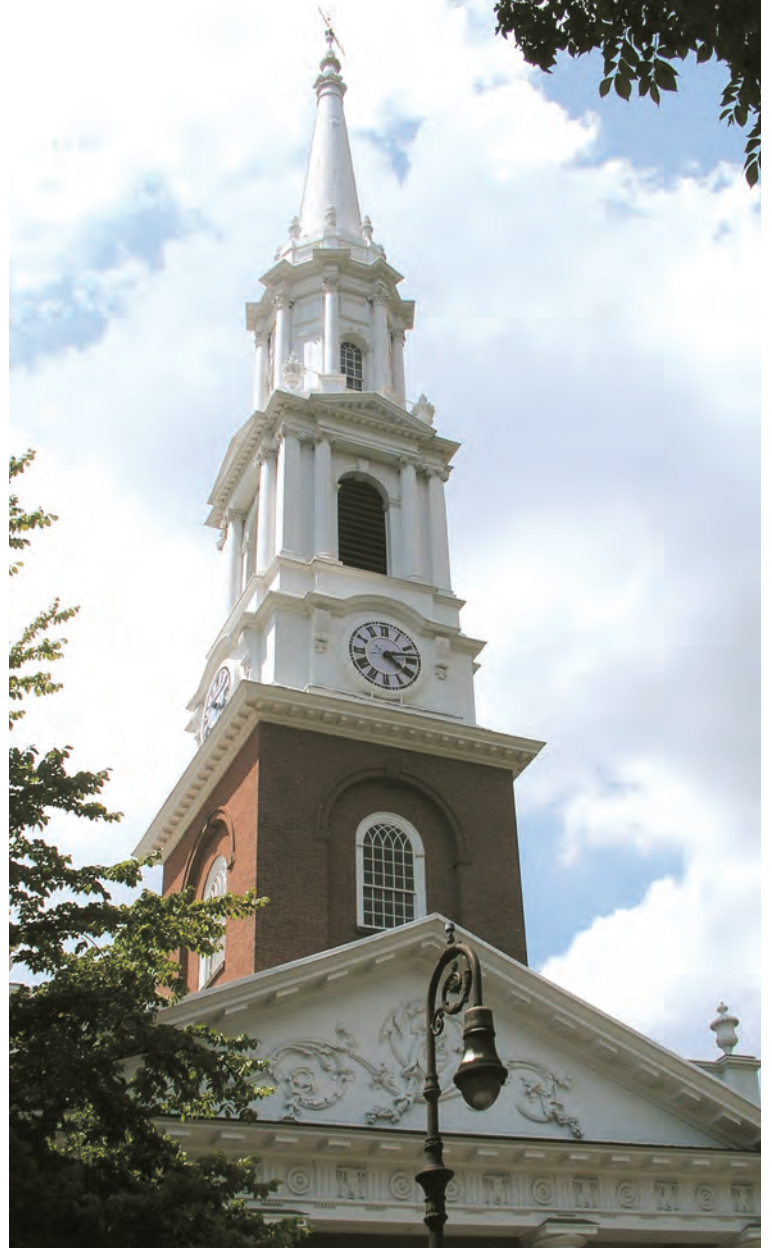
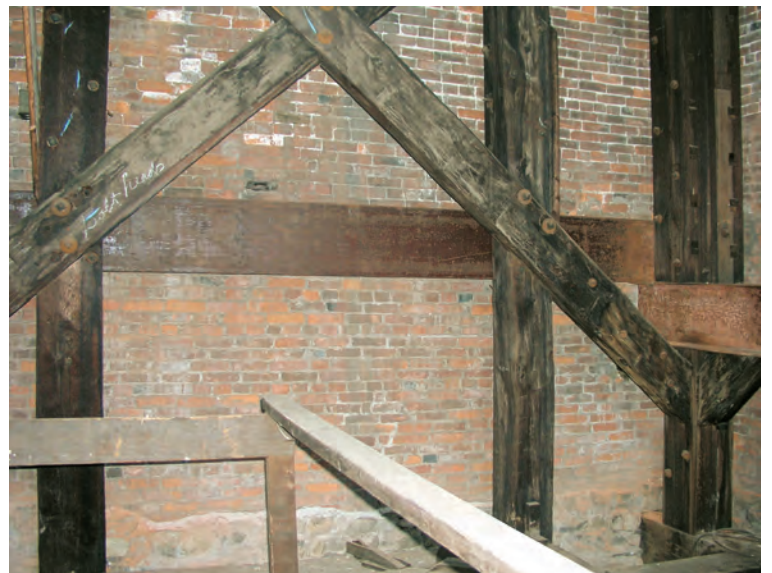
*Figs. 7–8. Center Church, New Haven, Conn., 1811. Deep penetration of stages to those below successfully resists effects of wind. Below, lowest wood-framed stage is deeply lodged in brick tower.*

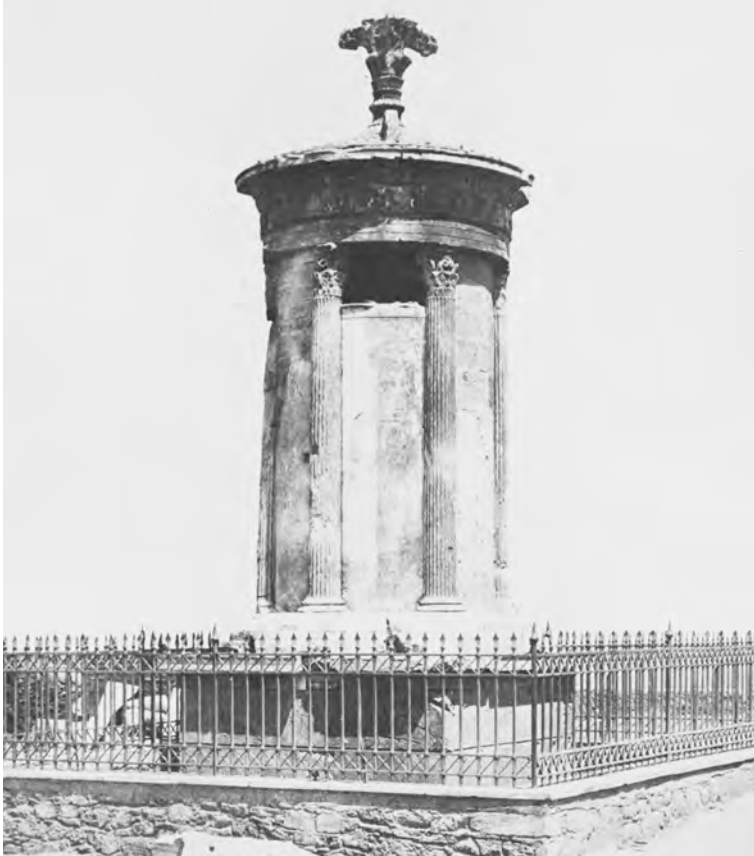
Fig. 9. *The Choragic Monument of Lysicrates, Athens, ca. 350 B.C. Drum surmounting Corinthian columns was adapted to other forms in 19th-century America.*

The open bell deck, a stylistic choice of form that threatens many spires, often provides no concealed space for stages above to drop long posts into stages below. The insertion of an open colonnade of four, six or eight slender posts, sometimes surrounding a bell, is a post-Gothic feature based on certain classical structures such as the Choragic Monument of Lysicrates (Fig. 9). Wren and

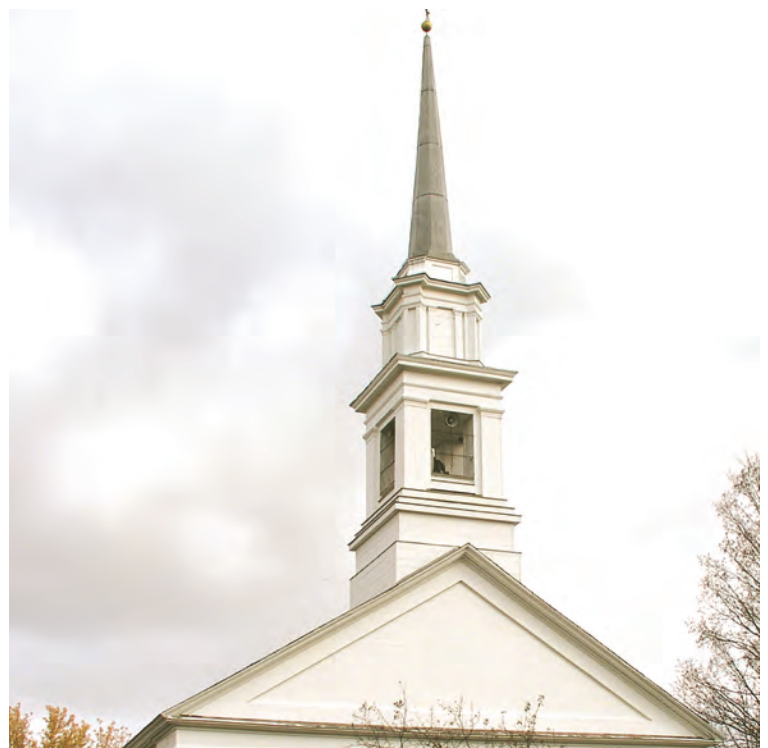
Fig. 11. *Steeple at Castleton, Vt., Federated Church, 1832, showing thickened belfry corners to conceal telescoped posts from above.*

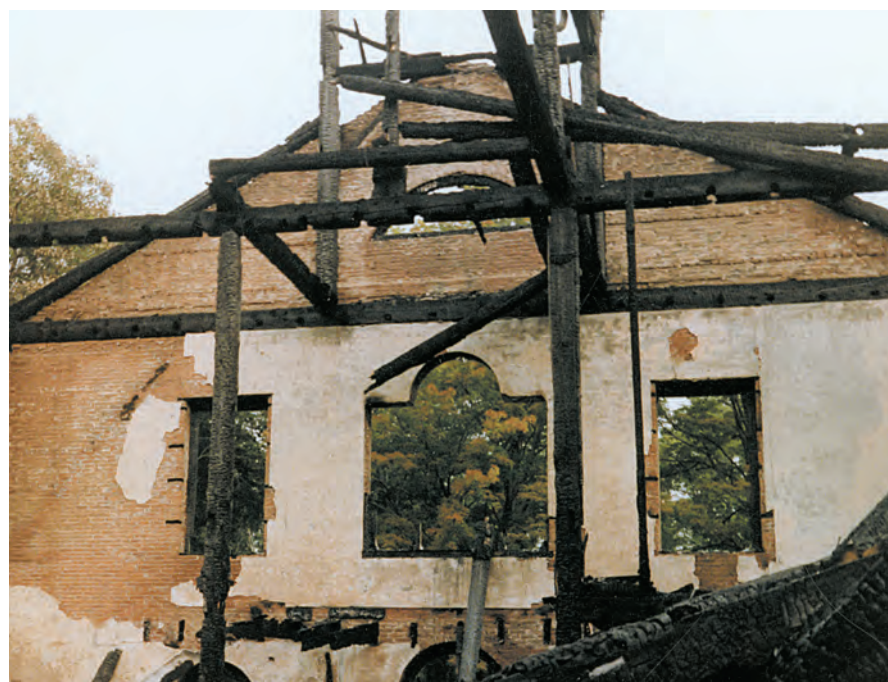
Fig. 16. Weathersfield standing timber remains included three tower posts, inset front plate, sleepers, first truss tie beam and vestibule posts.

**T**HE WEATHERSFIELD MEETINGHOUSE. In 1985 a fire destroyed all the timber portions of the 1826 Weathersfield, Vermont, Meetinghouse, leaving the brick walls standing (Fig. 16). The church's insurance company was quick to offer a check for the insured value, but the policy also promised to replace the building in kind. A determined church committee waved away the first offer and decided to discover what "in kind"

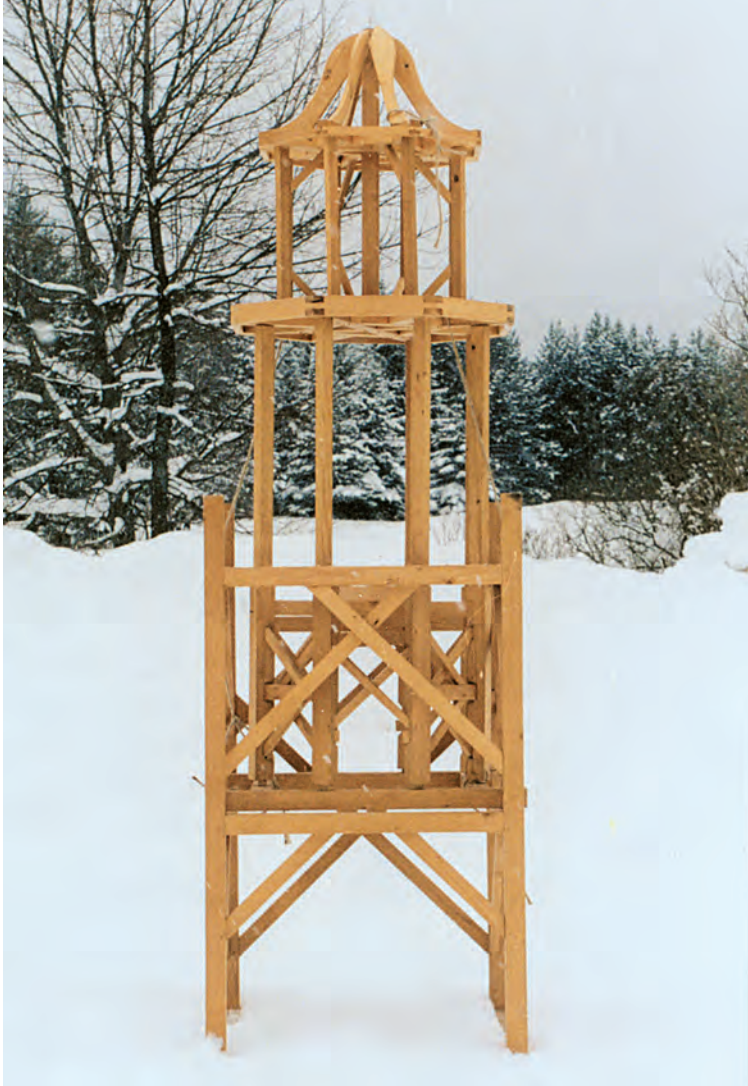
*Fig. 17. One-inch-scale Weathersfield steeple model in spruce and with correct joinery, built by Ted Ingraham. Model stands 70 in. high.*
