# TIMBER FRAMING

JOURNAL OF THE TIMBER FRAMERS GUILD

Number 87, March 2008

*Reproducing a Burned Steeple*

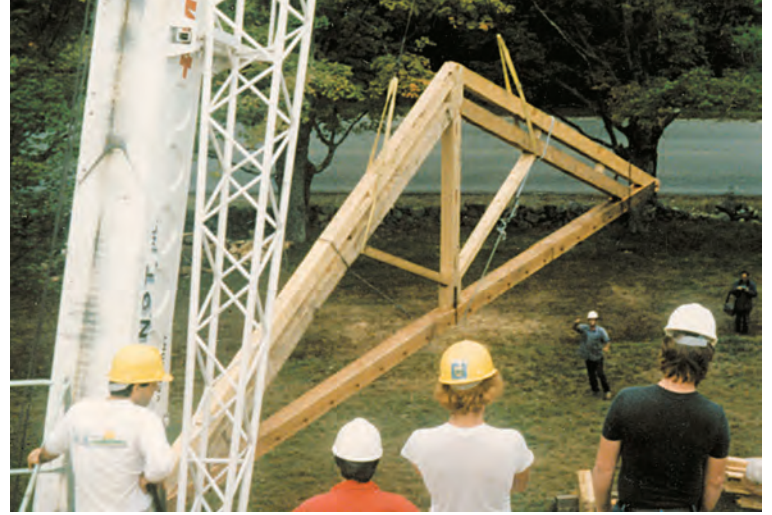
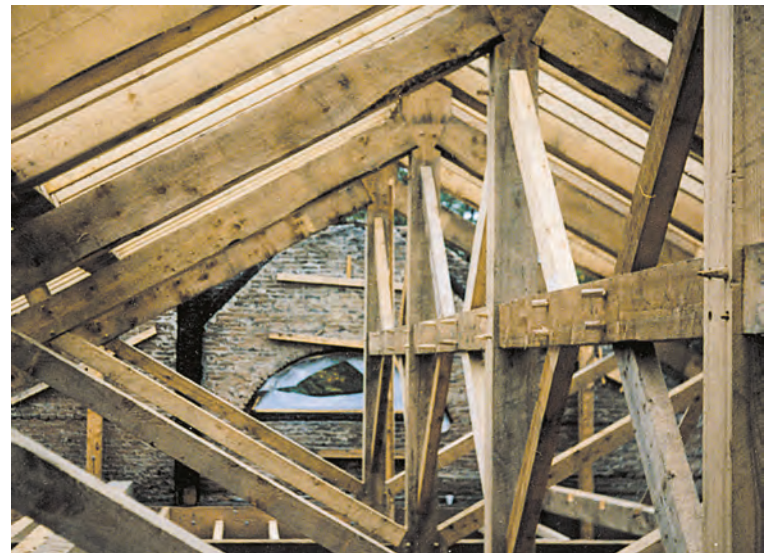
*Figs. 18–19. Weathersfield truss fly-in was complicated by making up the closed mortise and tenon joinery of many connecting members.*

The assembled trusses were then flown into position atop the plates and their closed mortises engaged, laboriously, with the 32 tenons awaiting each side of each truss. These tenons belonged to longitudinal girts and bracing entering the kingposts, purlins entering the upper rafters and many ceiling joists entering the tie beams (Figs. 18–19). At this point in my heavy-timber-framing career, I had not discovered that practical framers of the past had invented at least four methods of insertion (TF 76:23) to avoid having to engage all the ceiling joists simultaneously.

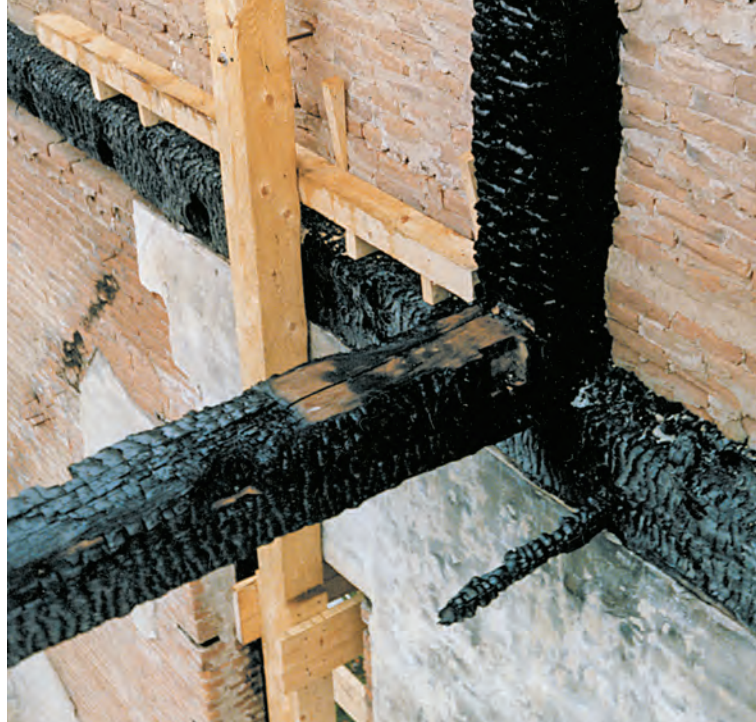
*Fig. 20. Charred remains of inset plate, front tower post and long sleeper to carry steeple. New material is part of front-wall shoring.*

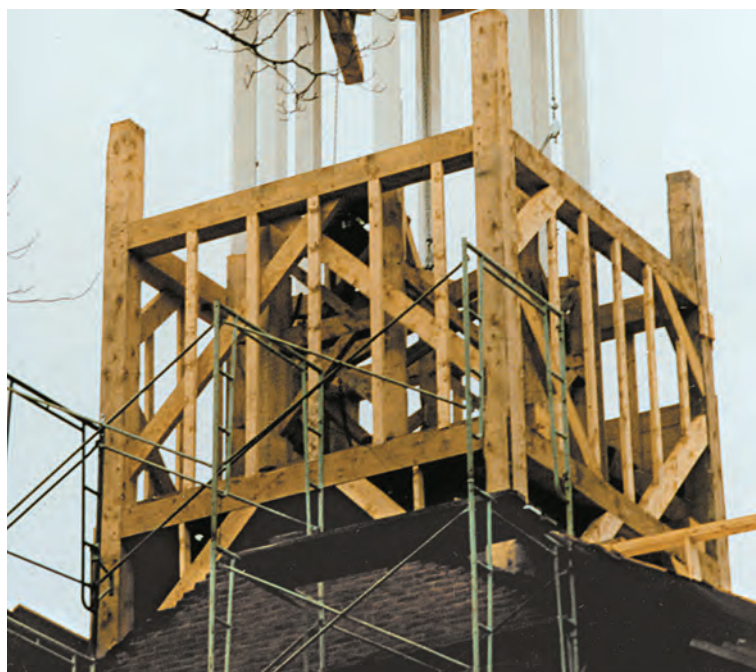
*Fig. 21. Weathersfield tower frame in place, well braced and studded for exterior finish. Posts descend to long sleepers in attic and carry short sleepers halfway up to foot belfry posts. See also Fig. 17.*

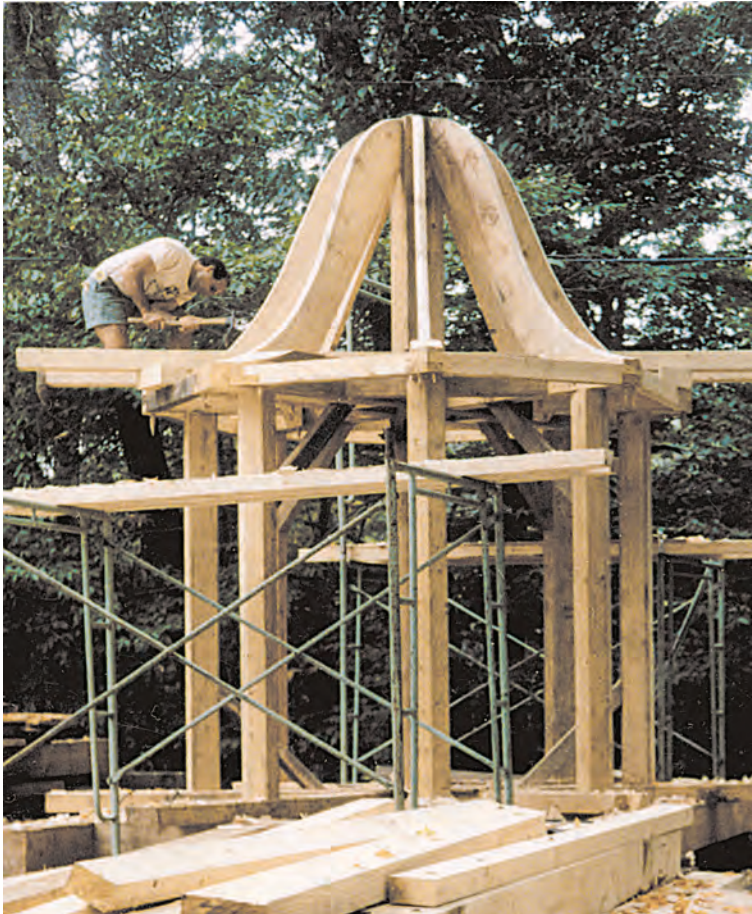
*Fig. 23. Mike Cotroneo fairing legs of lantern crab to cupola roof's ogee rafters. An adze in good hands remains unsurpassed for such work. Lantern posts will tenon to major crab atop belfry in Fig. 24.*

The desired framing of the lantern, the top stage, was less obvious. We had the remains of a mast that anchored the weather-vane and rose the full height of the lantern and its cupola roof. How it could pass through a crab was unclear, so for the lantern crab that would carry its cupola roof we altered the typical design of the period by turning its main axis into partners, parallel timbers spaced apart, to accommodate the mast we knew to be original. The ogee rafters of the lantern's cupola roof were cut from solid 2½x18 white pine plank, and careful adzing continued their curve onto the supporting crab legs (Fig. 23 overleaf).

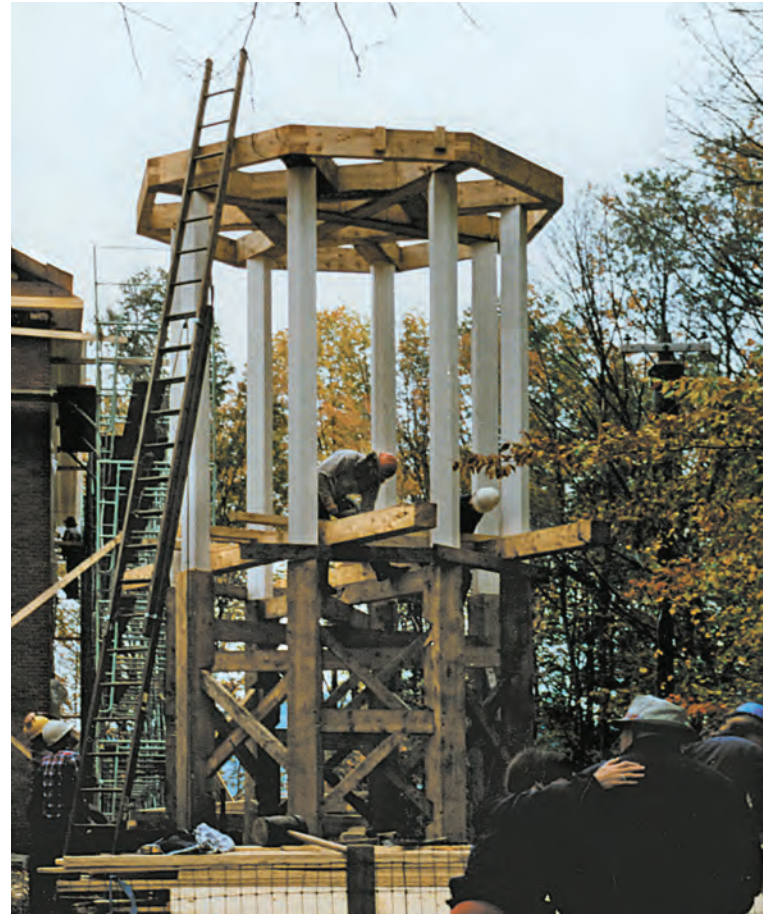
*Fig. 24. Belfry frame with major crab installed on top to carry lantern. Workers rig heavy lifting timbers that will bear under the crab to transport the assembly to the meetinghouse.*

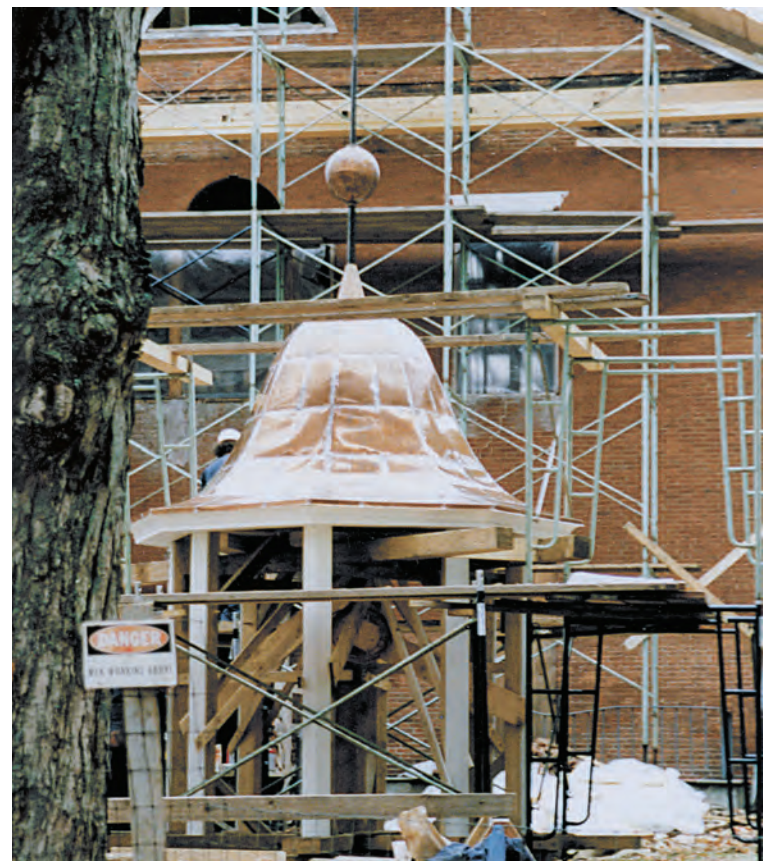
*Fig. 25. Lantern covered by soldered copper cupola roof, topped by mast with orb (weathervane unseen above), awaits lift to top of belfry. Timbers just under cornice will be strapped to lift the stage.*

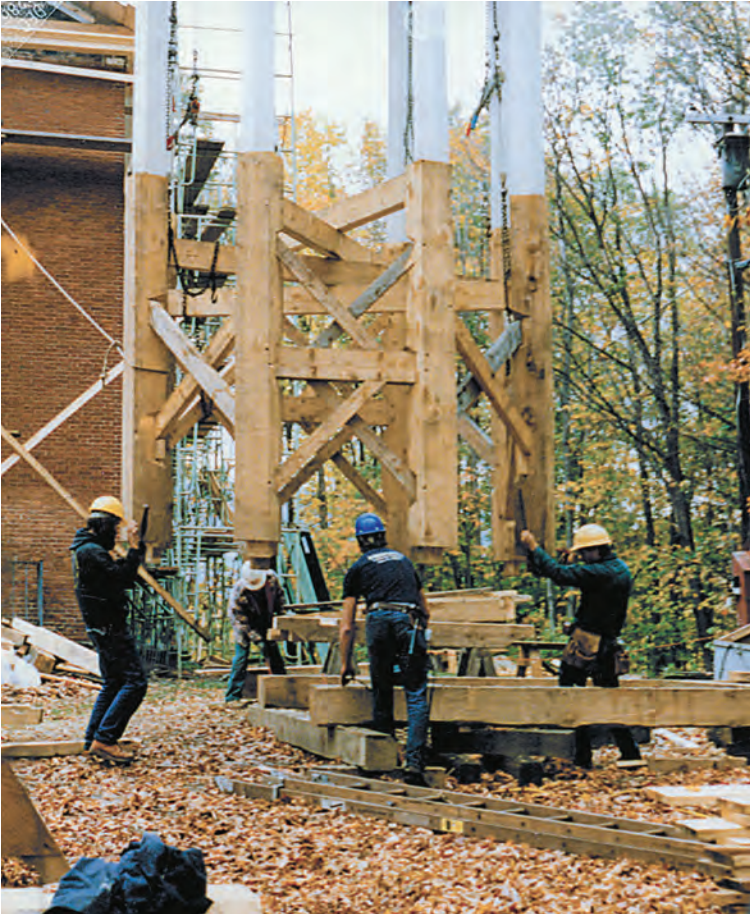
Fig. 26. Belfry frame with lantern (unseen) lifts off. Scale of work, hardly apparent once steeple is in place, is plain enough near the ground. Braces and girts were added to frame design to counter vibration.

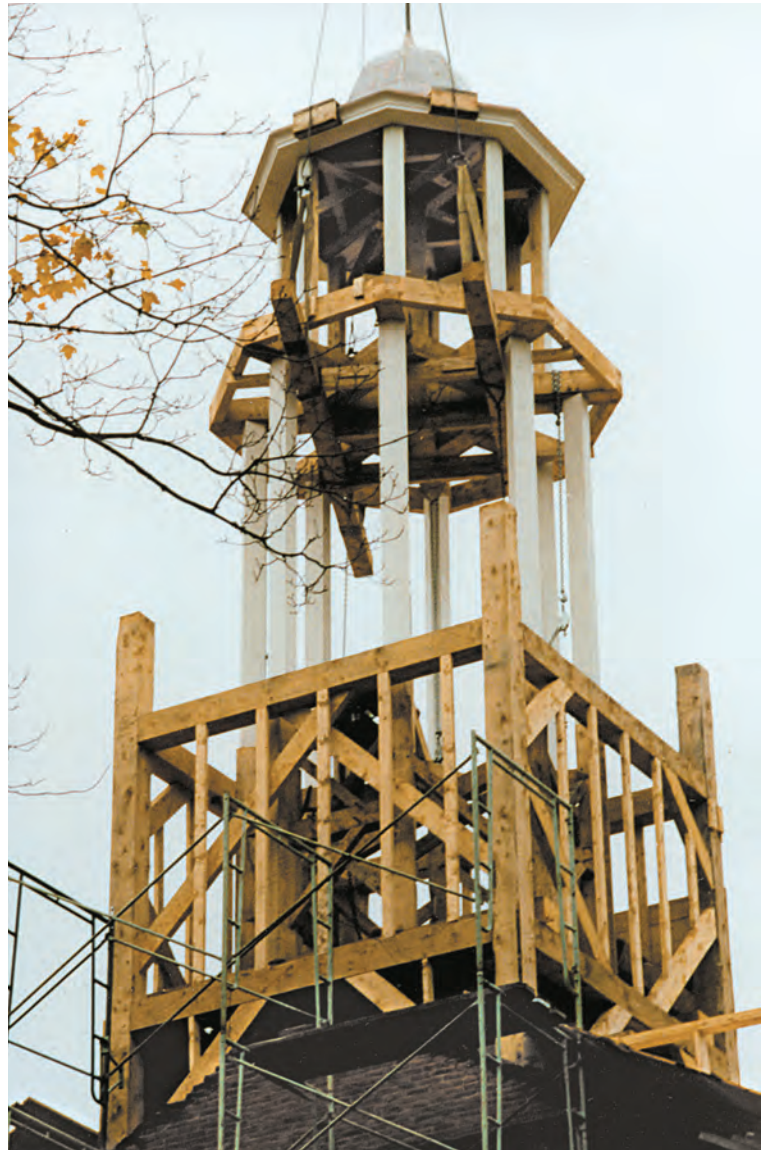
Fig. 27. Completed steeple frame installed on meetinghouse, awaiting bell girts and bell and considerable finish work. Crab with partners to allow passage of central mast visible in ceiling of lantern.
