# TIMBER FRAMING

JOURNAL OF THE TIMBER FRAMERS GUILD

Number 85, September 2007

# Danish Country Manor Open Timber Roof

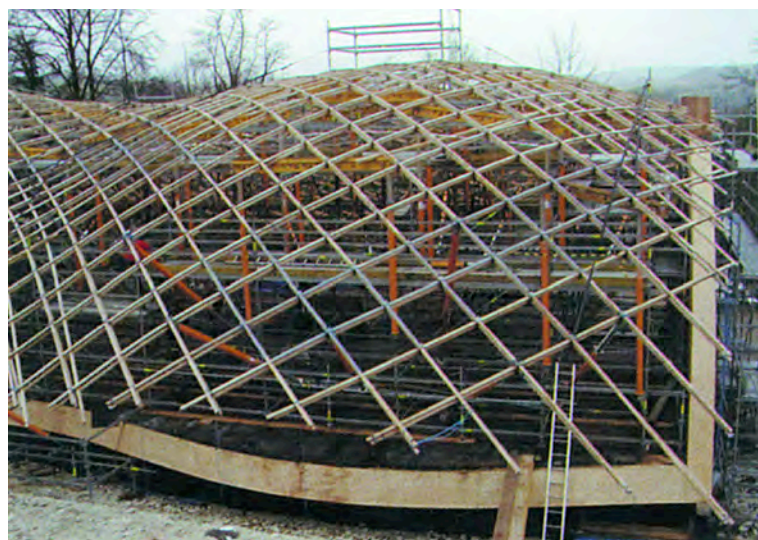
**Fig. 3.** Double-layer gridshell at Weald & Downland Museum, Sussex. Edward Cullinan Architects with Buro Happold, engineers, built by Green Oak Carpentry Co., about 49 ft. by 164 ft. in plan, 33 ft. high.

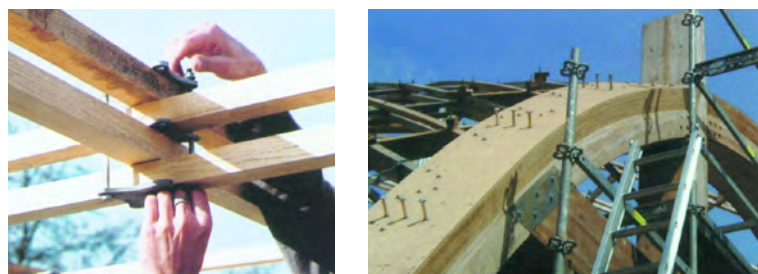
**Fig. 4.** Gridshell construction details. Above, assembling and bolting together a node with patented system of plates. Above right, European larch glulam arch over entrance. At right, cladding of UK-grown red cedar. Boarding is laid to account for expected cupping.

In the UK most external finishes are of masonry and we don't often see timber used as cladding or siding. In recent years designers have been specifying it on fairly well-known public buildings. Aided by engineers in dealing with the classic issues of movement and corrosion of fasteners, the designers' new approach has led to a fair amount of reinventing the wheel. It has to be said that there are one or two well-reinvented wheels as a result, and the book gives them a fair showing. Buildings clad with timber acting as a rain screen invariably look really attractive, and anything that gets more timber into everyday use has to be a bonus (Fig. 4).

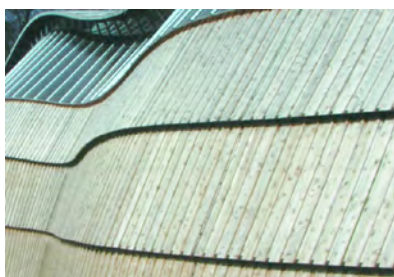
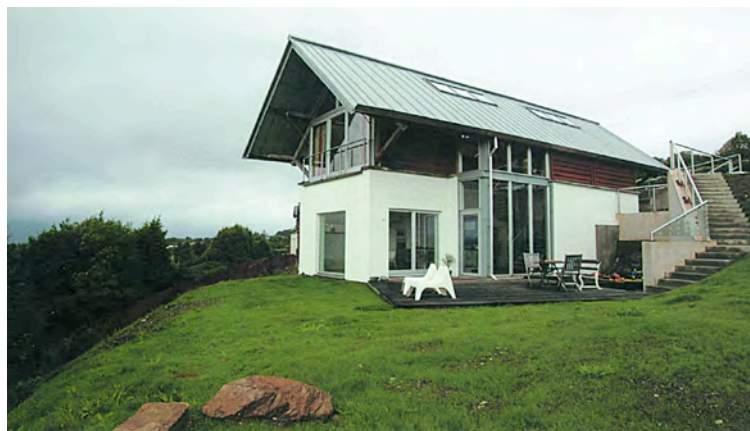
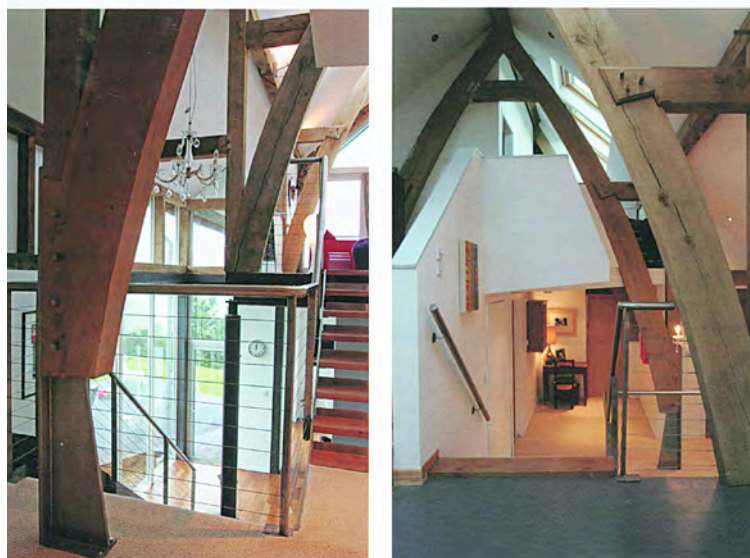
**Fig. 5.** Composite waterfront house framed in oak and stainless steel, designed by Bl@st Architects and framed by Carpenter Oak & Woodland.

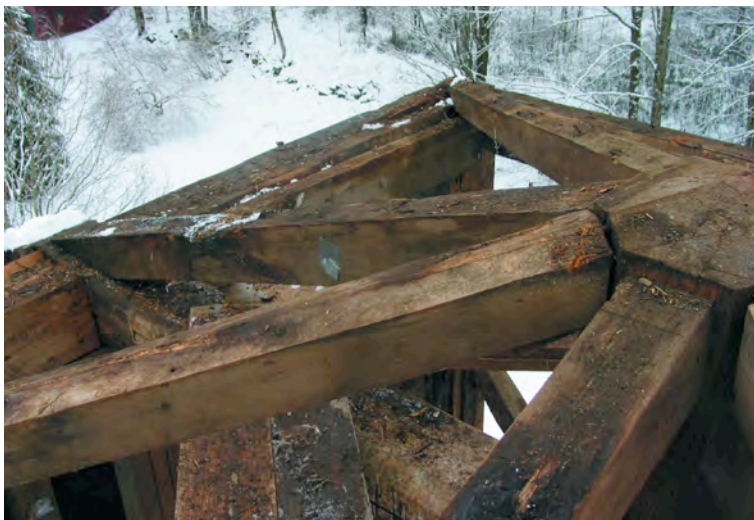
Fig. 2. Original South Woodstock bell deck. Since belfry is open to weather on four sides, deck must be framed and sheathed to shed water. Rafters measure  $4 \times 4\frac{1}{2}$ , hips  $3\frac{1}{2} \times 5$ . Short kingpost is 14 in. across flats.

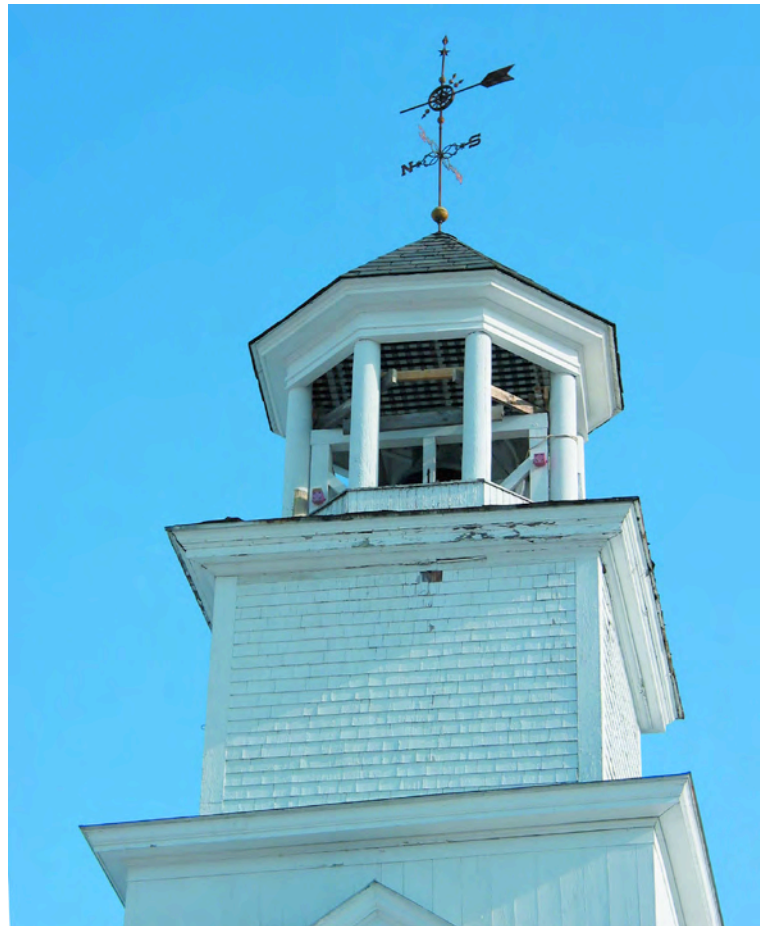
Fig. 3. Steeple of South Woodstock church before repairs. Compound tilt, somewhat unusual, includes typical backward lean from overloading of the first interior truss combined with sideward lean from rotting posts and sleepers along the south side of the tower.

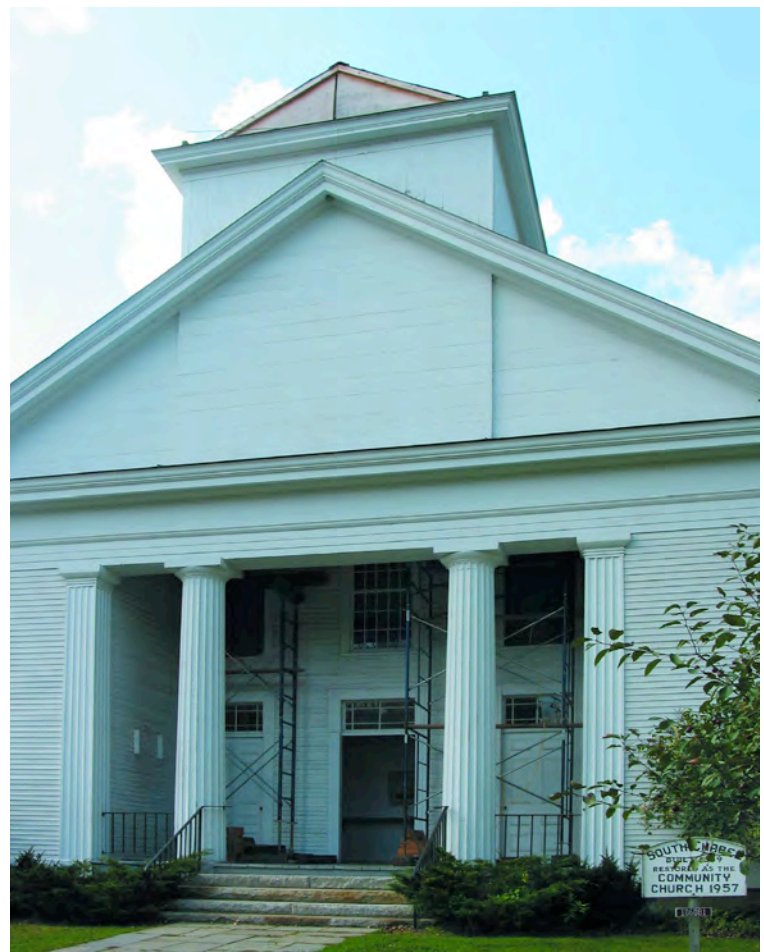
Fig. 4. Greek Revival facade of South Woodstock Community Church after removal of steeple upper stages and capping of tower with light temporary roof. Church was built in 1839 as South Woodstock Congregational Chapel and took its present name in 1957.

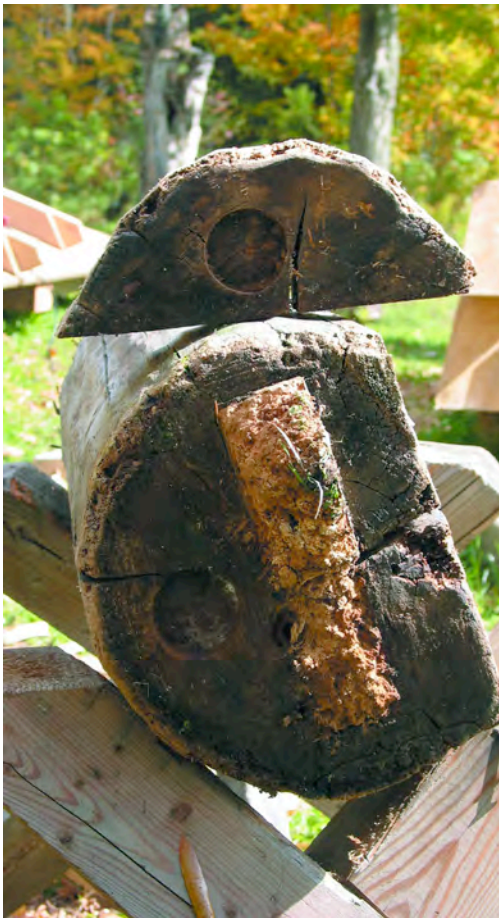
*Fig. 5. Original column butt with turning center and regularly offset tenon. Crescent section perched on top is from another column.*

With the columns on the ground, we discovered the original turning centers, 2-in.-dia. holes 2 in. deep, giving us reference points for correctly locating tenons on the bottom of restored or replacement columns. An octagonal layout had been superimposed upon the diagonal sleepers, and mortises cut at eight regularly spaced points. We were able to cut (or insert) tenons on the bottoms of the sleeper mortises correctly to hold the columns plumb (Figs. 5–7, 10).

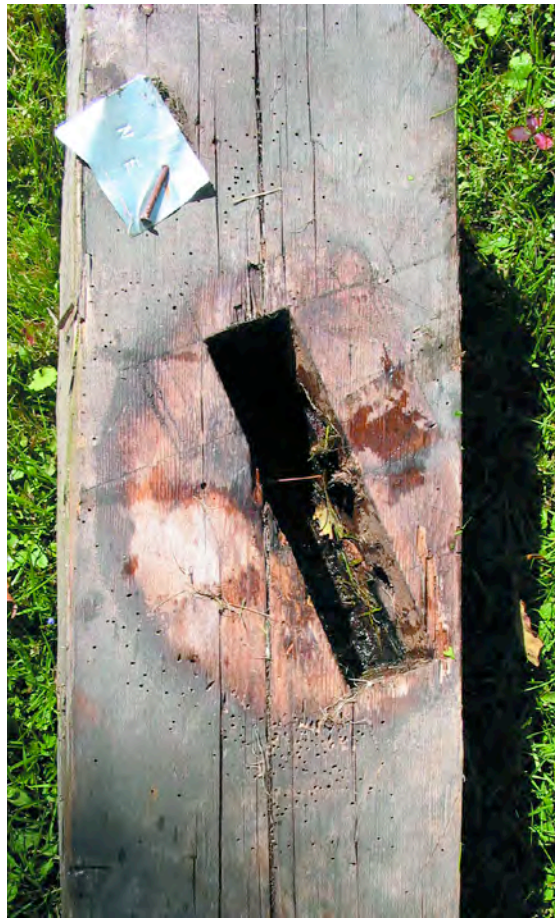
*Fig. 6. Original mortise in sleeper, skewed as necessary to follow regular octagonal pattern. Ghost reflects hewn clearance reduction of column in Fig. 5.*

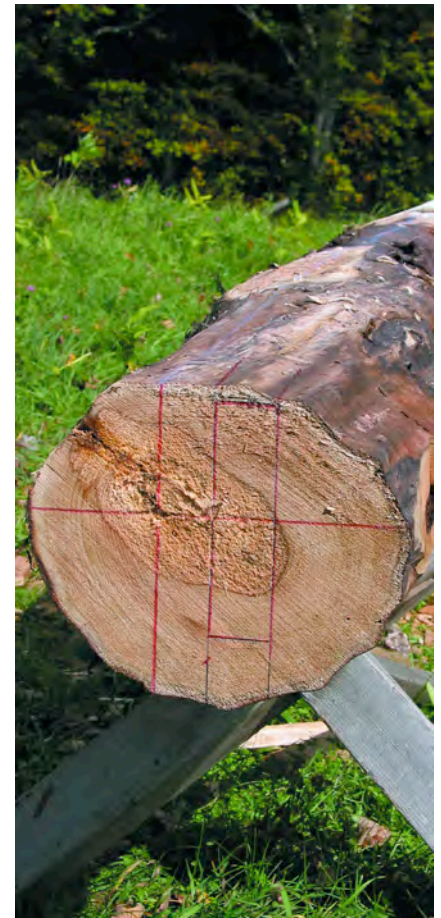
*Fig. 7. Layout for tenon on repaired column. Pierced hole at upper left crossing of lines represents reference center.*

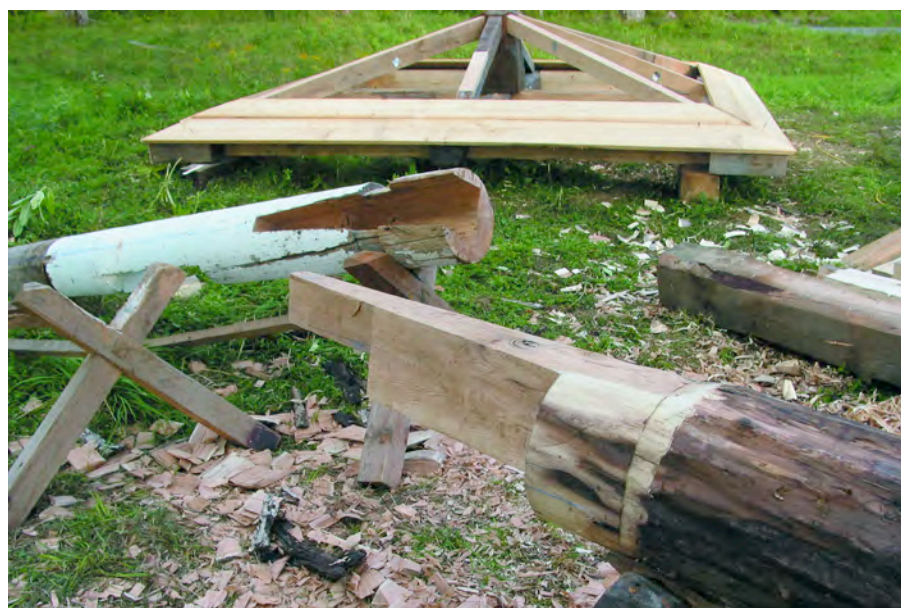
*Fig. 8. Distinctive scarf joint in progress between new column bottom and old column top. Mostly rebuilt bell deck in the background.*

Restoration required copying the dimensions, species and joinery of the various members and reassembling them. The in-place tower called for extensive free and slotted tenoning since it couldn't be fully pulled apart. We were free to rebuild the second stage, however, as it was originally built. The butternut columns were elaborately repaired and two replaced, although finding reasonably straight and sound 13-in.-dia., 18-ft. butternut logs was difficult because of the present diseased state of the species (Figs. 8–11).

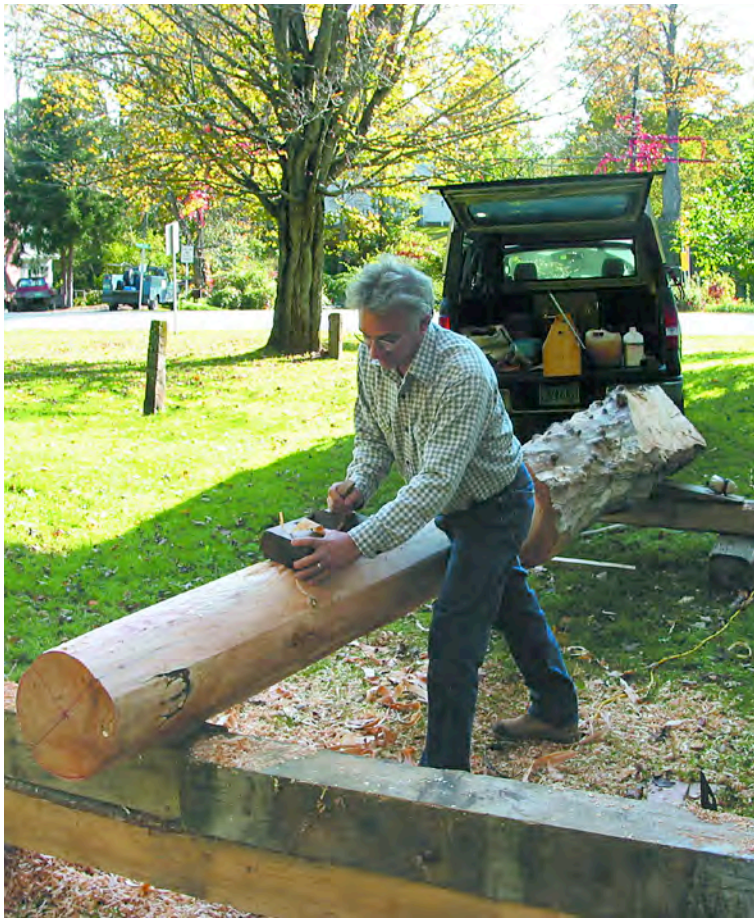
*Fig. 9. Author smooths one of two new replacement columns, laid out, sawn, shaved and planed rather than turned as were originals. Bully surface where left rough suggests difficulty of finding good butternut today.*

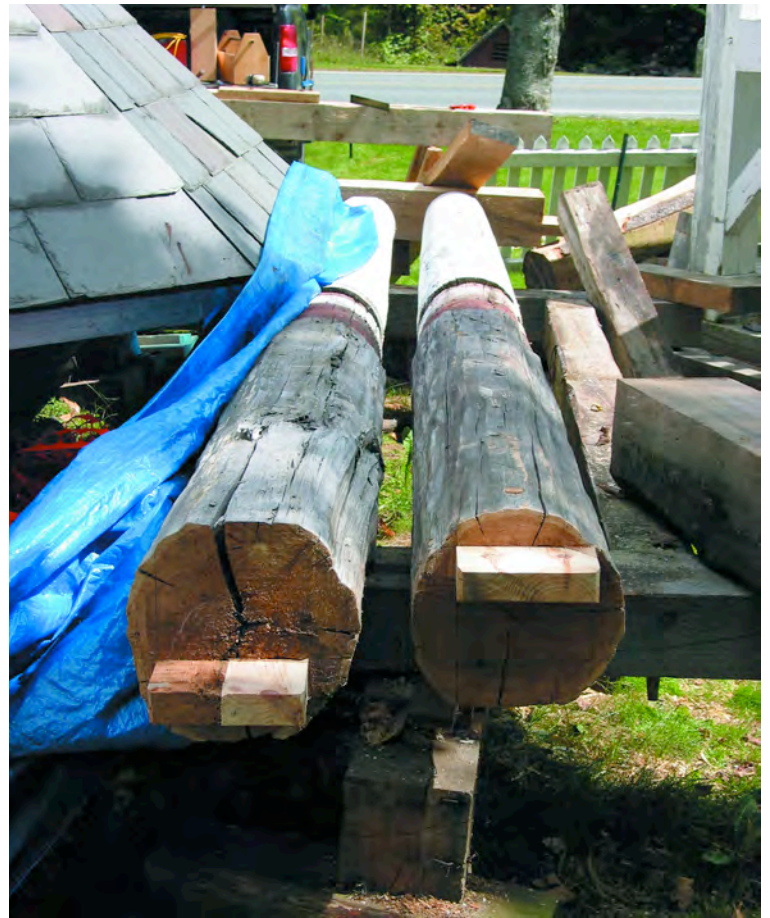
*Fig. 10. Repaired columns using original lower ends, shortened to remove decay, in one case leaving enough sound wood for an integral half-tenon. Pale wood indicates free tenons.*

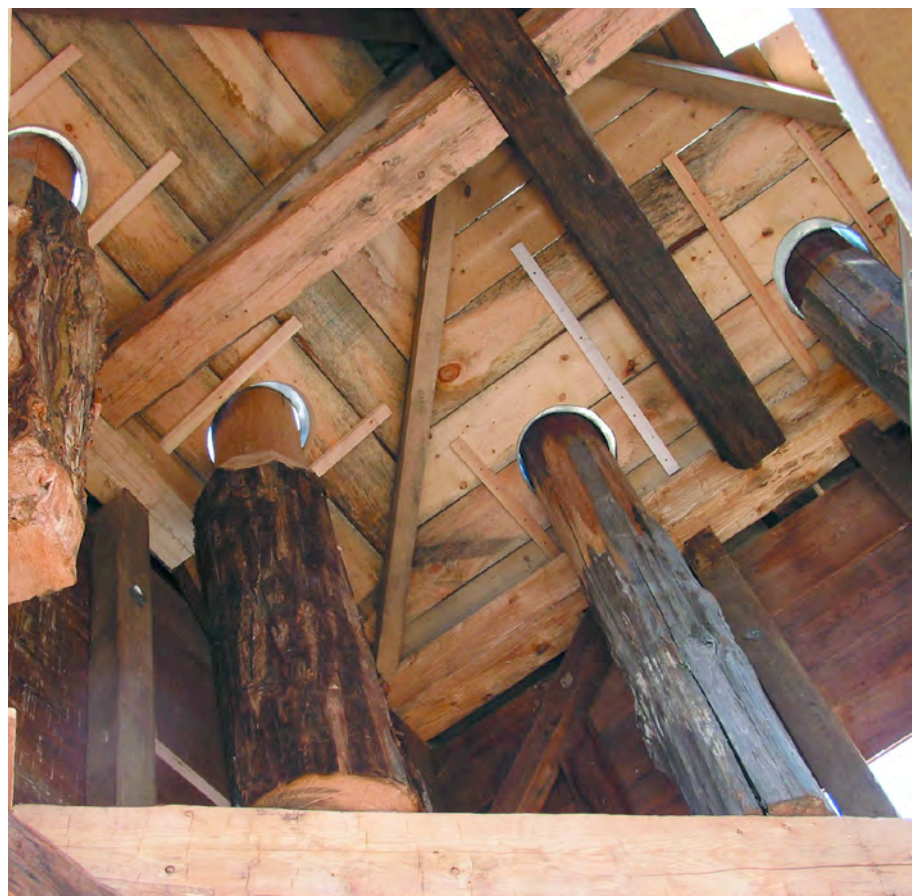
*Fig. 11. Reconstructed bell deck admits scarfed and new columns (two at left) through the boarding to appear in the belfry as tapered cylinders.*

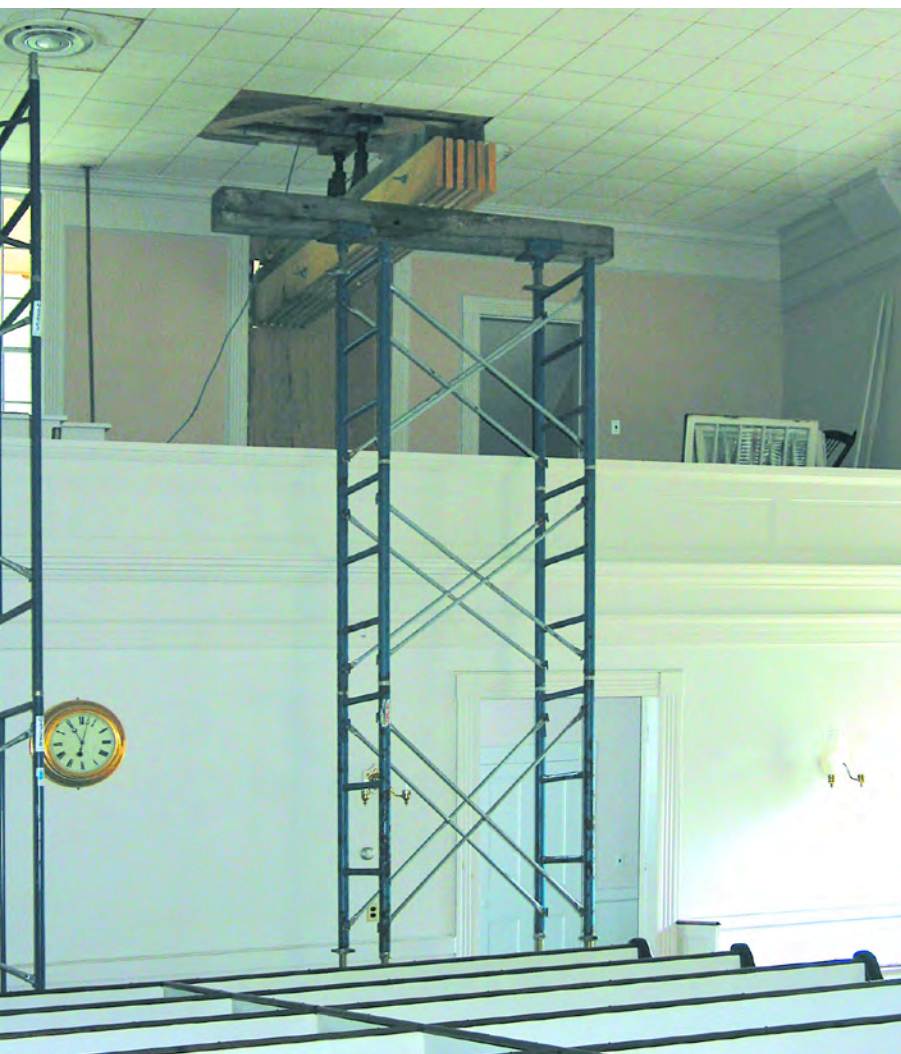
Fig. 12. Structural stage inside church paired with another on the porch outside (see Fig. 4) provided base for lifting elements within tower.

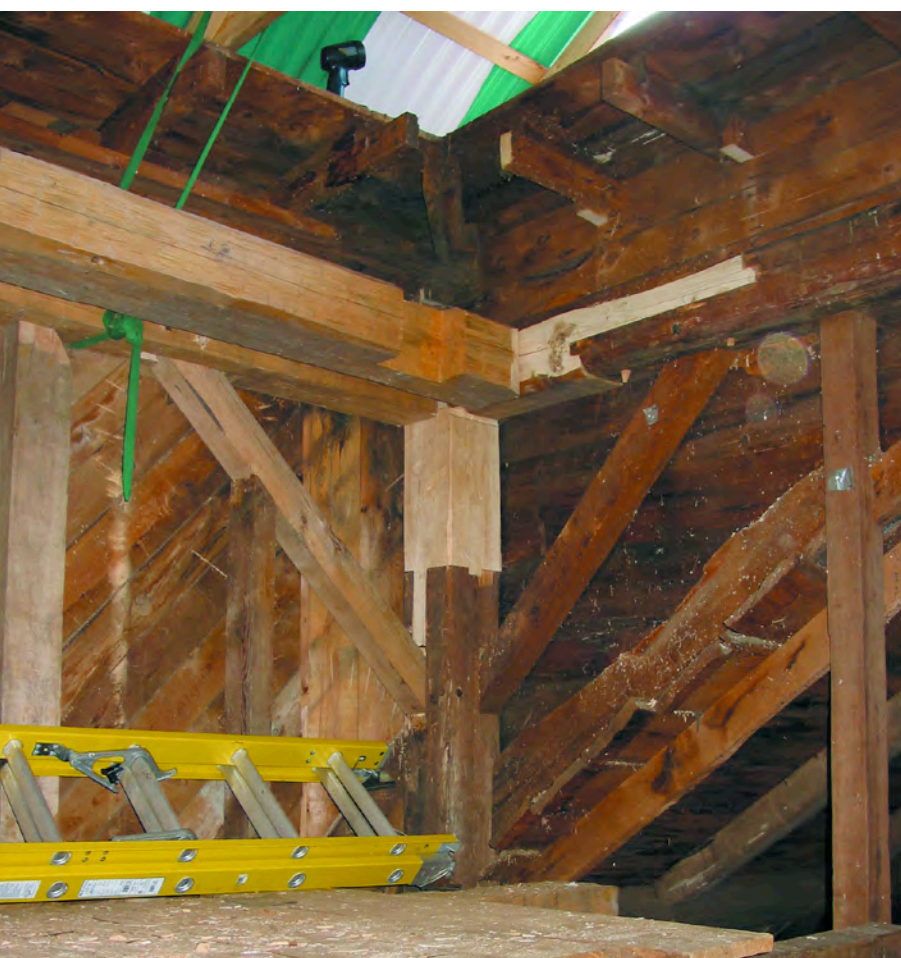
Fig. 13. Tower required numerous scarfed repairs and whole-member replacements, using structural staging as jacking base for insertions.

Each pair of scaffolding towers carried large built-up beams passing through the second floor windows of the front gable of the church. Screwjacks atop these lifted the sagged truss chord to slightly above level so that the additional queenpost elements could be installed and then loaded. We also increased the sleepers for the octagon columns from 7x9 to 10x11 inches in response to sagging observed in the originals. After completing repairs to the tower (Fig. 13), we lifted the ensemble, stage by stage, back into position.

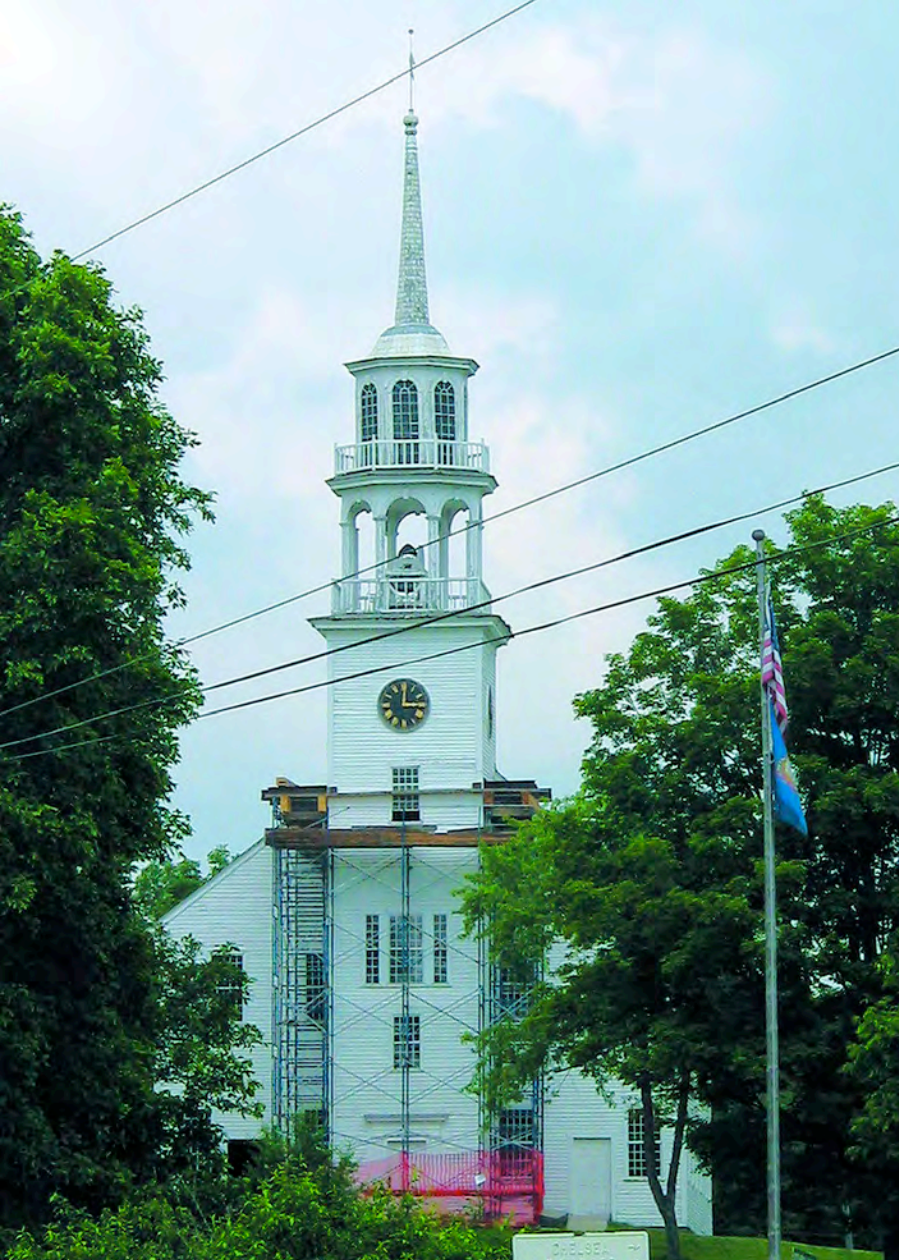
*Fig. 15. Strafford Town House, Strafford, Vermont, 1799. Author used structural staging to lift and internally hold 68 ft. of steeple while repairs were made in place to supporting tower girts threatening failure.*

Since the belfry, lantern and spire were to be left in position at Strafford, the rigging problem was how to lift these upper stages off the tower girts that were failing under load. The solution was to erect 42 vertical ft. of tied-together structural scaffolding around all three sides of the tower, footed on good gravel. On top of the scaffolding at two opposing sides of the tower we established framed cribs, each composed of two levels of stacked 8x9x17 hemlock timbers spread 5 ft. apart by tenoned 6x6s (Figs. 15 and 18).

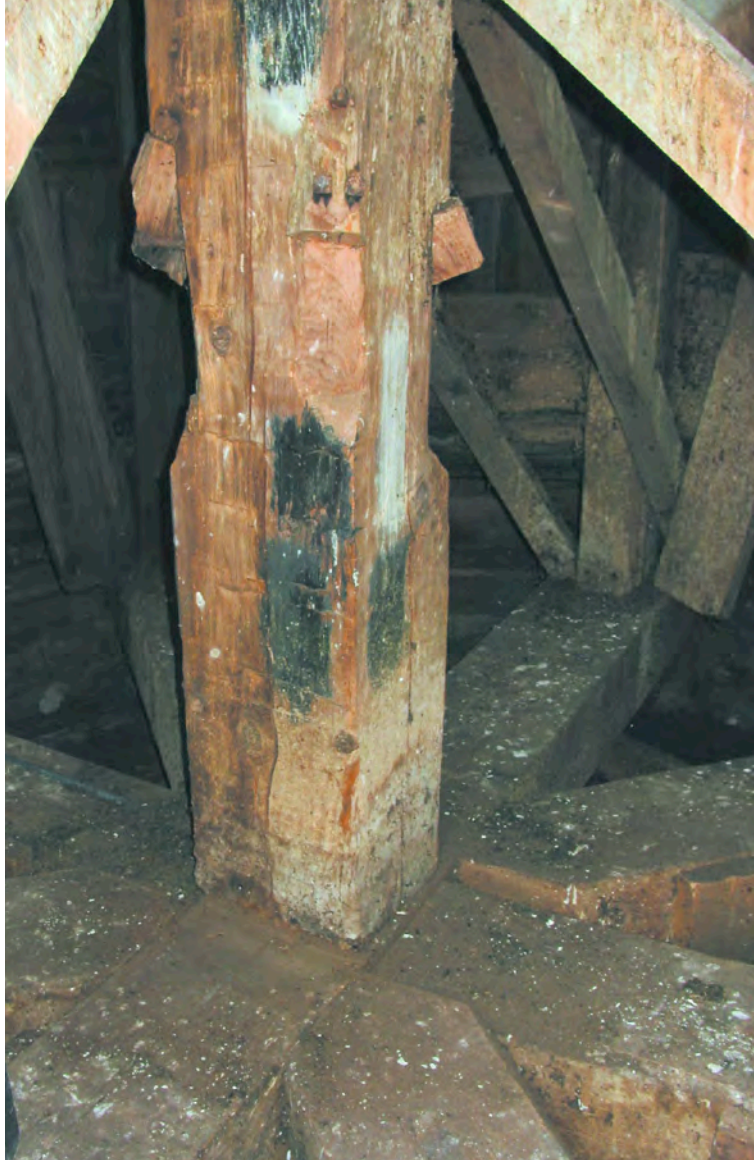
*Fig. 17. Mast for Strafford spire is footed in eight-legged crab in belfry roof, which also forms base of octagonal lantern.*

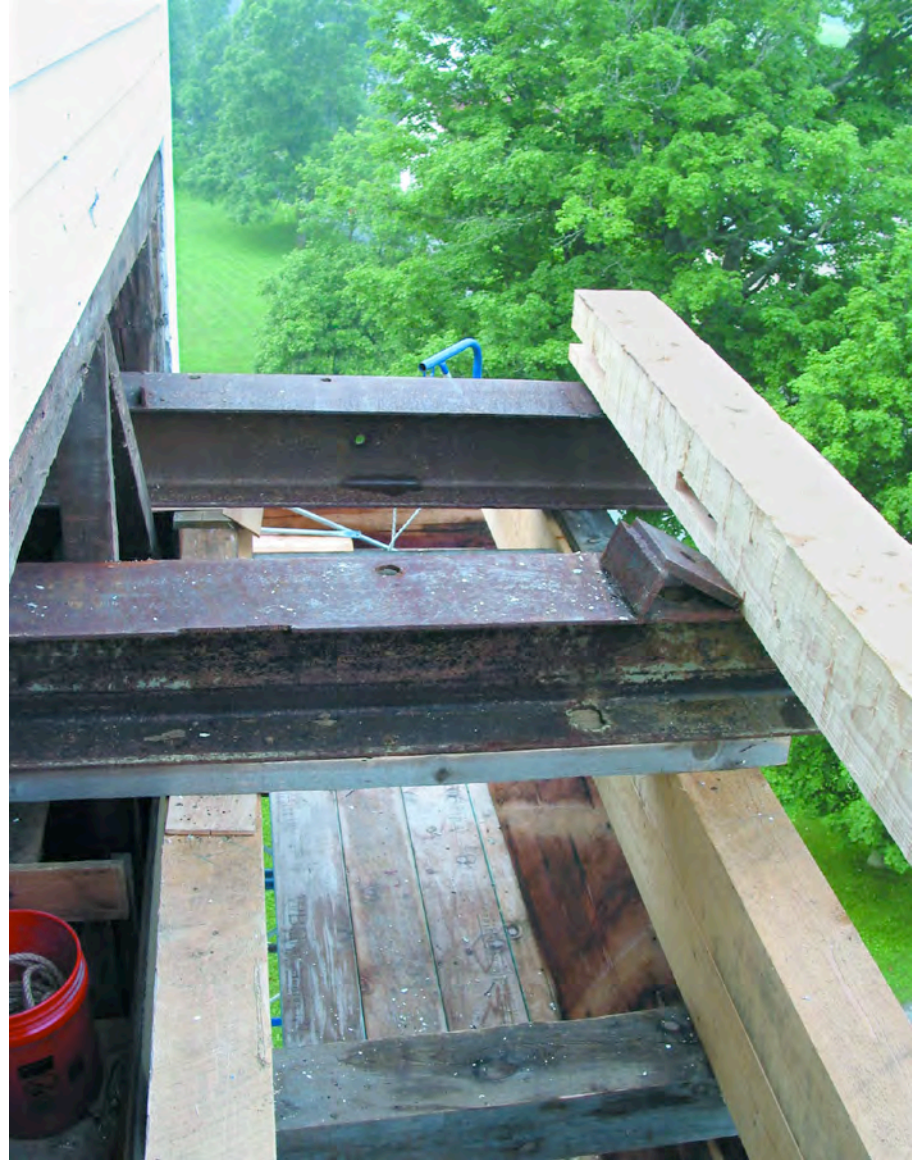
*Fig 18. Structural staging supports cribbing to carry steel I-beams that lifted upper stages of Strafford steeple off supporting tower girts.*

tion them over the panel points of the scaffolding. From this high platform we carefully removed the original clapboards and wide sheathing boards, saving them and their wrought nails, to expose the girts we would replace and to provide a space for the steel to be slipped through. The 12x12 I-beams, 25 ft. long and weighing about 2000 lbs. each, were lifted by crane and beam tongs and guided into the tower to rest on wooden rollers over 3-in. planks (Fig. 18).

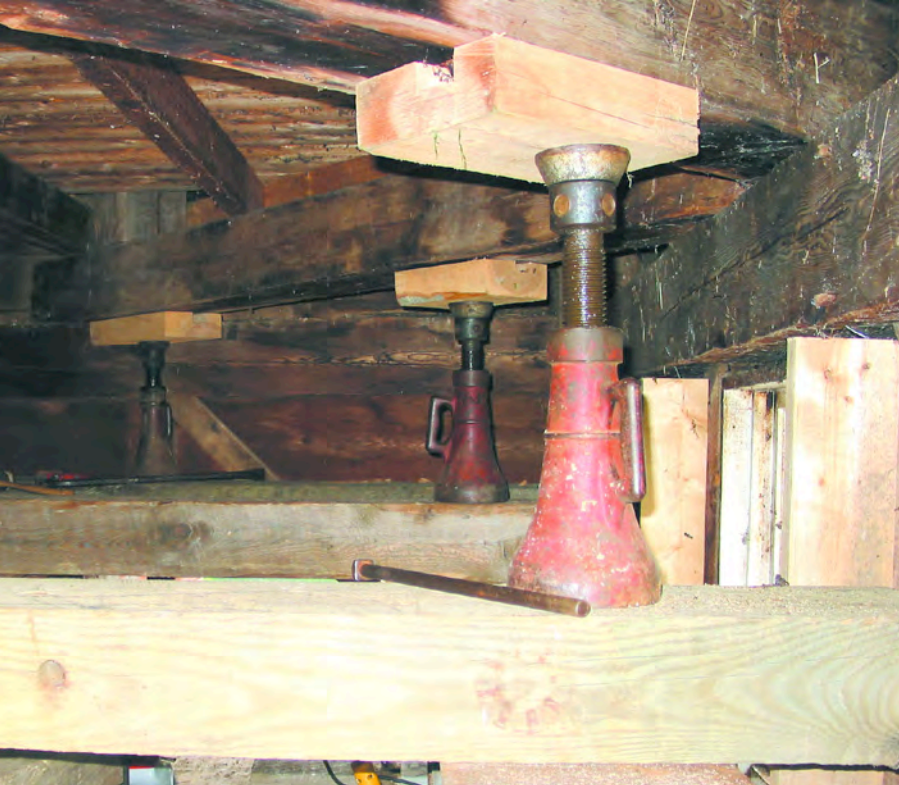
*Fig. 19. Eight 20-ton screwjacks (three visible here) push up under belfry post positions to lift Strafford's upper steeple stages.*

Turning these eight jacks at first deflected the I-beams a couple of inches and then readily lifted the approximately 20,000 lbs. of upper steeple off the girts. At this point we were free to cut out the damaged girts and replace them with new timbers (spruce of very high quality), free-tenoning one end to engage the fixed frame, and then repair or reposition the diagonal braces that rose to the girts.

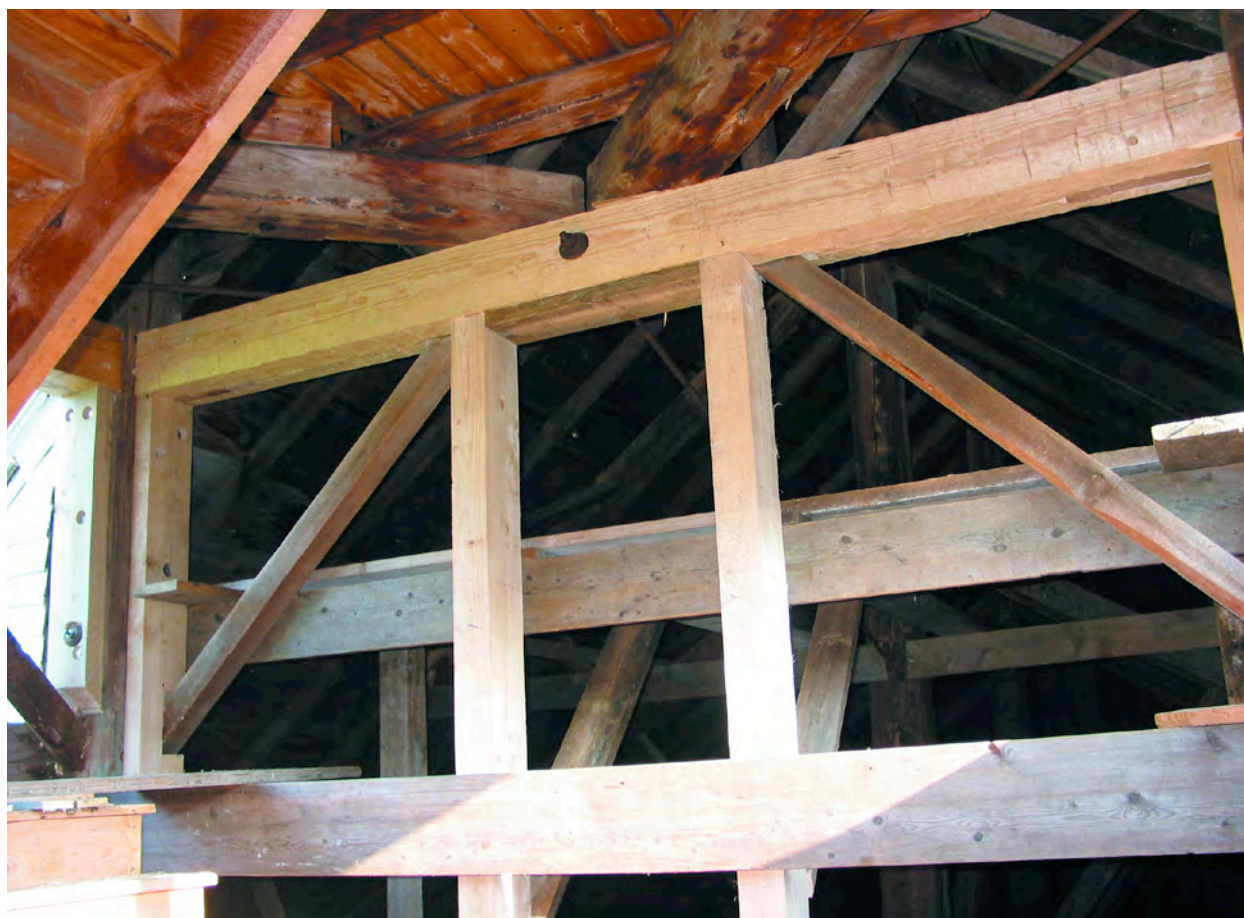
*Fig. 20. New spruce tower girt supports diagonal sleepers carrying upper stages. Bolted 4x9 sisters at each end relieve 2-in. splined tenons of shear forces; long braces and median posts stiffen middle of girt against bending. At girt center, nipped iron rod (old but not original) runs back to tie beam of second interior roof truss.*

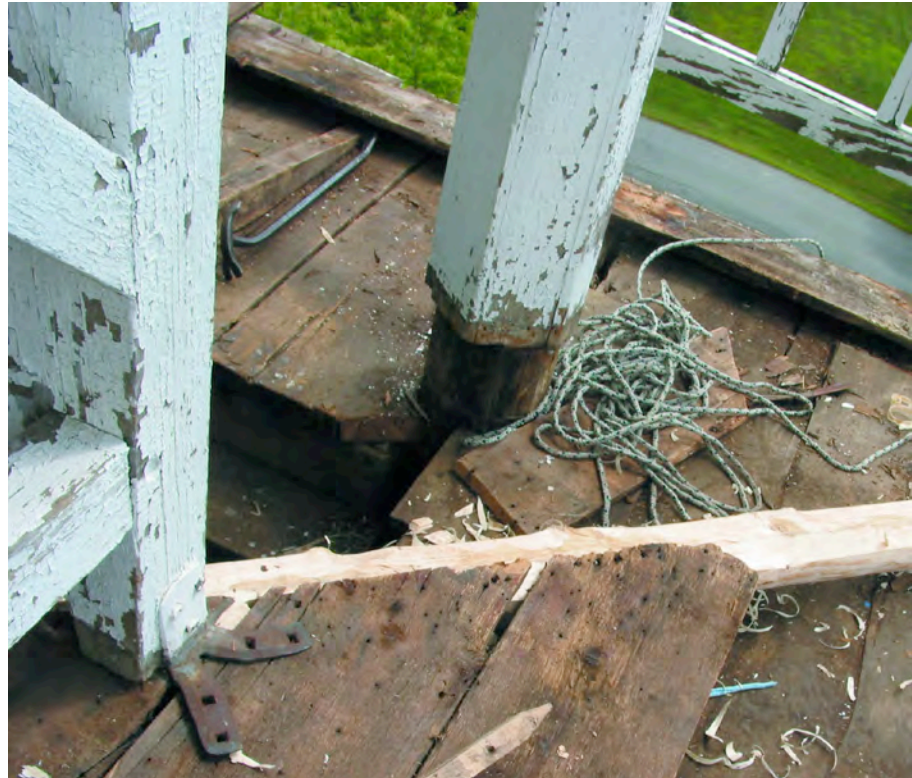
*Fig. 21. Old bell deck covering of thick planks caulked with oakum and tar revealed by removal of younger deck of rafters, boards and shingles.*

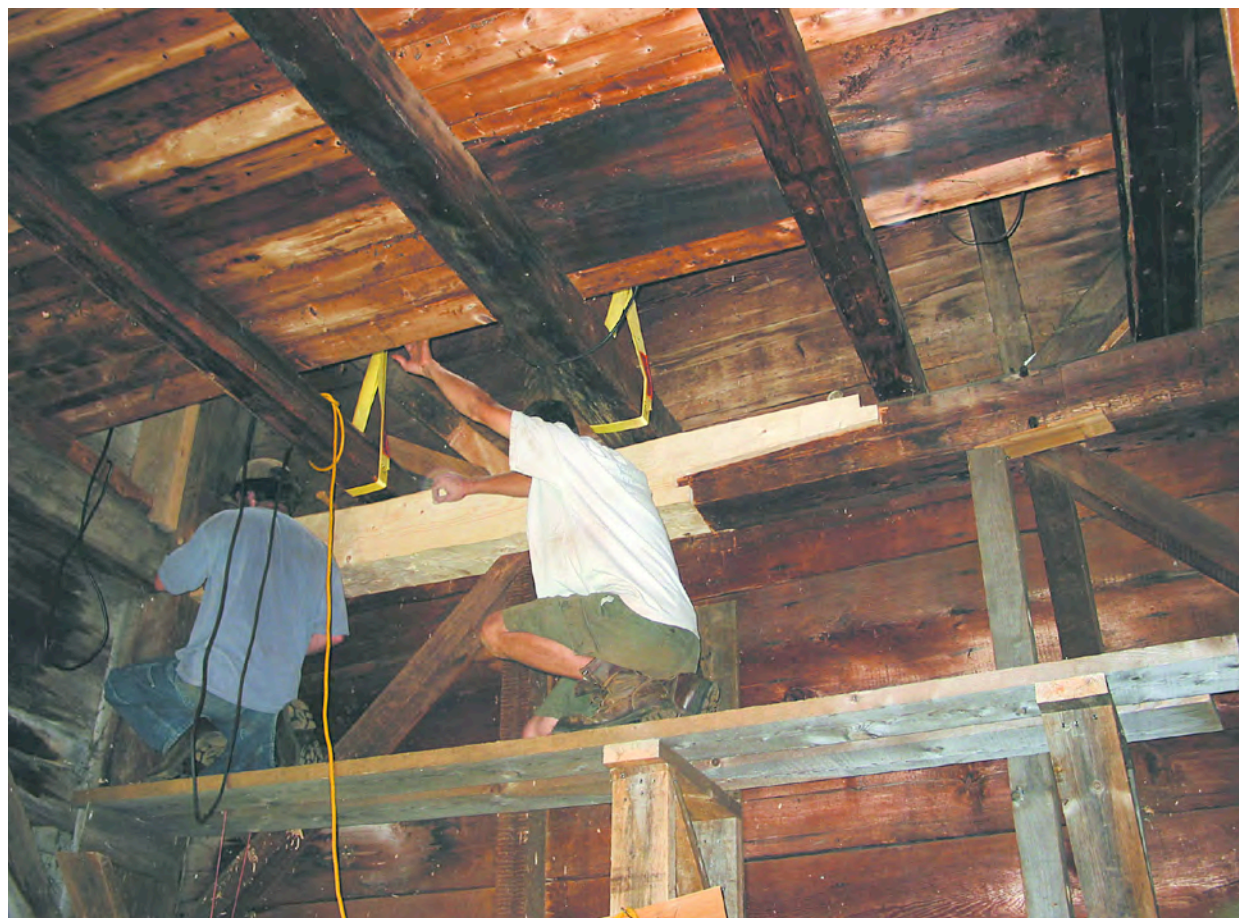
*Fig. 22. Seth Kelley (at left) and Michael Cuba install stop-splayed and tongued scarfed repair to rotted wall girt in Strafford tower. Girt carries relatively light clock-room floor, does not support upper steeple stages. Free tenon (hidden by Kelley) allows insertion of new piece from side.*

Other problems at Strafford included a horizontal tower girt (not directly bearing upper steeple loads) rotted for half its length and needing a scarfed timber repair (Fig. 22 overleaf). The bell deck was leaking and in need of a new covering as well as replacement of some of its structural members, including two hip rafters.

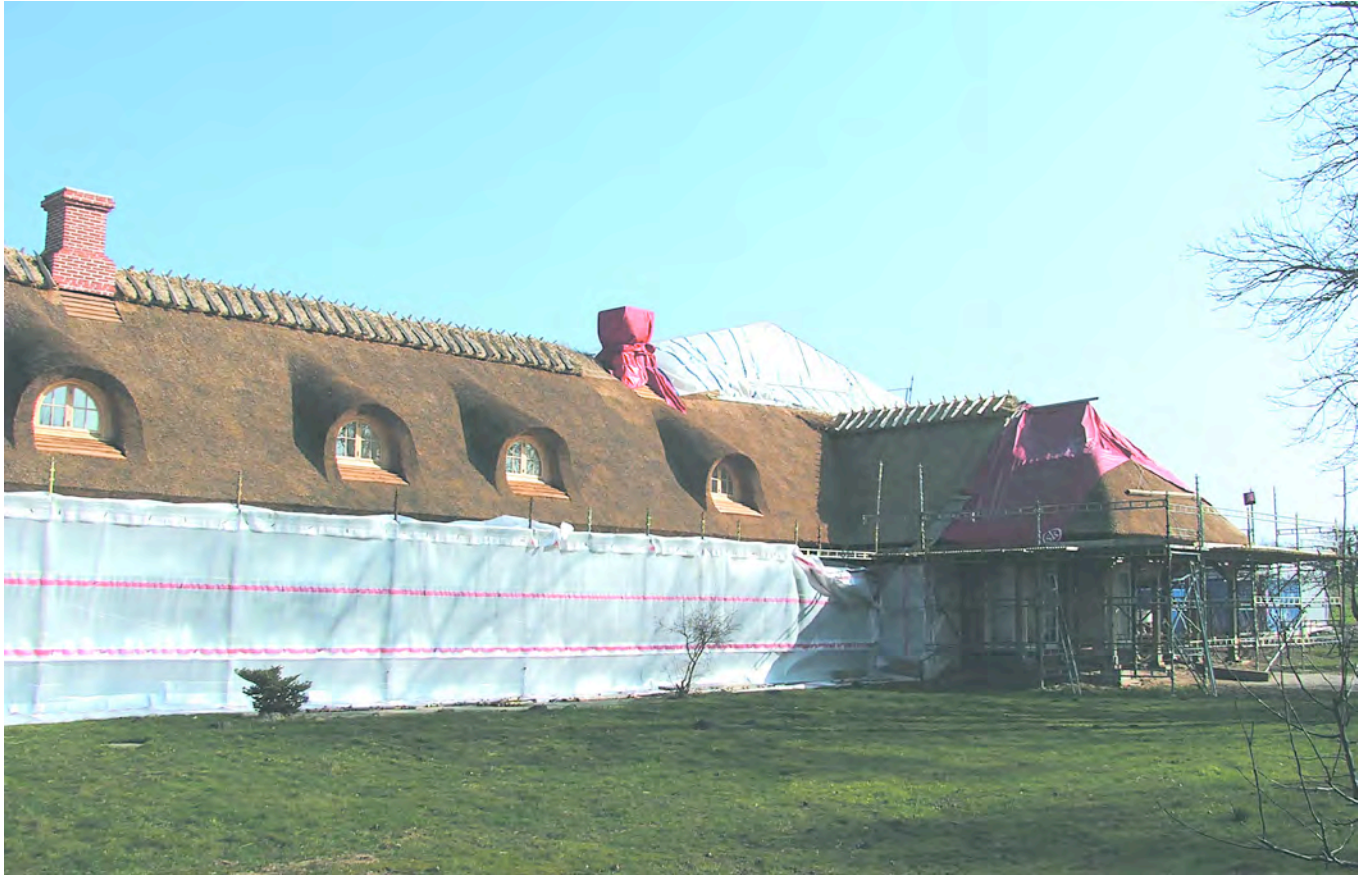
*Fig. 1. Thatched house under construction at Stubbegaarden, Denmark. Great room is under tarped scaffold roof.*

**S**TUBBEGAARDEN lies 40 miles north of Copenhagen in Denmark's Northern Zealand province. We are working there on timberwork for a large project that has really stretched our skills. Eventually it will include a horse barn and a riding area (Figs. 1 and 8).

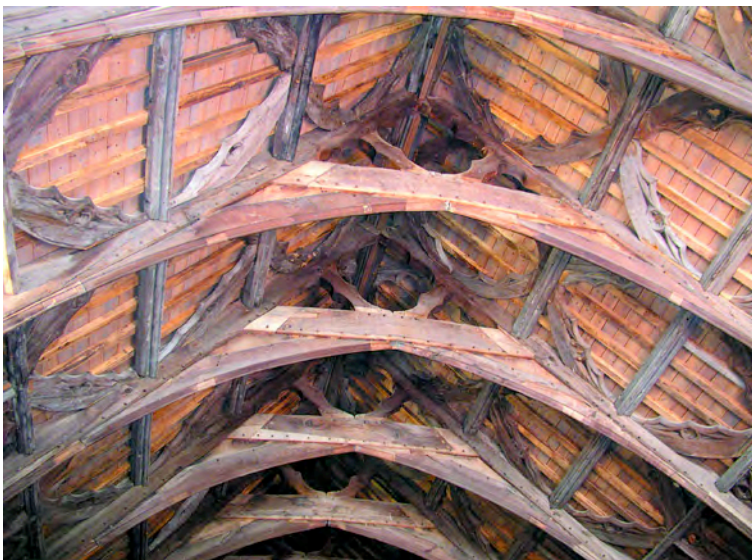
*Fig. 2. Open roof over Guesten Hall, ca. 1330, Avoncroft, Worcestershire.*

braces in the roof plane at Guesten Hall are aligned across the bents and form nice diagonal lines across the roof (Fig. 2).

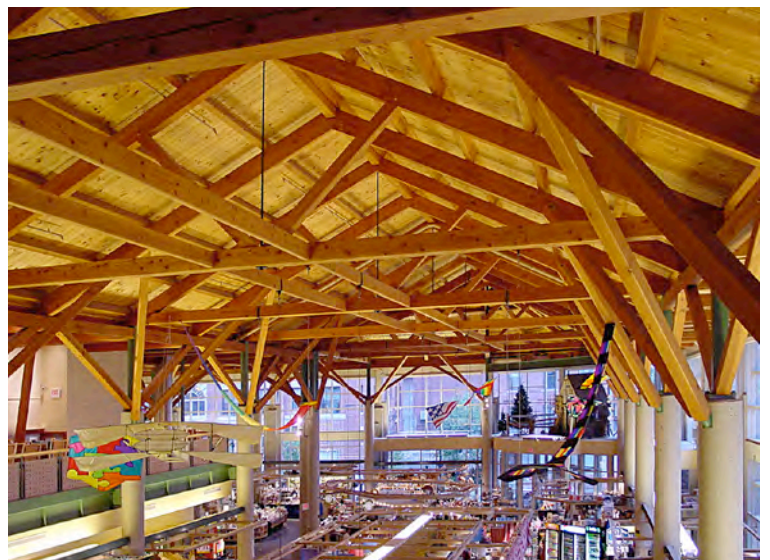
*Fig. 3. Open roof over the Public Market, ca. 2002, Portland, Maine.*

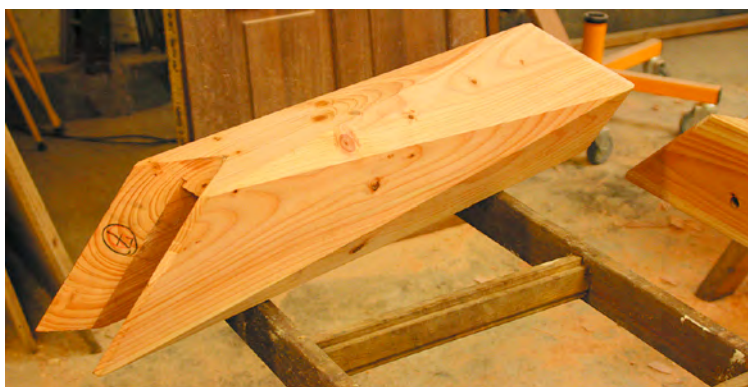
*Fig. 7. Short brace is rotated to simplify connection at one end, with serious consequences at the other.*

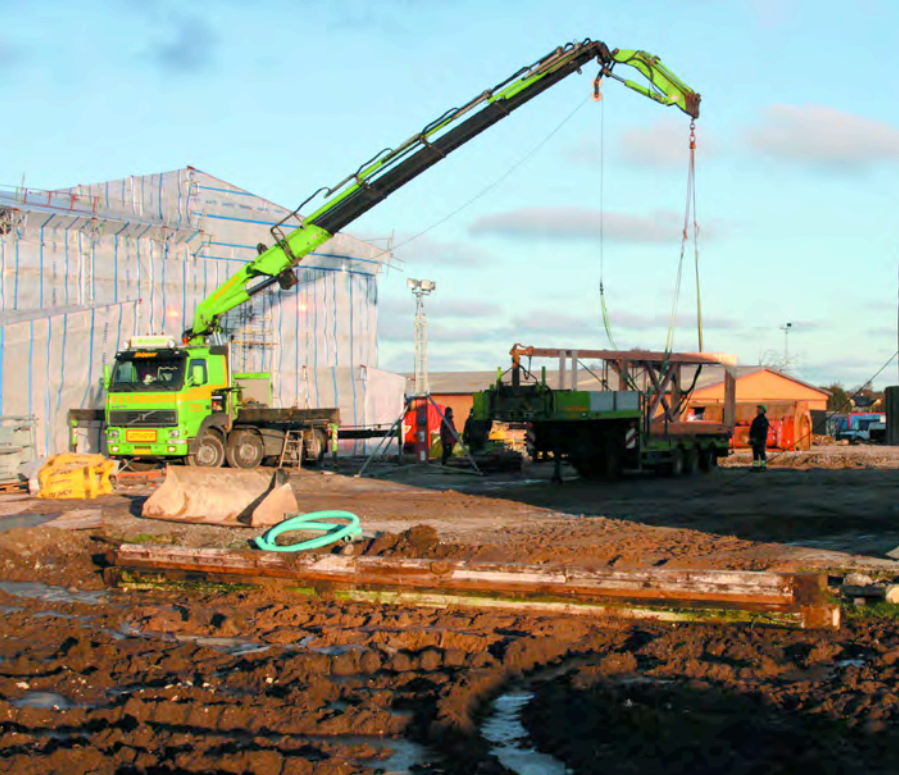
*Fig. 9. Unloading trusses at site. Building underway is fully enclosed.*

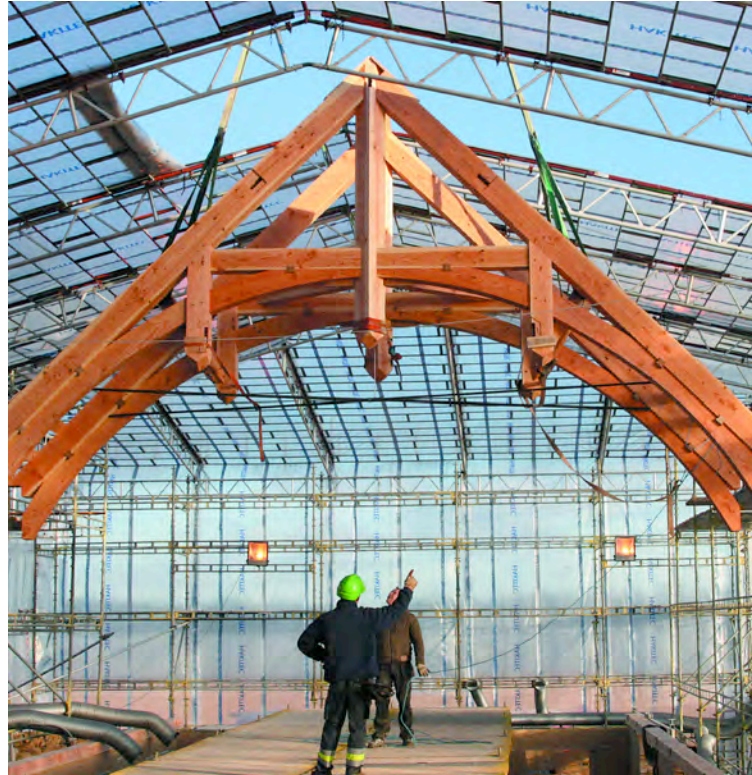
*Fig. 10. Double truss of Danish Douglas fir flown in through roof.*

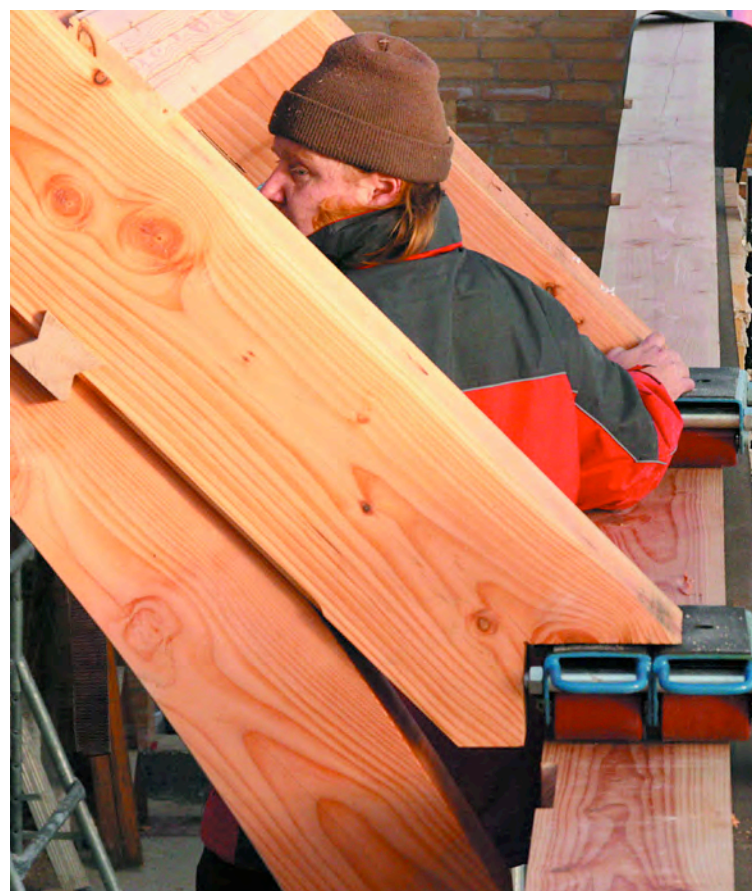
*Fig. 11. Stefan Hildebrand rolls truss to position on skates. Pairs of shoring jacks assisted removal of skates and final descent of truss.*
