# TIMBER FRAMING

JOURNAL OF THE TIMBER FRAMERS GUILD

Number 85, September 2007

# Danish Country Manor Open Timber Roof

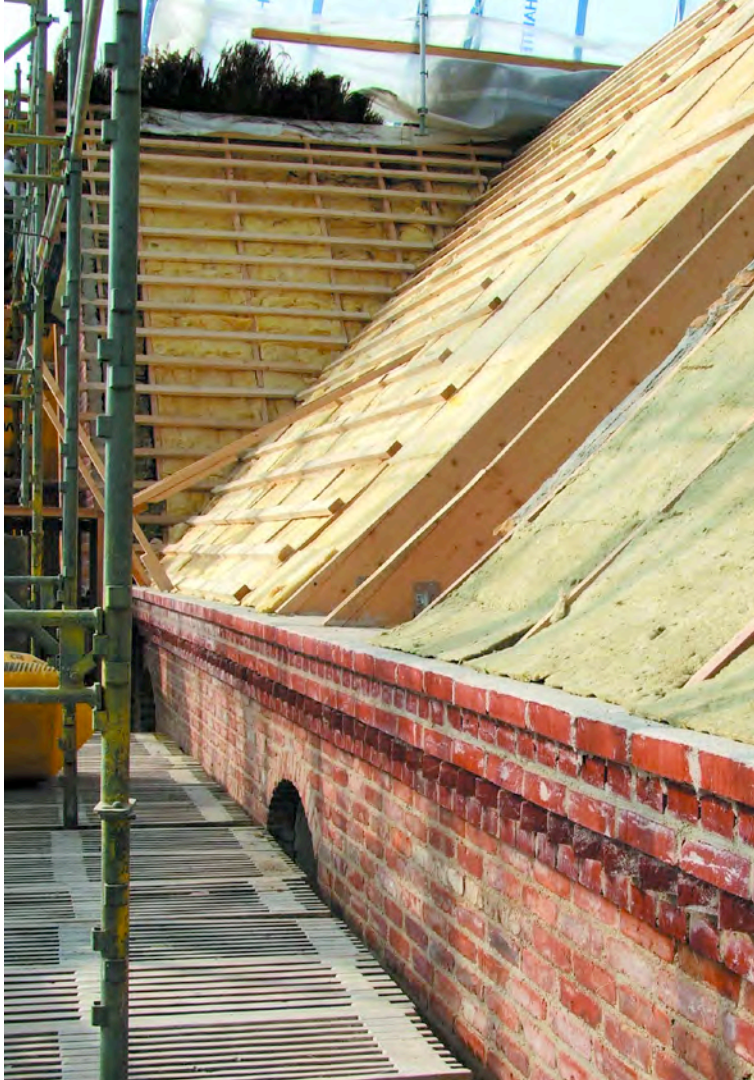
*Fig. 12. Mineral wool thoroughly insulates cavities in roof and walls against air and fire movement. Treated fiberglass blanket will cover roof battens before application of thatch. All masonry is lime-mortared.*

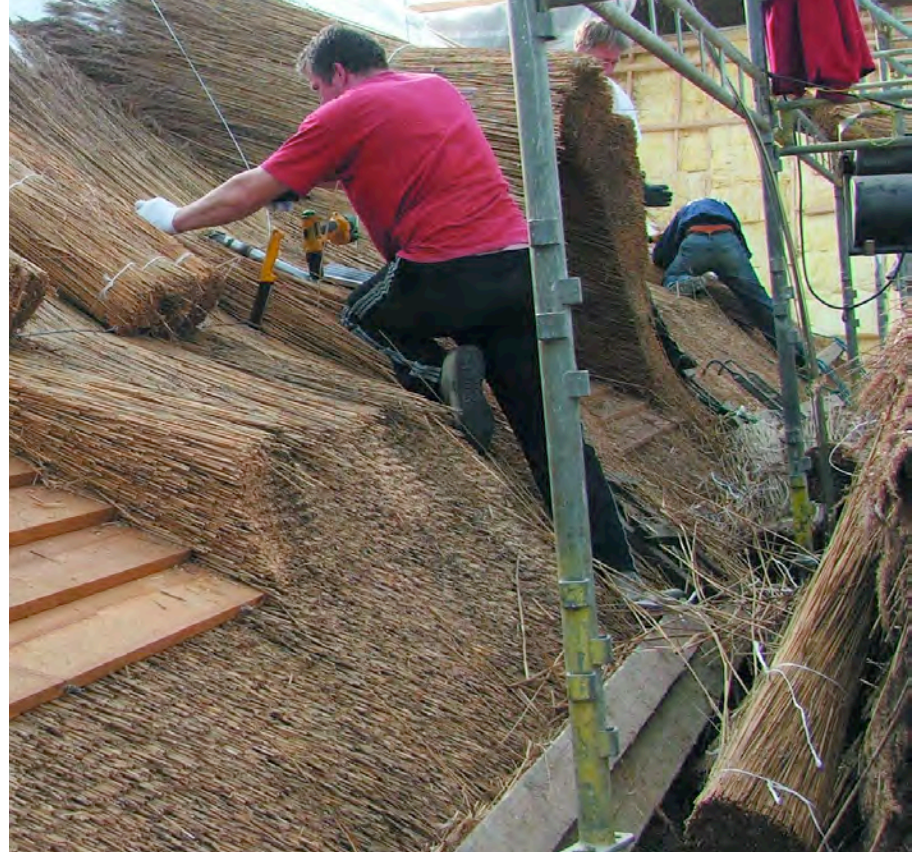
*Fig. 14. Algis Kucinskis wiring down bundles between dormer windows, thatching boss Michael Jahrle just visible behind thatched dormer, Ramunas Lukasuskas busy at the far end (see also Fig. 13).*

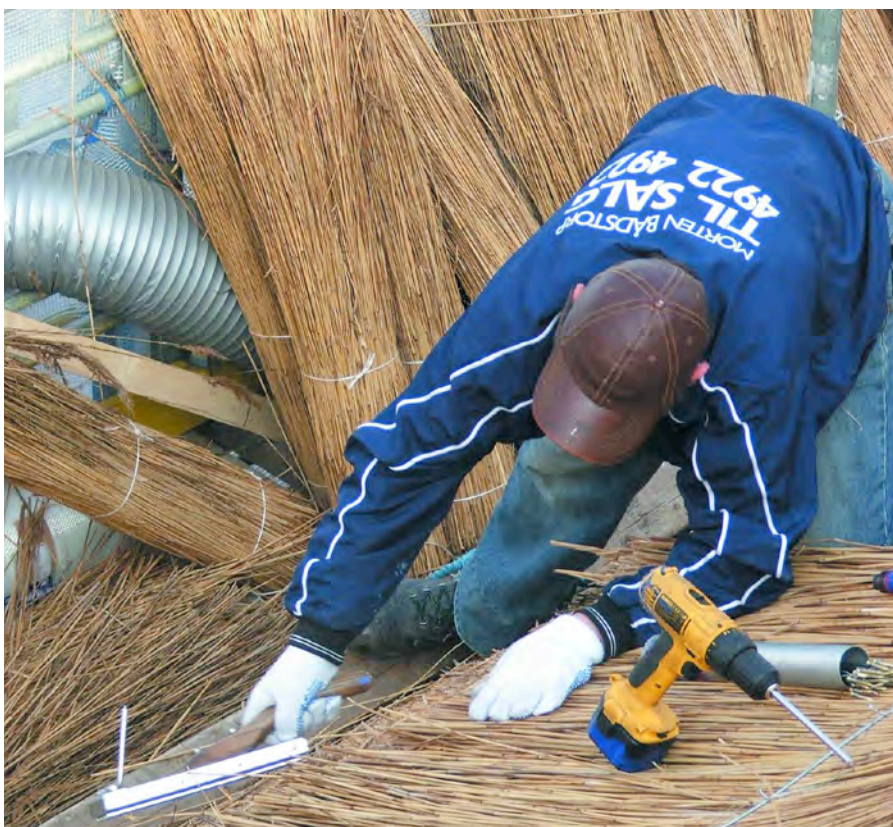
*Fig. 13. Ramunas Lukasuskas uses petting board to stroke and shape bundles of thatch. Gloves protect hands from abrasive thatch. Drill drives long screws prefitted with two wires into roof batten below; thatcher then ties wires around bale. Heavy wire at lower right holds down entire course of bundles.*

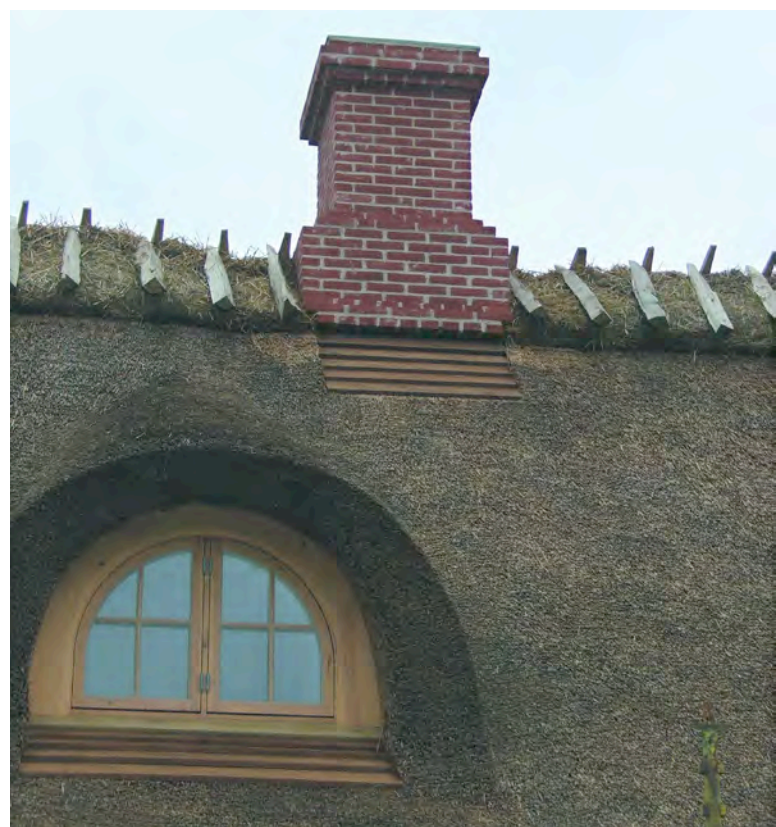
*Fig. 15. Crowsfeet made of cleft oak saplings bolted together hold down thatched ridge by their own weight. Wooden boarding laid shingle fashion serves as exterior flashing under window and chimney.*

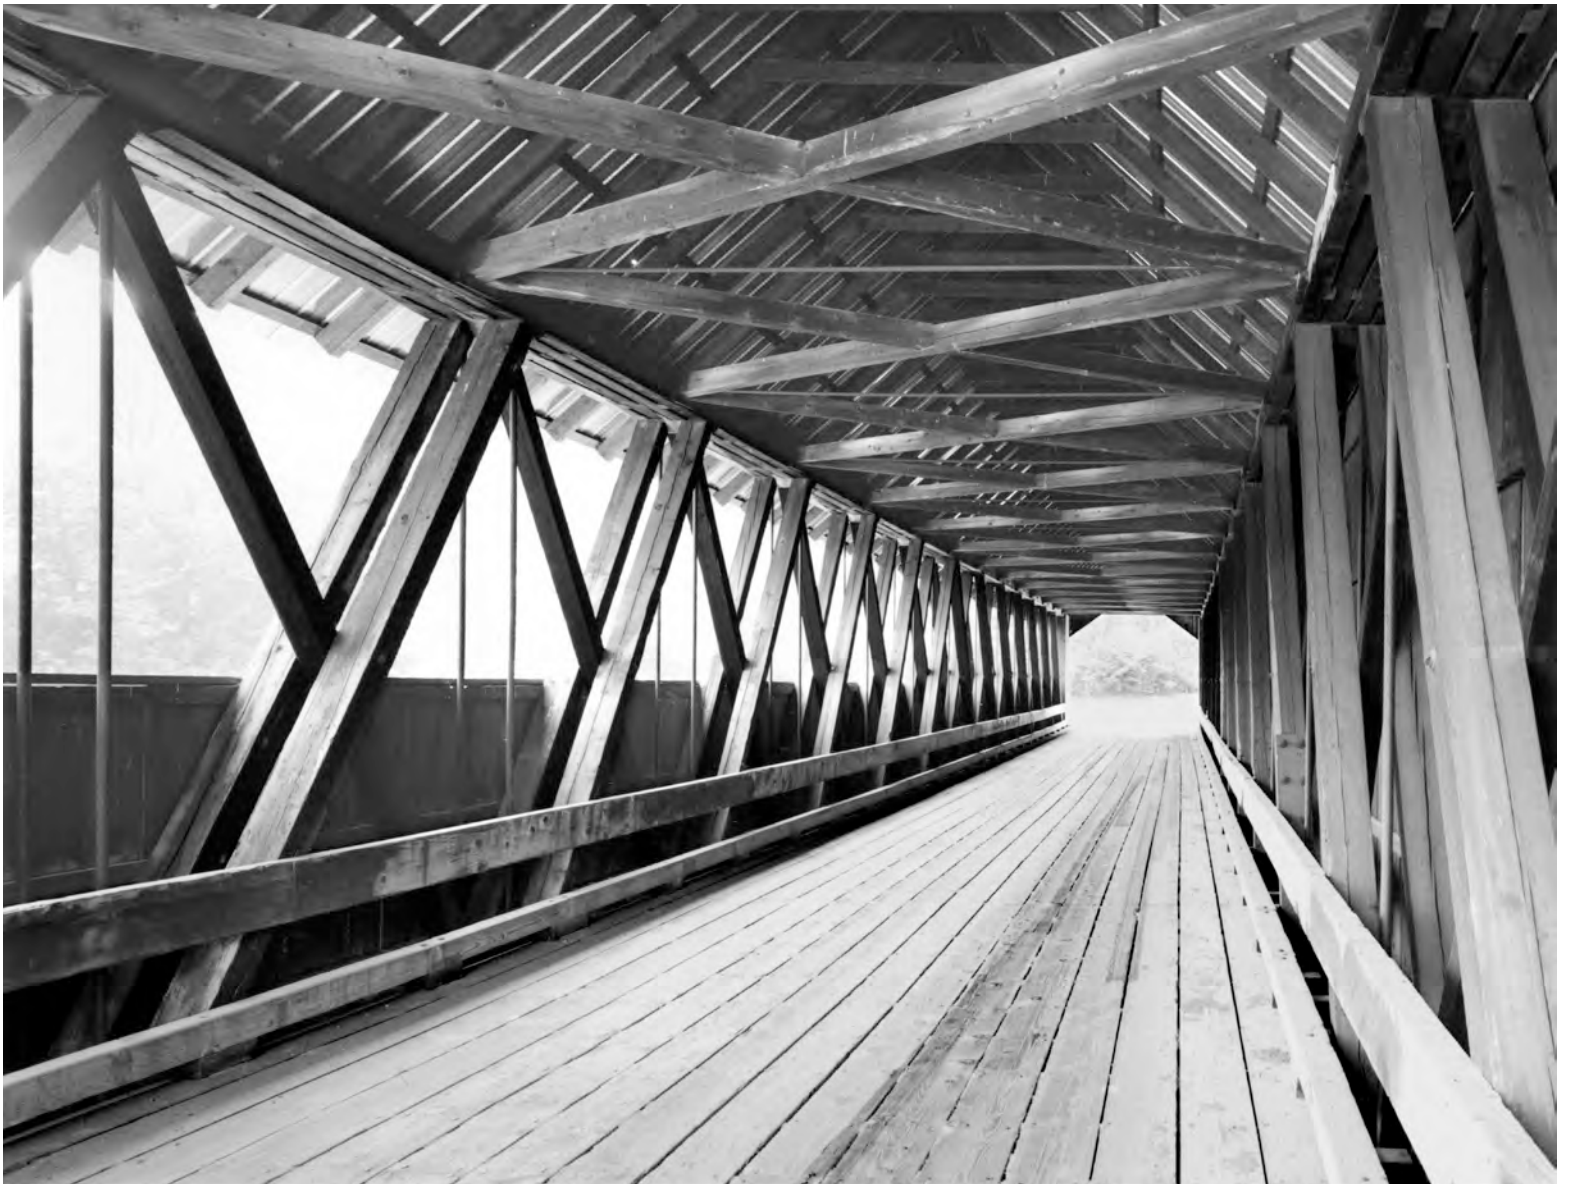
*Fig. 2. The classic form of the Howe truss as widely built in the 19th century, although this example dates from 1912. Columbia Bridge over the Connecticut River just south of Colebrook, N.H., between New Hampshire and Vermont.*

As commonly built, the Howe truss used panels with only a single web (Fig. 2). In truss terminology, "web" describes a plane of braces or counterbraces, and there may be more than one plane per panel. But in describing Howe trusses, the web number indicates whether the braces and counters are self-contained (single web) or run past panel points to the next panel (double web), as in Fig. 1.

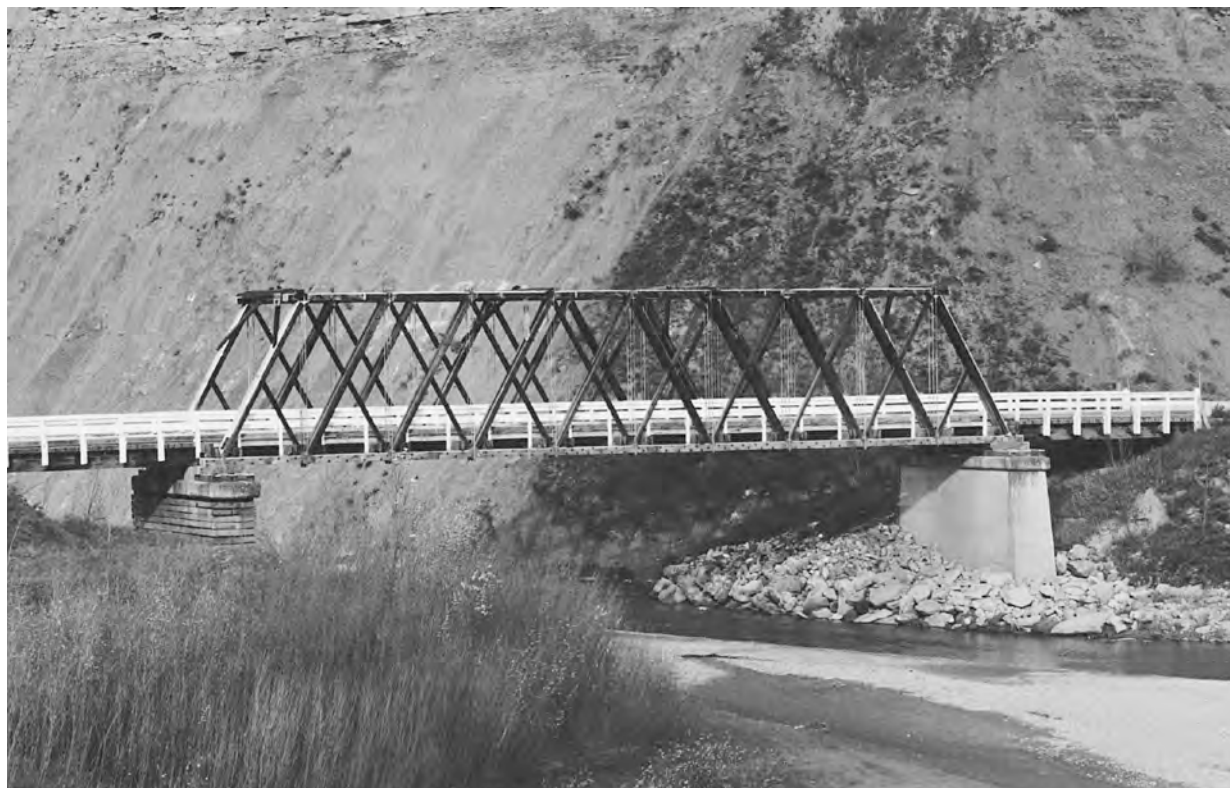
*Fig. 3. Moose Mouth Bridge over Alces River south of Clayhurst, B.C., Canada, built in 1961. End panels are cut off such that top chords end just past last set of rods. Howe trusses built in British Columbia since the 1930s used chords fabricated from smaller sticks pinned with sections of steel pipe like treenails, with no space between sticks.*

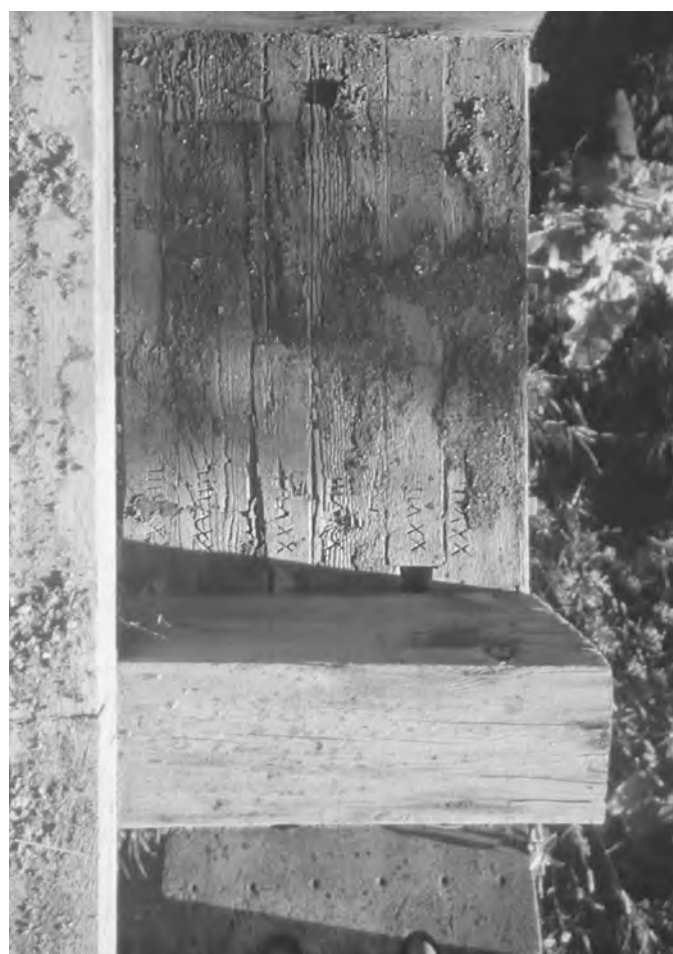
*Fig. 4. Marriage marks on shear blocks and bottom chord, top view looking down. Tracey Mills Bridge, Carleton County, New Brunswick, built in 1936. Note angle block at bottom.*

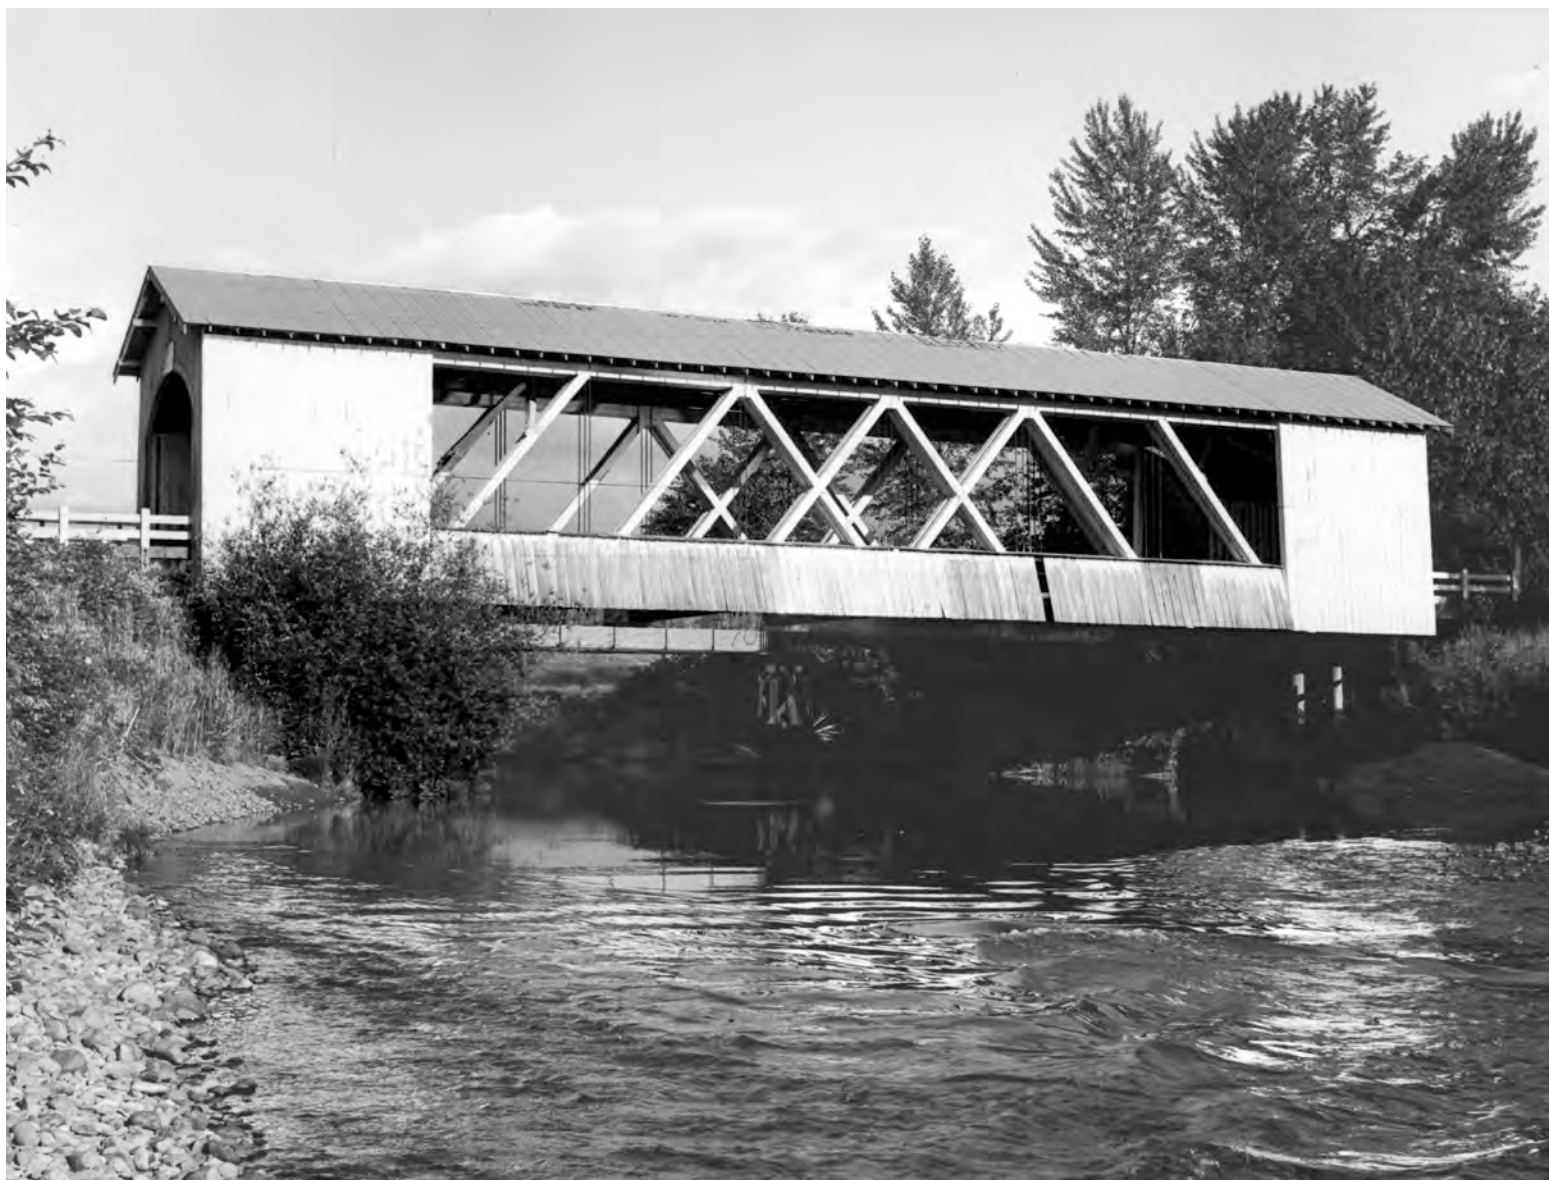
*Fig. 5. Gilkey Bridge, Linn County, Oregon, built in 1939, with open sides but covered bottom chords. In the background (visible under the highway bridge) is a railroad bridge, itself once covered.*

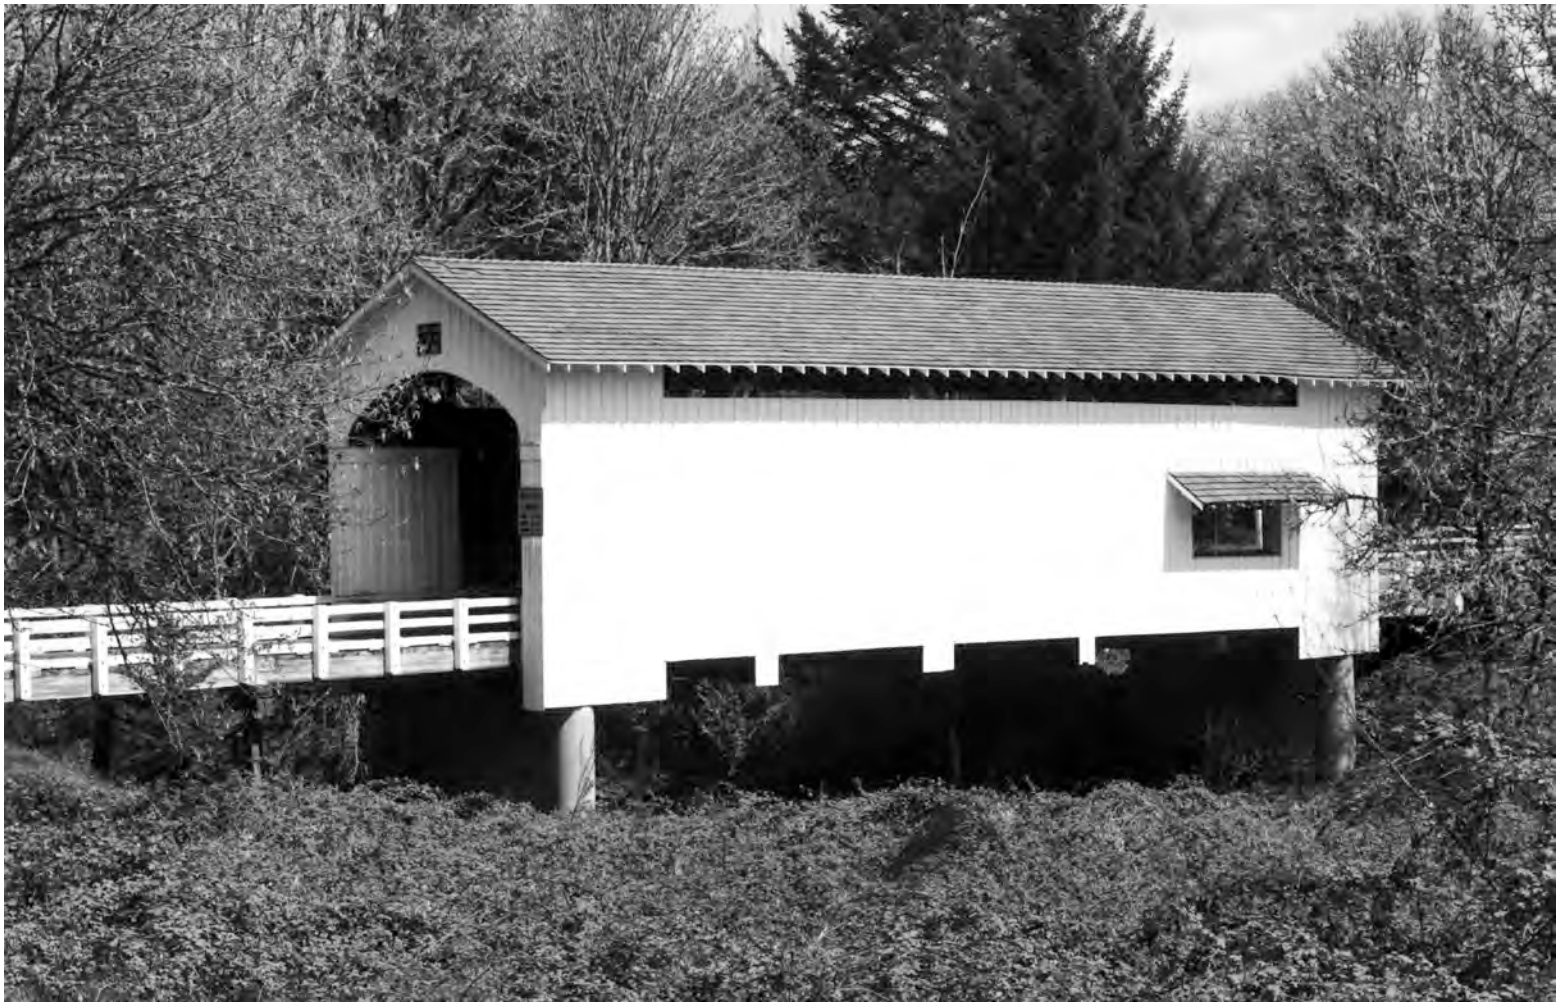
*Fig. 6. Earnest Bridge, Lane County, Oregon, built in 1938. Far end opens onto curve in road; note window for visibility.*

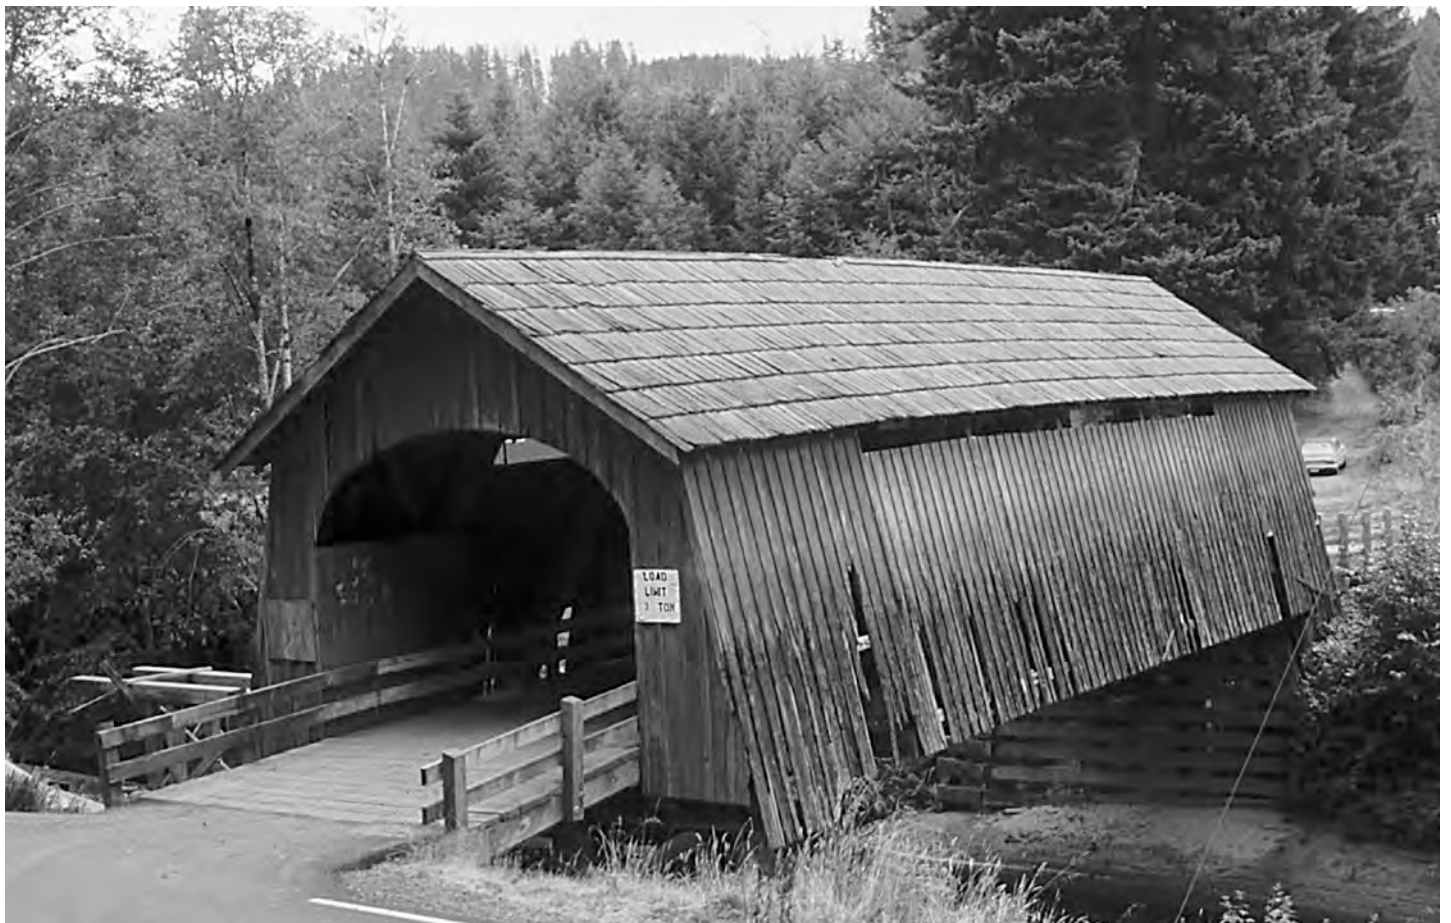
*Fig. 7. Fisher School Bridge, Lincoln County, Oregon, built in 1919, with broadly flared siding.*

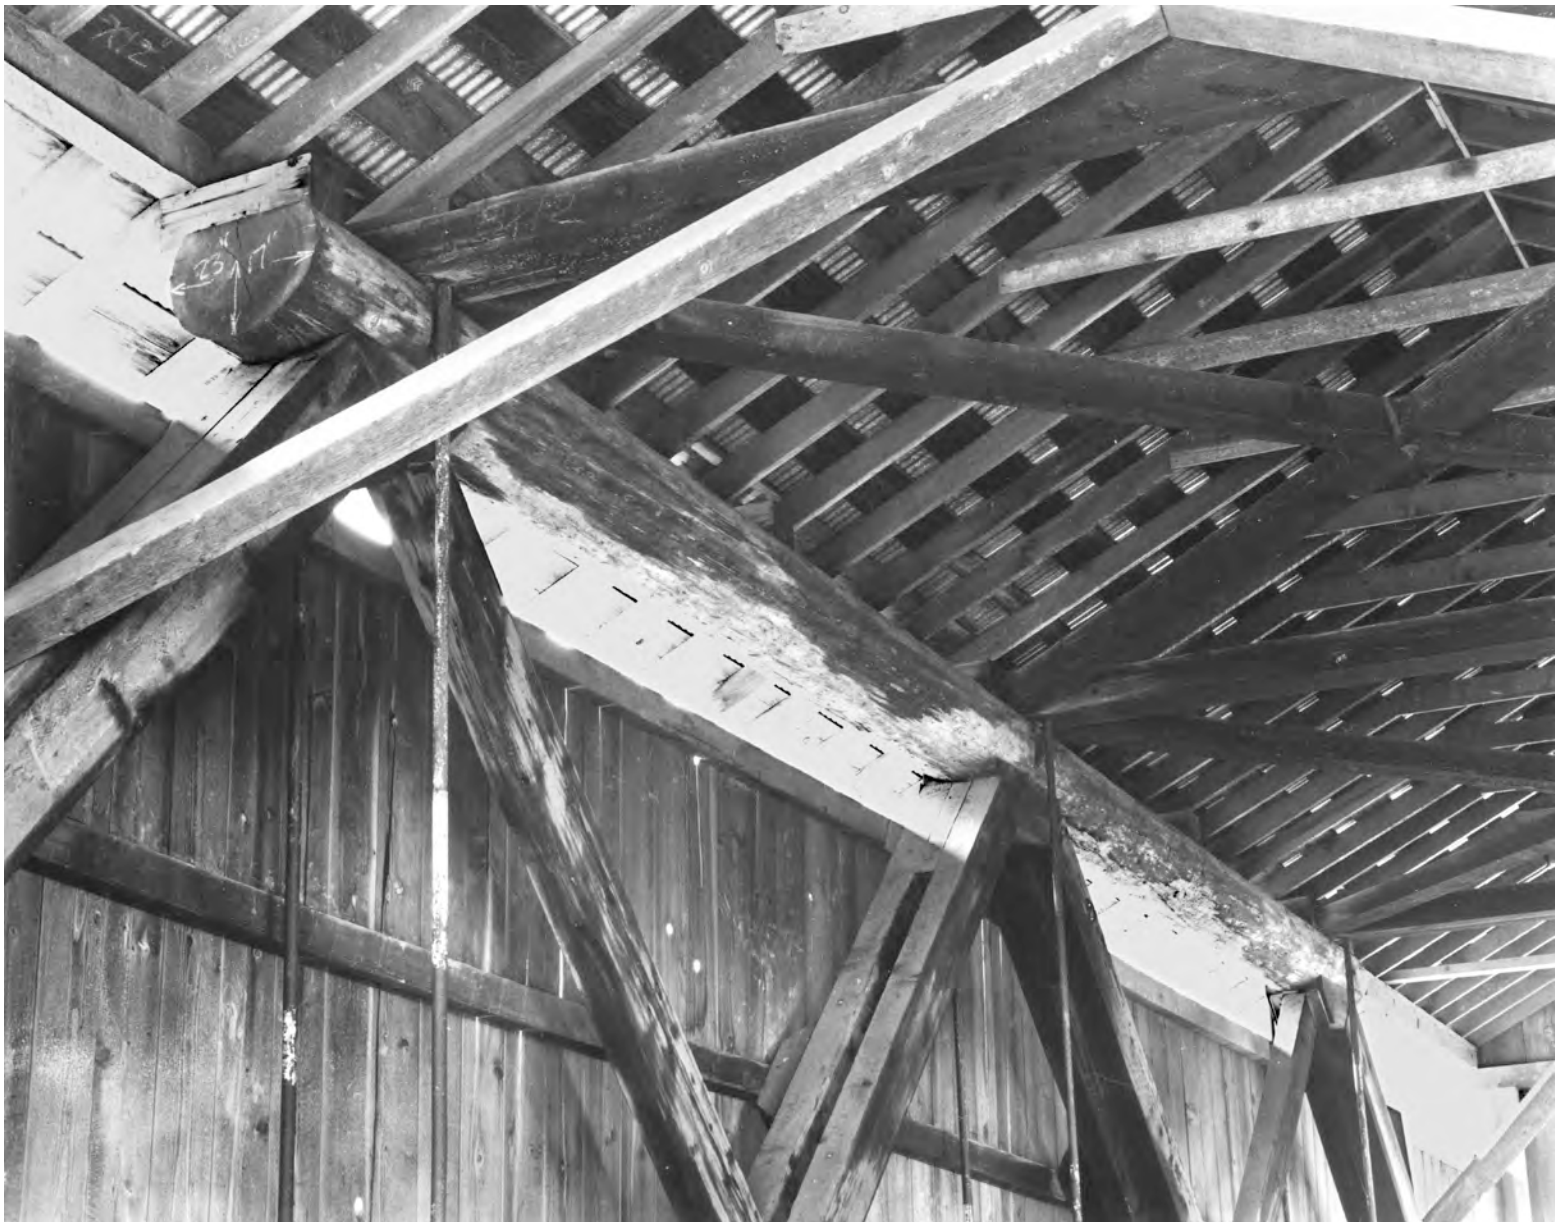
*Fig. 8. Top chord of Cavitt Creek Bridge (in fact over Little River), Douglas County, Oregon, built in 1943. Use of a log is impressive but unusual; standard practice was to square the timbers. Dimensions on near end were probably added by inspectors during load-limit calculations.*

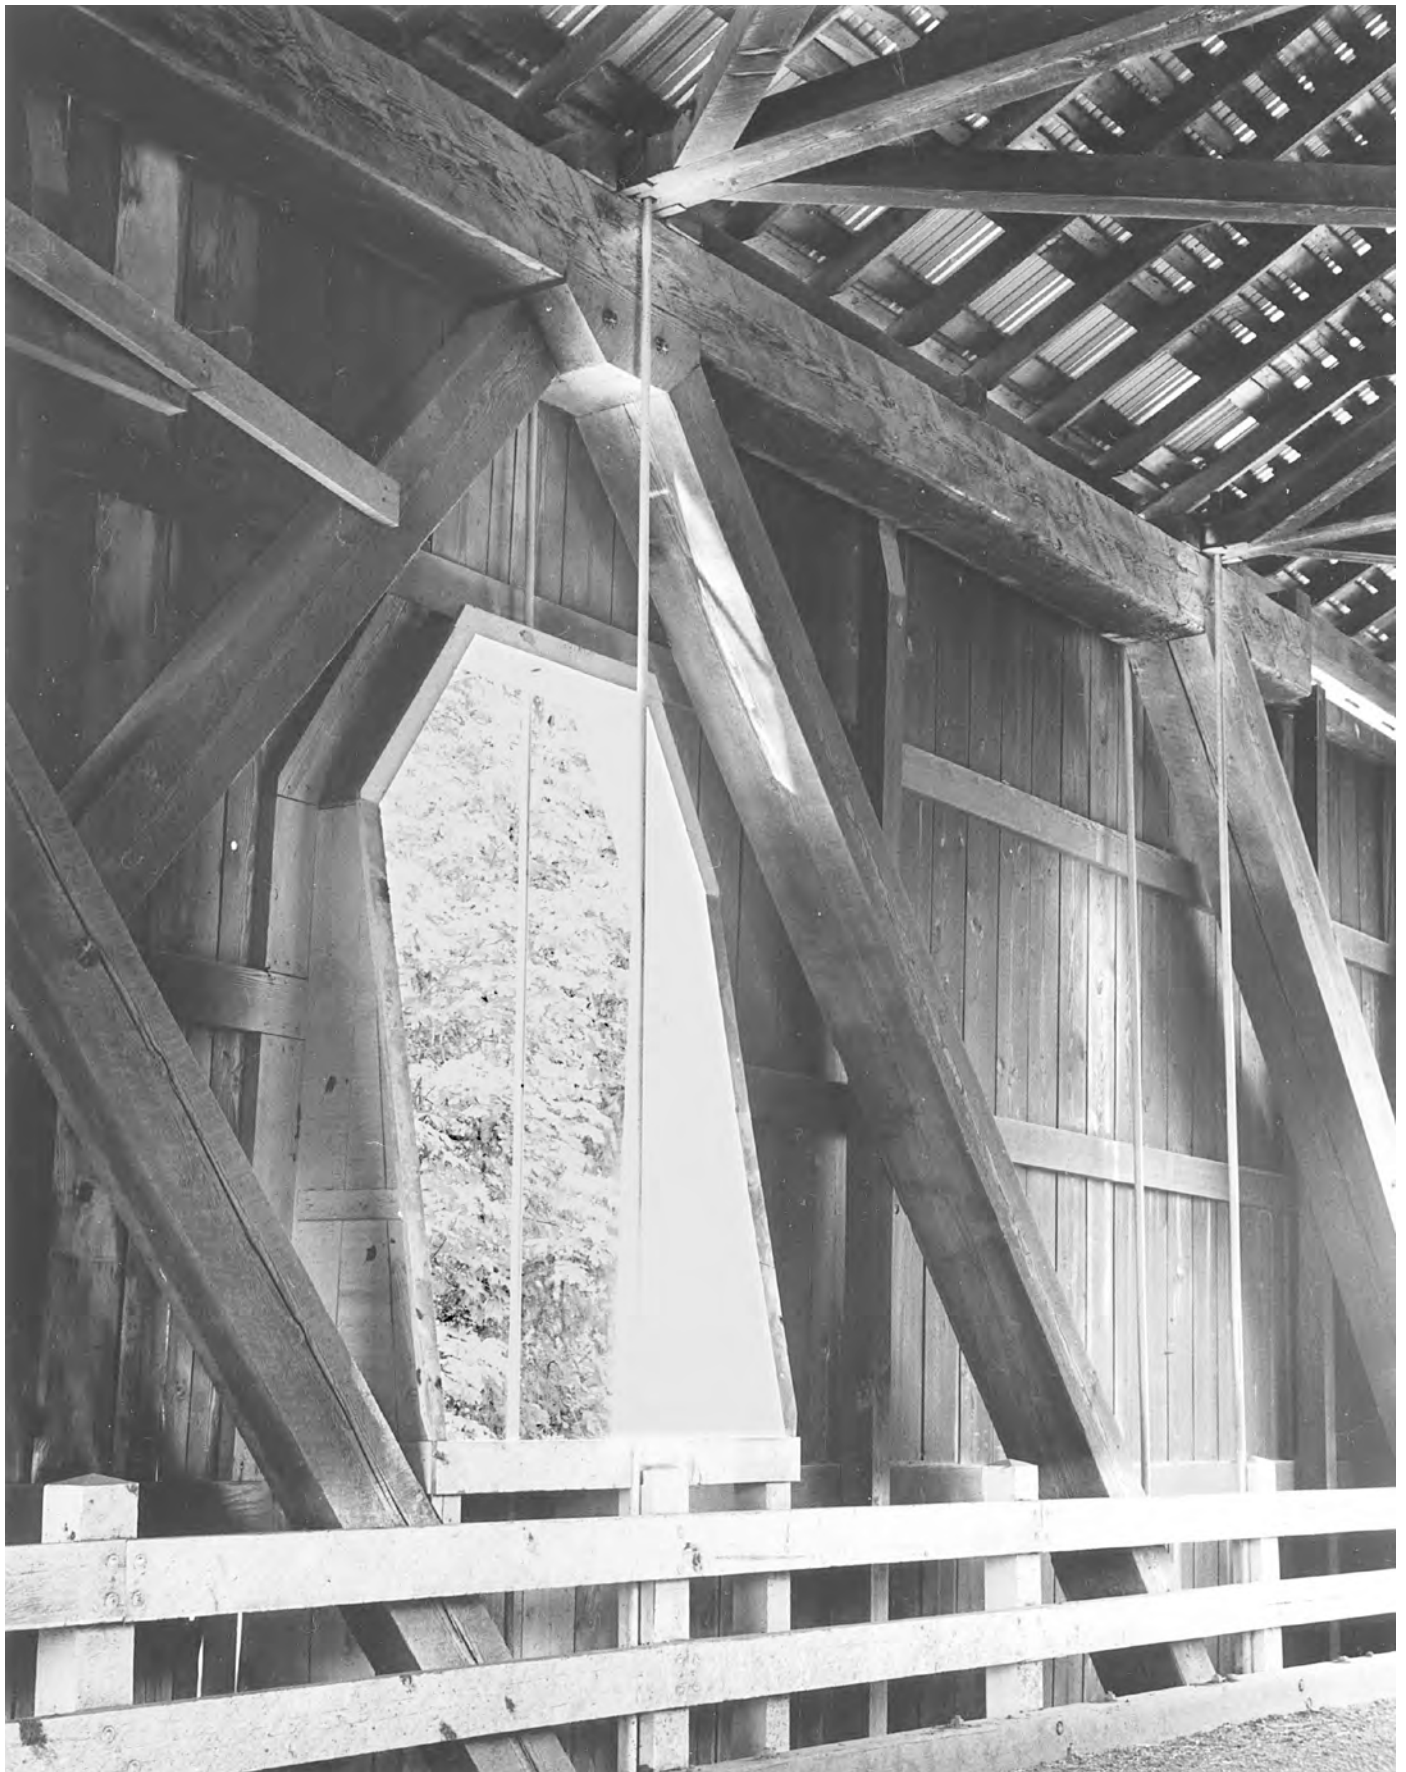
*Fig. 9. Braces and counterbraces connected to top chord with an angle block. Block is let slightly into chord to prevent it from shifting. Oregon occasionally used iron angle blocks in its 20th-century covered bridges, but much more often used wood. At far right, note batter brace joint in top chord made with a dap instead of a block. Top chord is hand-hewn while braces are sawn. Hoffman Bridge, Linn County, Oregon, built in 1936.*

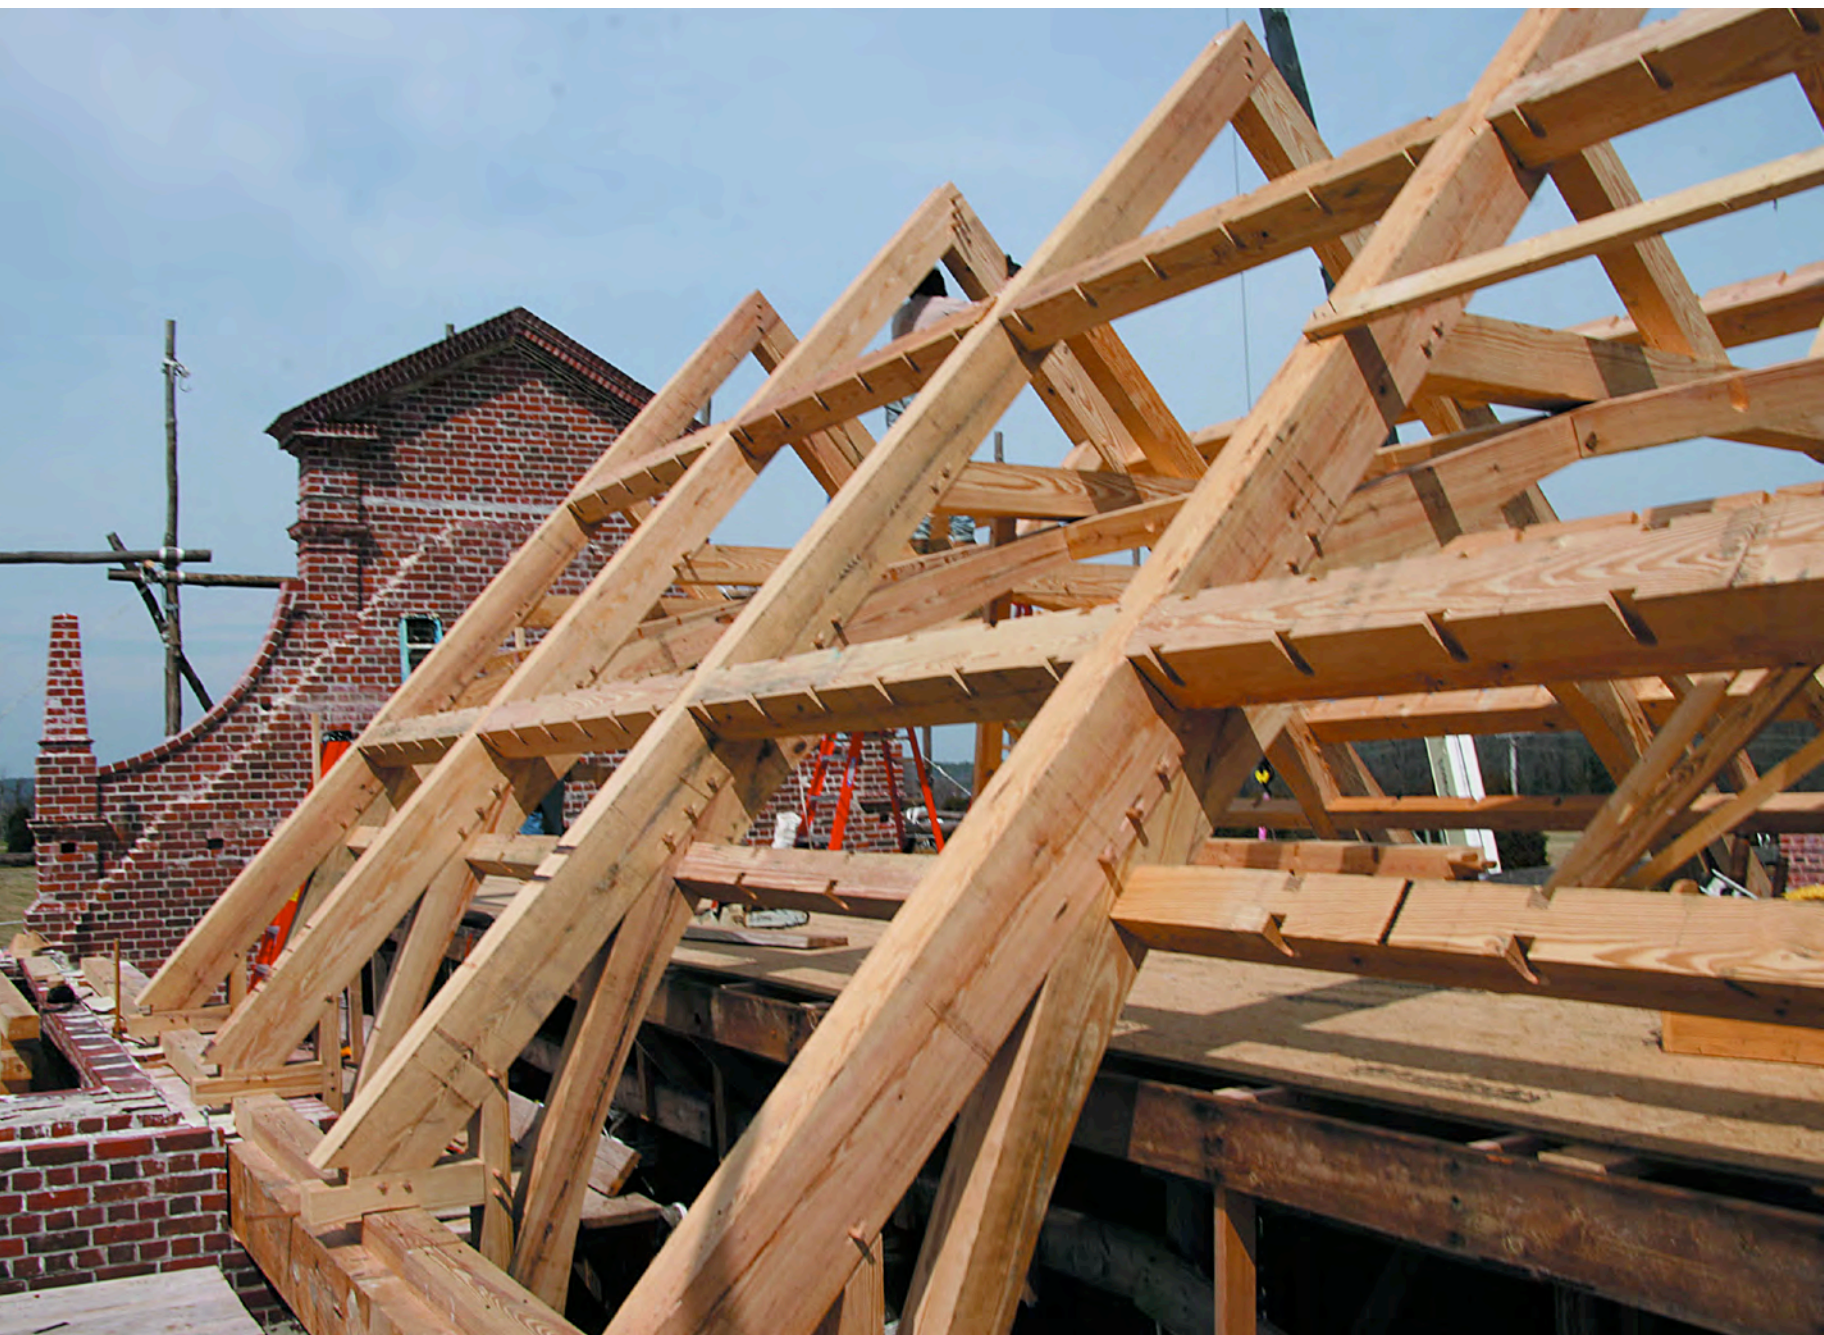
*Lacking only common rafters, freshly assembled 699-piece roof frame in Southern yellow pine, cut by Blue Ridge Timber Frame, Swannanoa, N.C., on a Hundegger K-2, for raising by volunteers at St. Mary's City, Md., over the nave at the 1667 Brick Chapel reconstruction. St. Mary's was established by Lord Calvert and 140 colonists as the first English Catholic colony in the New World. Roof will be closed, ceiled by a barrel vault following the framed arch. Mesick, Cohen, Wilson and Baker Architects (Albany, New York) developed conjectural 17th-century chapel and truss designs. Challenge for Blue Ridge was to design joinery for orderly and efficient frame assembly on a remote site by inexperienced workers.*
