TIMBER FRAMING

JOURNAL OF THE TIMBER FRAMERS GUILD

Number 84, June 2007

| 1700s GERMANIC FRAMING IN MORAVIAN SALEM, N.C. John Larson | 4 |

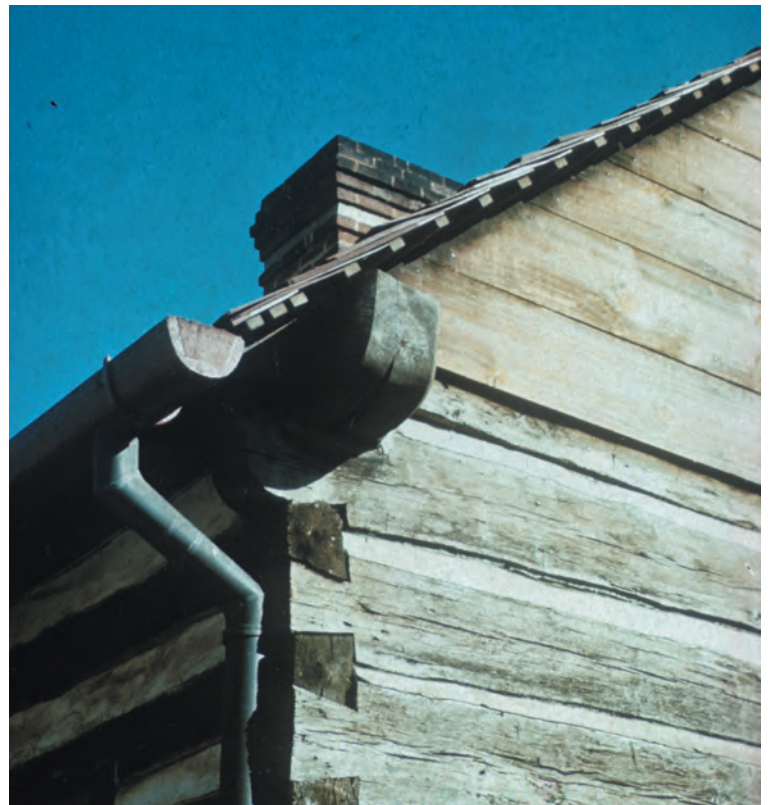
Fig. 1. The Lick-Boner house, 1787, Salem, N.C. Mature chinker log construction with hewn logs and dovetailed corners.

scribed logs. In rudimentary form, the logs were left round and the ends probably tapered to engage the groove. On better examples, the logs were hewn on two or four sides and ended in tenons engaging the grooves and sometimes pegged. This log construction, so common in Pennsylvania, was soon abandoned by the Moravians and seemingly by other 18th-century Germanic settlers in North Carolina in favor of a corner notching system. The log structures of early Salem a decade or so later were defined by a preference for white oak logs, hewn on two sides, with rocks and shims used as chinking. The full dovetail was the preferred notching. The purlins, plates and sills extended beyond the plane of the log walls (Fig. 1).

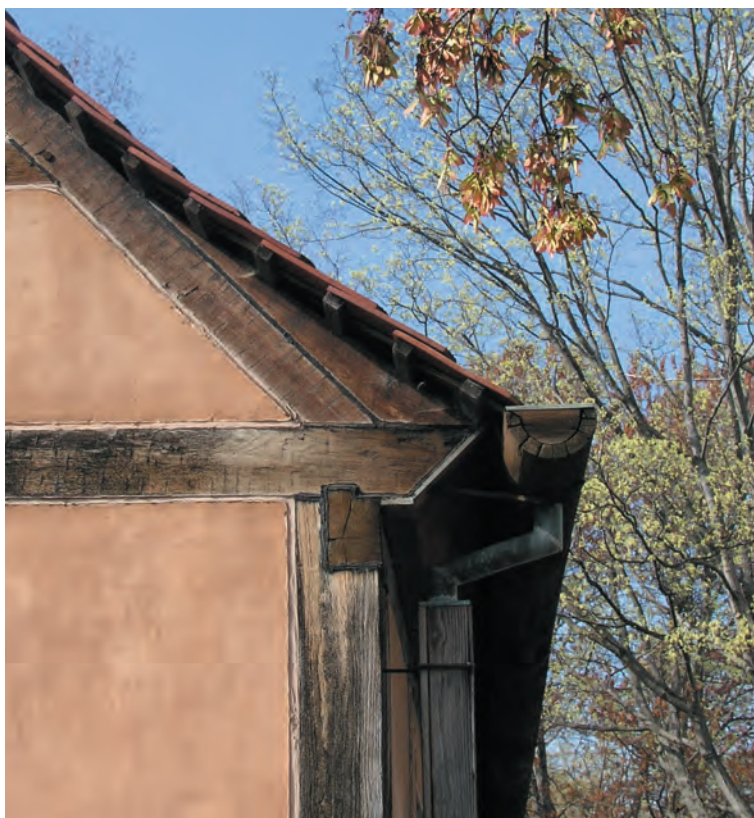
Fig. 2. *Miksch House, 1771, a Fachwerk house with the characteristic roof pitch “kick” at the eaves. Note coggled tie beam at front plate.*

In the framing of the *Fachwerk* houses the non-Anglo details are most visible. Roof frames comprised common rafter pairs, each with a single collar and tie beam. Purlins ran under the collar beams and were supported by posts resting on a false plate. These posts also served as studs to support lath and plaster in the occupied attic spaces. Rafters terminated directly over the wall plate and required a change in roof pitch to extend the eaves beyond the plane of the wall without descending inconveniently far. Hence a small wedge-shaped extension was attached at the foot of each rafter. This “kick” is a defining detail of 18th-century Germanic roof framing in North Carolina (Fig. 2).

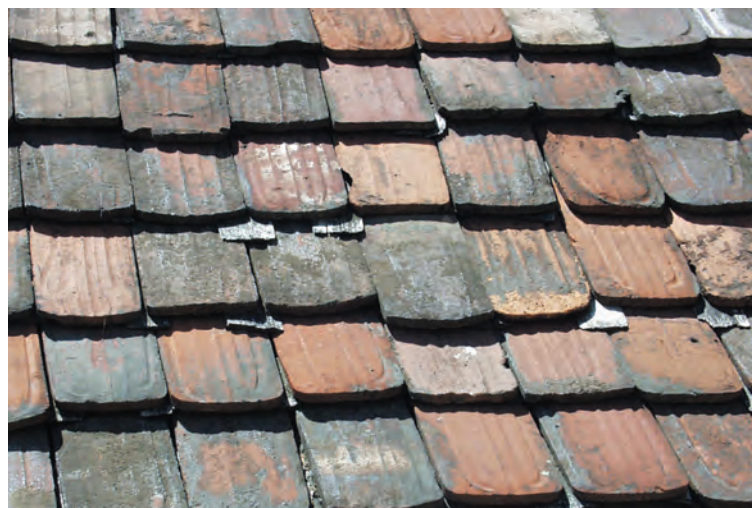
Fig. 3. *Roof tiles are laid in straight files without staggering the joints. Instead, thin wooden slips under the joints shed onto one another.*

are held in place on top of the lath by a clay lug molded on the back of the tile. Any leakage through the aligning joints is addressed with small wooden slips. In Salem, roofing tiles became a visual signature (Fig. 3).

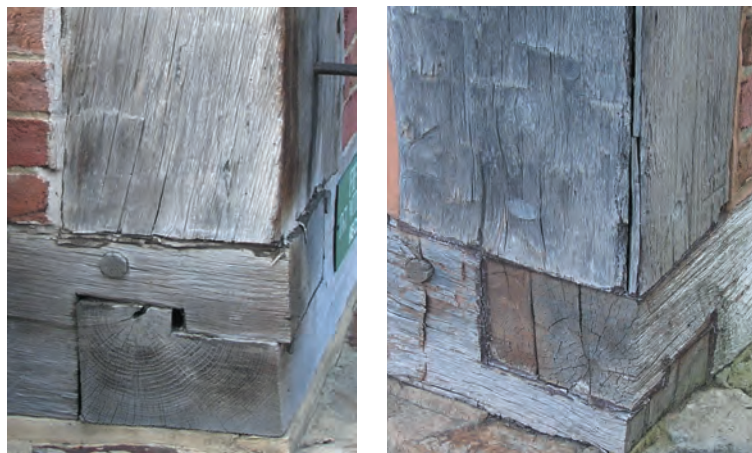
Fig. 4. *Sill corner details in Salem, one coggled, one dovetailed.*

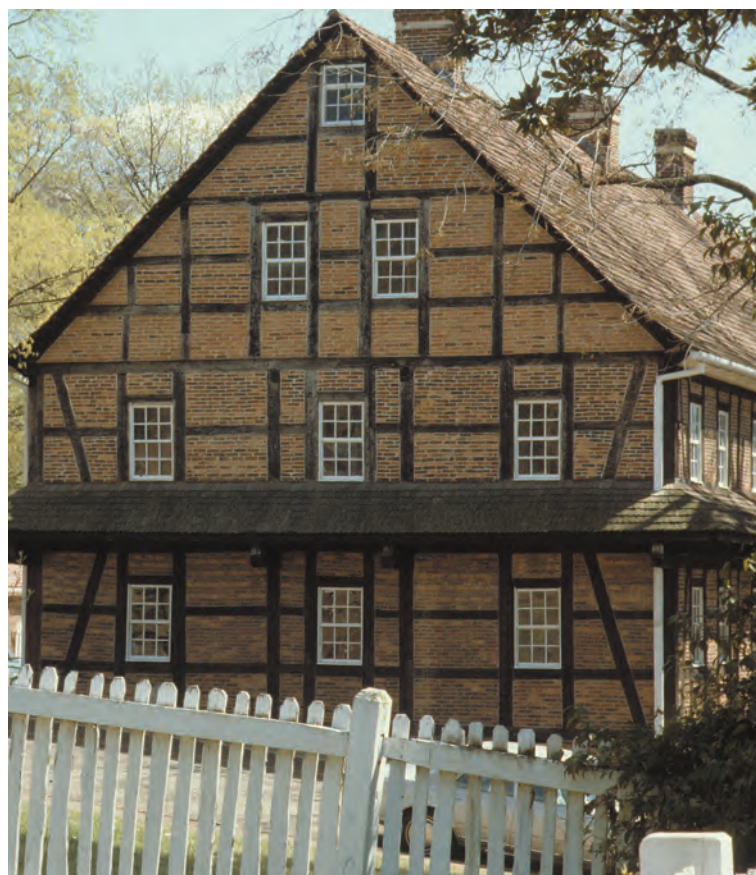
Fig. 6. The Single Brothers' House at Salem, 1769, two stories plus finished attic and walkout basement at the rear. The pentice sheltering the entry floor is rare in North Carolina.

The largest *Fachwerk* building of Salem, the Single Brothers' House (1769), a National Landmark, shares the same vocabulary as the smaller dwellings. It took two days to raise the framing and 16 months to finish the building. It remains today one of the finest examples of 18th-century German framing in America (Fig. 6).

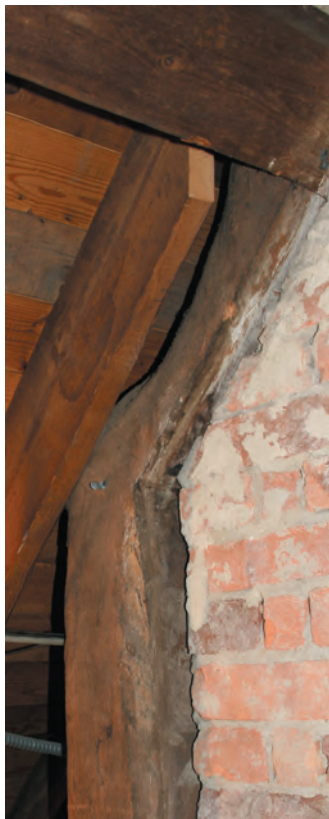
Fig. 8. Crucks post supporting purlin. Rafter is modern.

With the increased availability of lime, masonry became the preferred building technology after the American Revolution. The Moravians clung to their traditional common rafter system and to other throwback elements such as crucks (crank-headed) posts to support the purlin as late as the 1780s (Fig. 8).

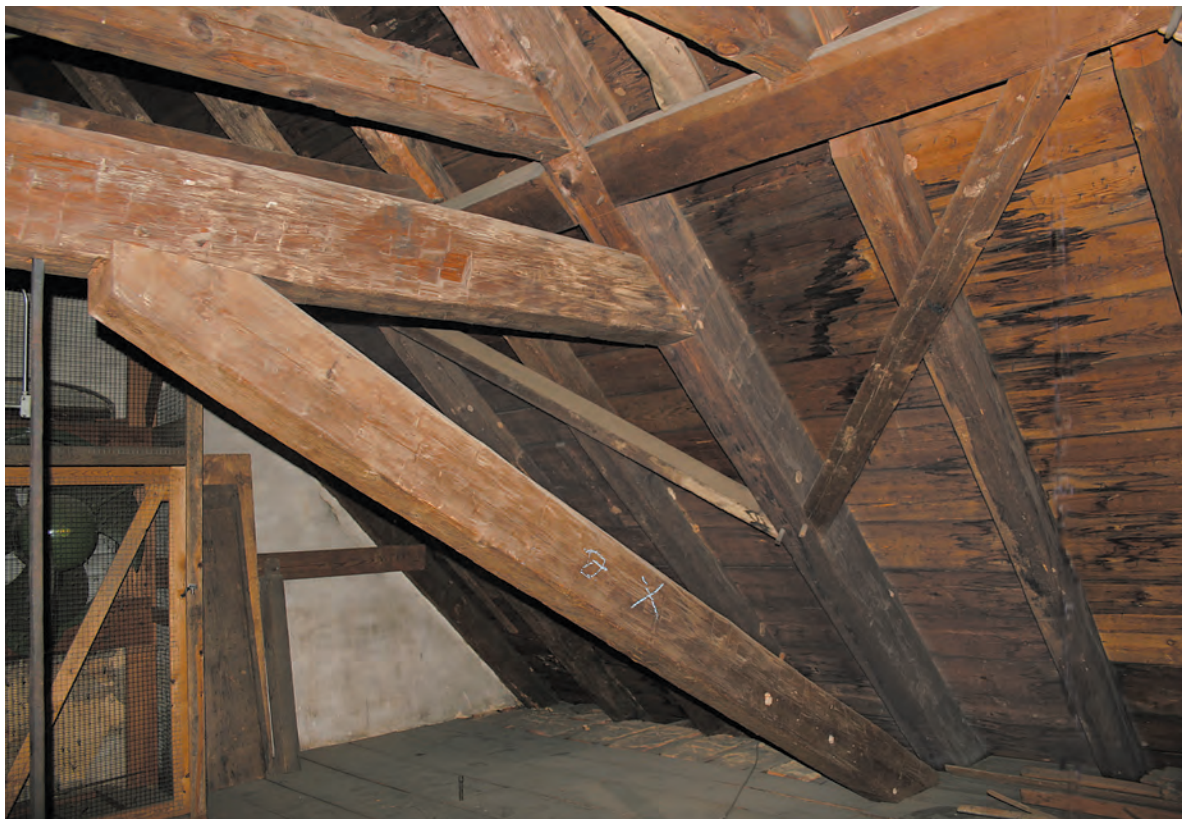
Fig. 10. Home Church principal rafters 8x12 carry tenoned and strutted purlins 5x6. Common rafters 5x7 run on 3-ft. centers. Strut, lower collar and rod at far left form part of truss to help hold up sanctuary ceiling.

By 1800, however, they would increasingly embrace the architectural style of their southern neighbors and the culture it reflected. The remnants of *Fachwerk* framing, along with the distinctive "kick," had been removed from the roof framing system. By the time Home Moravian Church (Fig. 9) was built in 1800, Marshall's 1765 advice was irrefutable: there was no oak long enough for the rafters, so yellow pine was used. In using the pine, available in larger sections as well as longer lengths, the roof framing was redesigned (Fig. 10). Marshall's original low truss

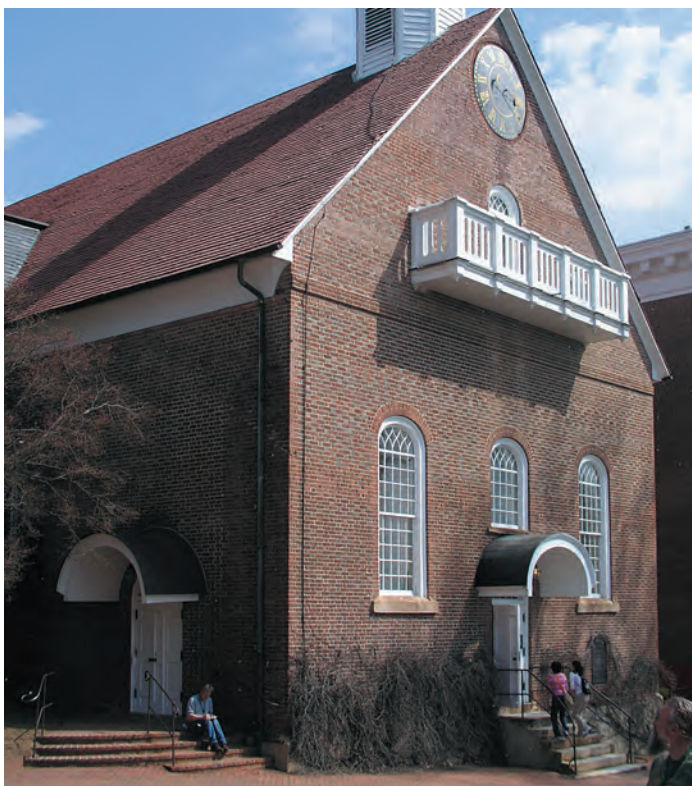
Fig. 9. Home Moravian Church, 1800. Arched canopies over entries are a signature Moravian device.

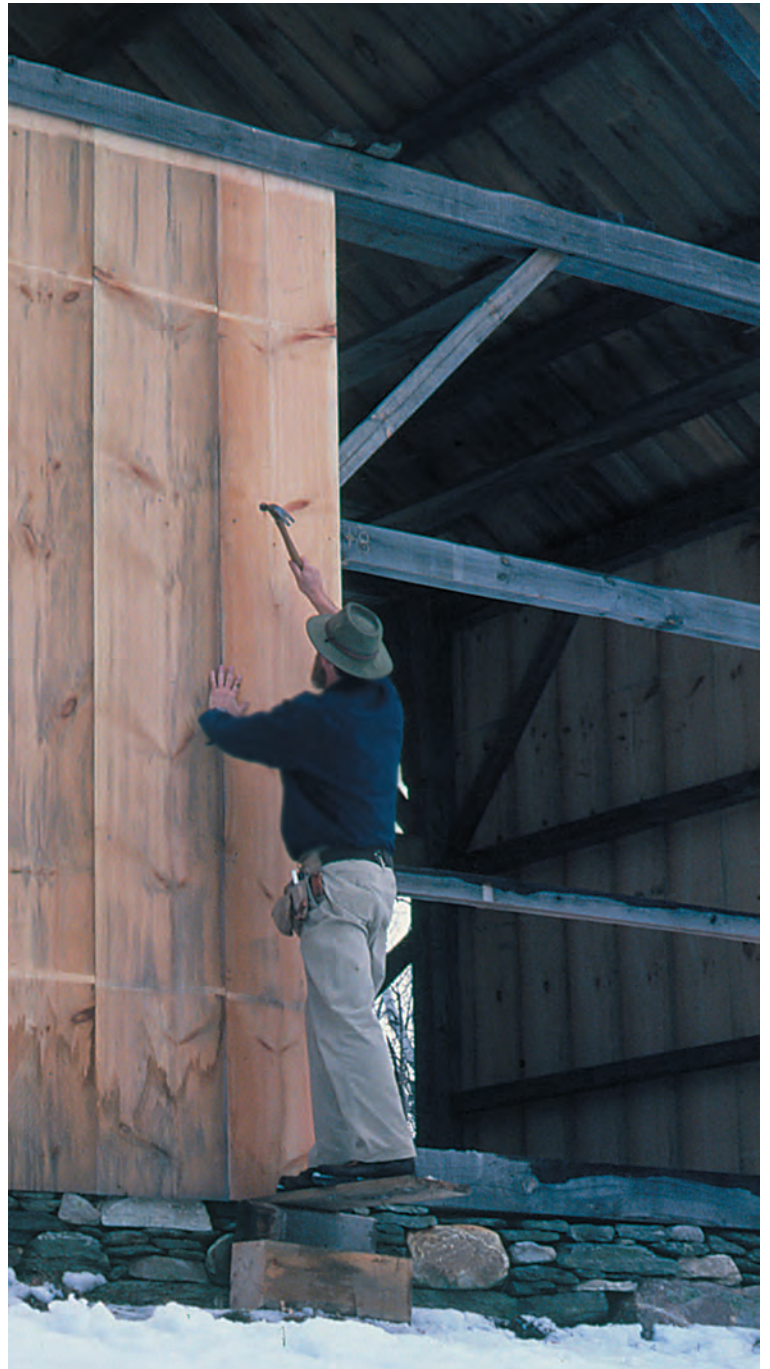
Fig. 1. Wide flitch-matched pine boards make quick work of the south gable end. Most of the boards had to be reduced slightly at their tops.

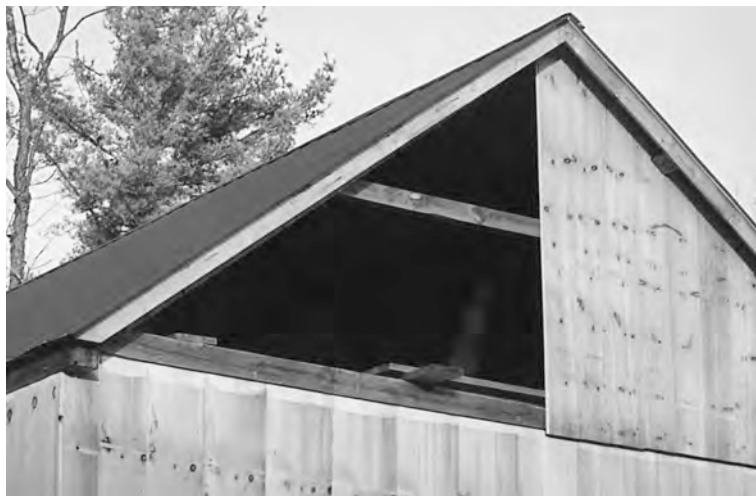
Fig. 2. Most gable boarding could be done from inside while standing on planks. A few last pieces near the eaves went on from a ladder.

I boarded the triangular upper gables while standing inside the barn on planks across the tie beams. Had the roof not already been covered, this task would have been considerably easier: the boards could have been left long and trimmed in situ above the last rafter. Working under the gable overhang, as the triangular space got shorter, I had to apply the last few boards from a ladder (Fig. 2).

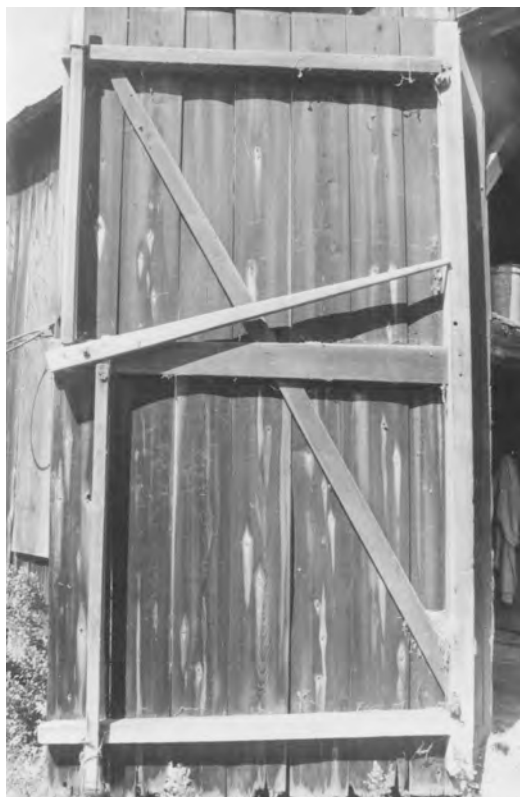
Fig. 3. Framed door in Savoy, Massachusetts, with ingenious lever-operated bolt.

DOORS. English barn doors were typically hinged (rolling doors became common only after the mid-19th century) and of two types, battened and framed. The latter has a sheathed mortise-and-tenoned frame of scantlings, usually 3x4s, and often includes a let-in diagonal brace to keep the door from sagging (Figs. 3–4).

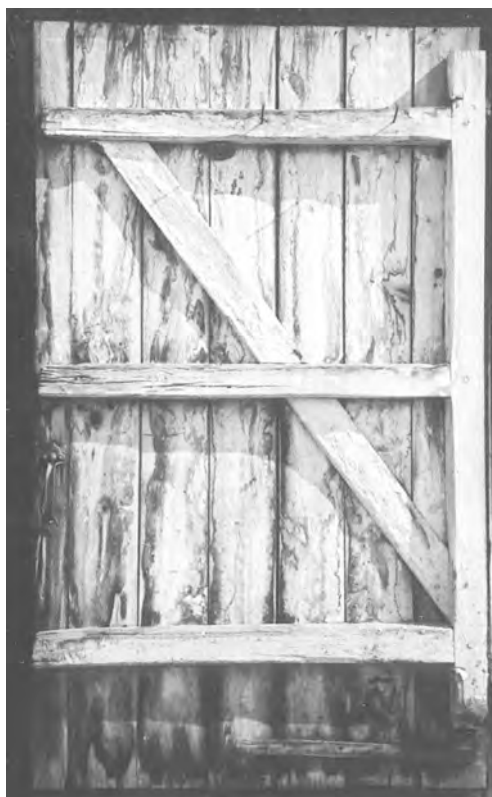
Fig. 4. A small, one-stile cow bay framed door (whitewashed) in Buckland, Massachusetts.

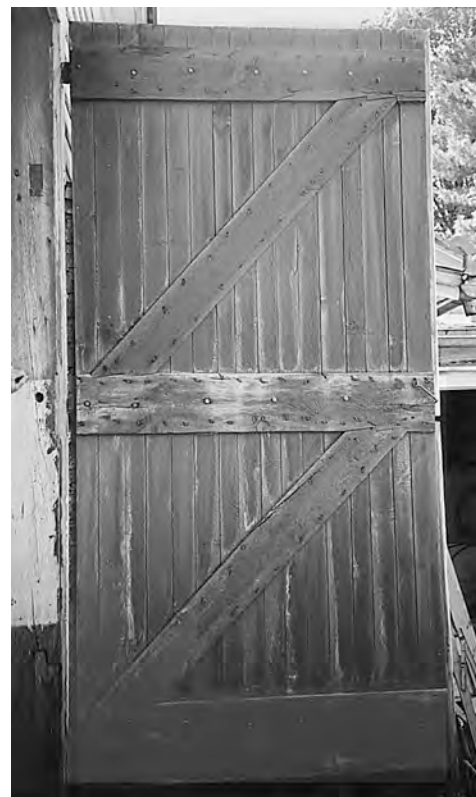
Fig. 5. A mid-19th-century three-batten door in Great Barrington, Massachusetts.

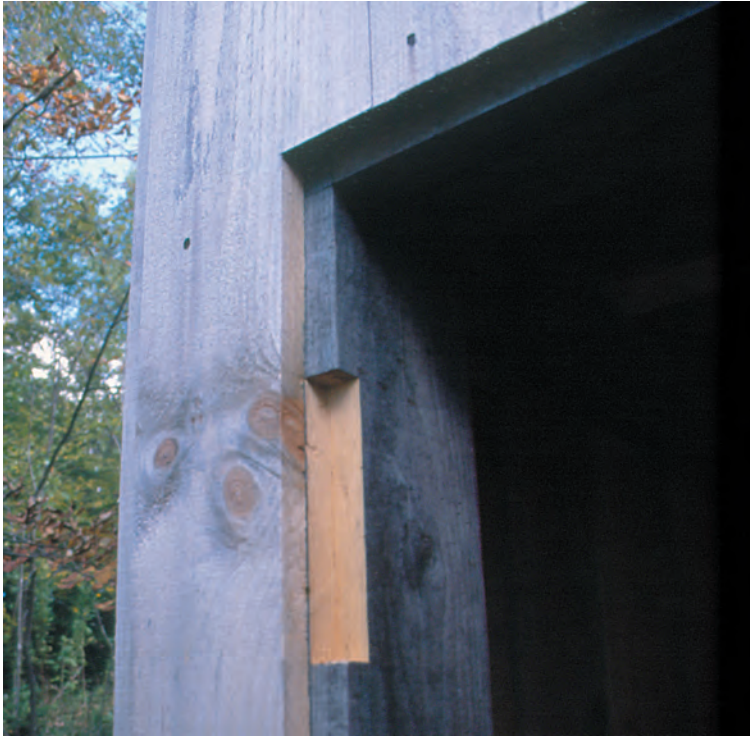
Fig. 6. Rabbeted notch in doorpost for an upper batten.

I began by cutting appropriate rabbeted notches into the posts and letting in full-doorway-width 1x10 pine battens (Fig. 6 overleaf). I drove in small wedges to send the battens tight to the top end of the rabbets, to compensate for later door subsidence, and temporarily nailed the battens. Then I clamped the 1x7 diagonal braces in position for scribing the gains. (But cutting the gain into the higher batten was better accomplished on horses than in place.) The braces temporarily secured, I began the boarding, continuing the flitch-matched effect across the doorways (Fig. 7 overleaf).

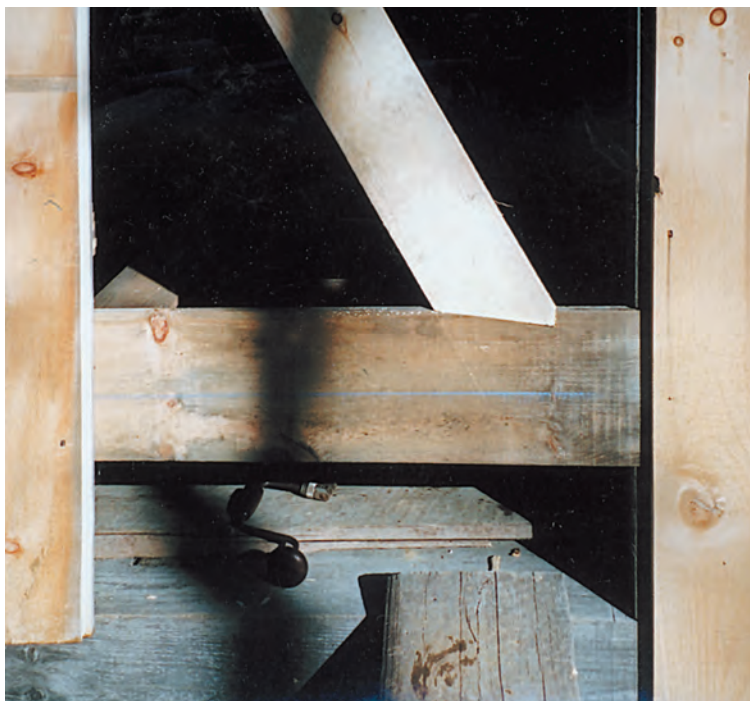
Fig. 7. Gain in lower batten for doorbrace. Sheathing is held back on post for door to make a seal on the hinge edge (at right).

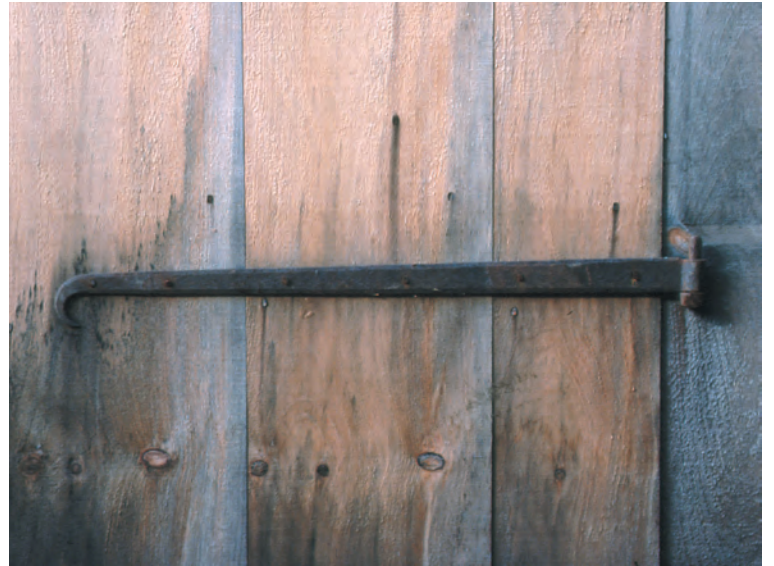
Fig. 8. Hinge straps (32 in. long on the big doors, 24 in. on the smaller doors) with decorative curled tips. Four 18th-century hinges were recycled from an old barn and additional new ones forged to match. Pintle (at right) with square tapered shaft was driven into doorpost.

After the boards came the hinges. Traditional forged pintles had tapered shanks, much like a very large wrought nail, and were driven into holes bored into the jambs. A few went completely through the jambs to be secured by threaded nuts. As I used an unthreaded type of pintle, I matched the hole size to the shank at about two-thirds penetration and chiseled out a squared opening in the pine sheathing to keep it from splitting. The hinge strap sat on the pintle during the driving to keep the latter from rotating

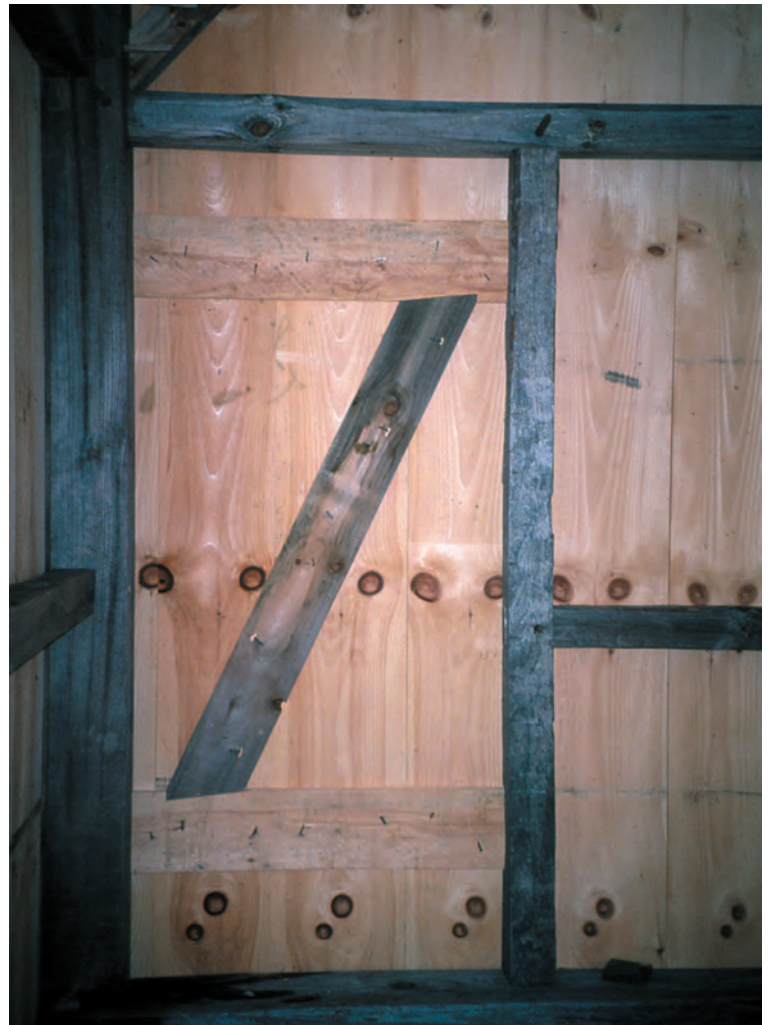
Fig. 9. Completed animal door viewed from inside. Clinched nails holding strap hinges and sheathing can be seen on battens and let-in brace. Flitch-matched sheathing boards form striking patterns.

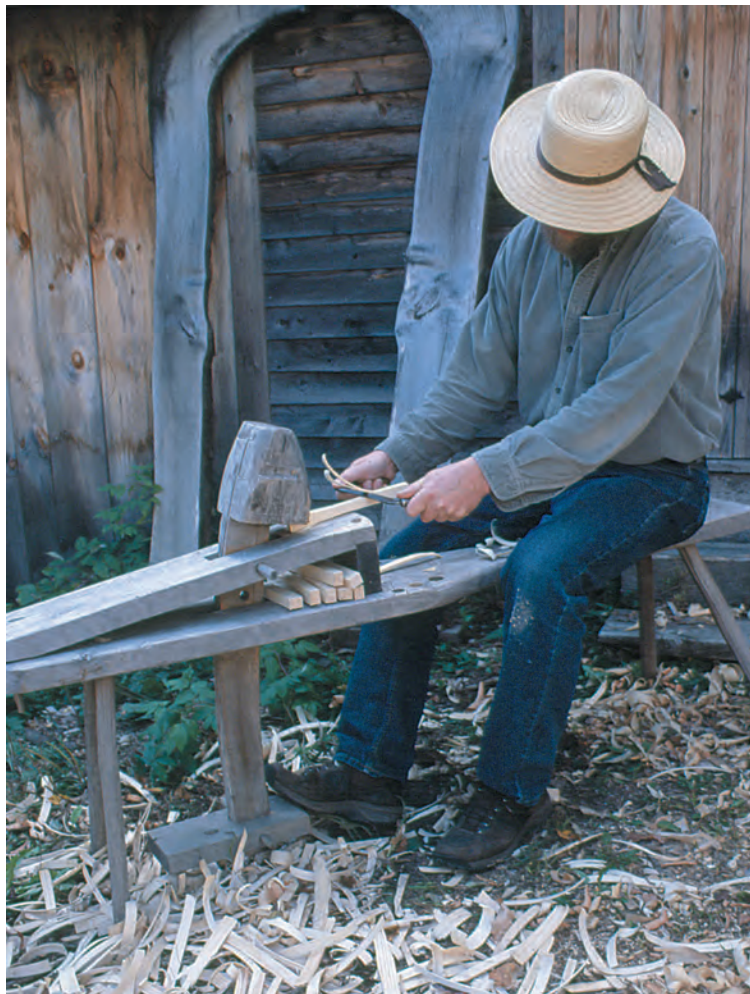
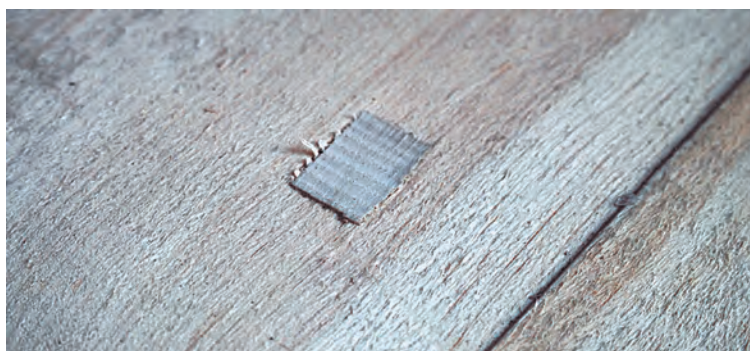
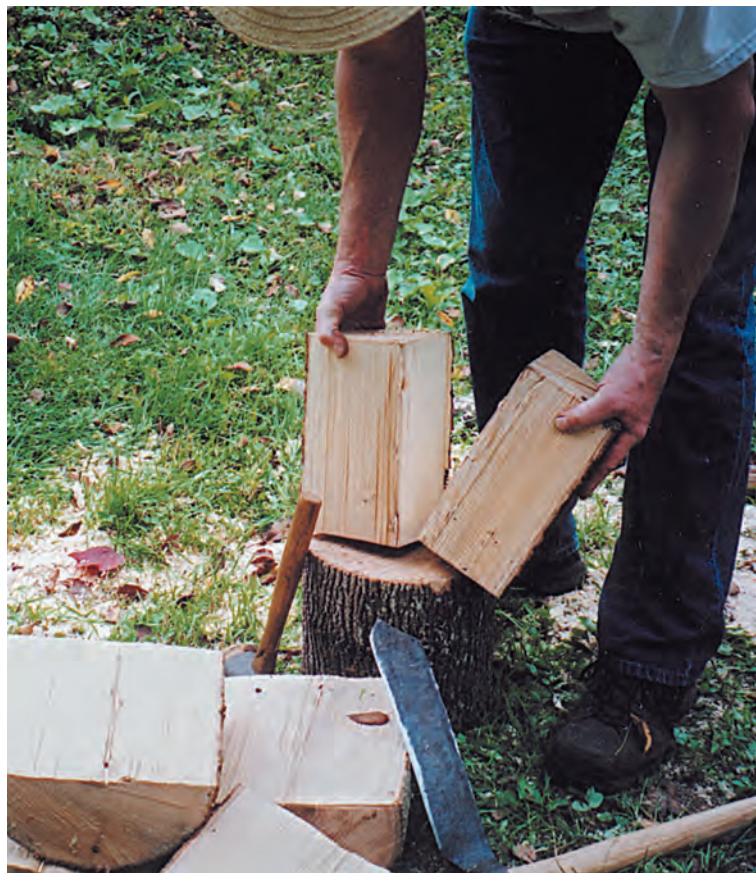
Figs. 10–13. Fig. 10, above, cleaving pin stock from clear ash billets 10 in. long using mallet and froe. Quarters are laid out on one end and further cleft into $\frac{3}{4} \times 1$ -in. rectangles. Fig. 11, at right top, with author on the shaving horse, the pin is given a flared head, squared shank and blunt point. Fig. 12, at right above, ash pins are driven into $\frac{13}{16}$ -in. holes in the flooring, angled to increase holding power, until refusal. Fig. 13, at right, a pin sawn off flush.

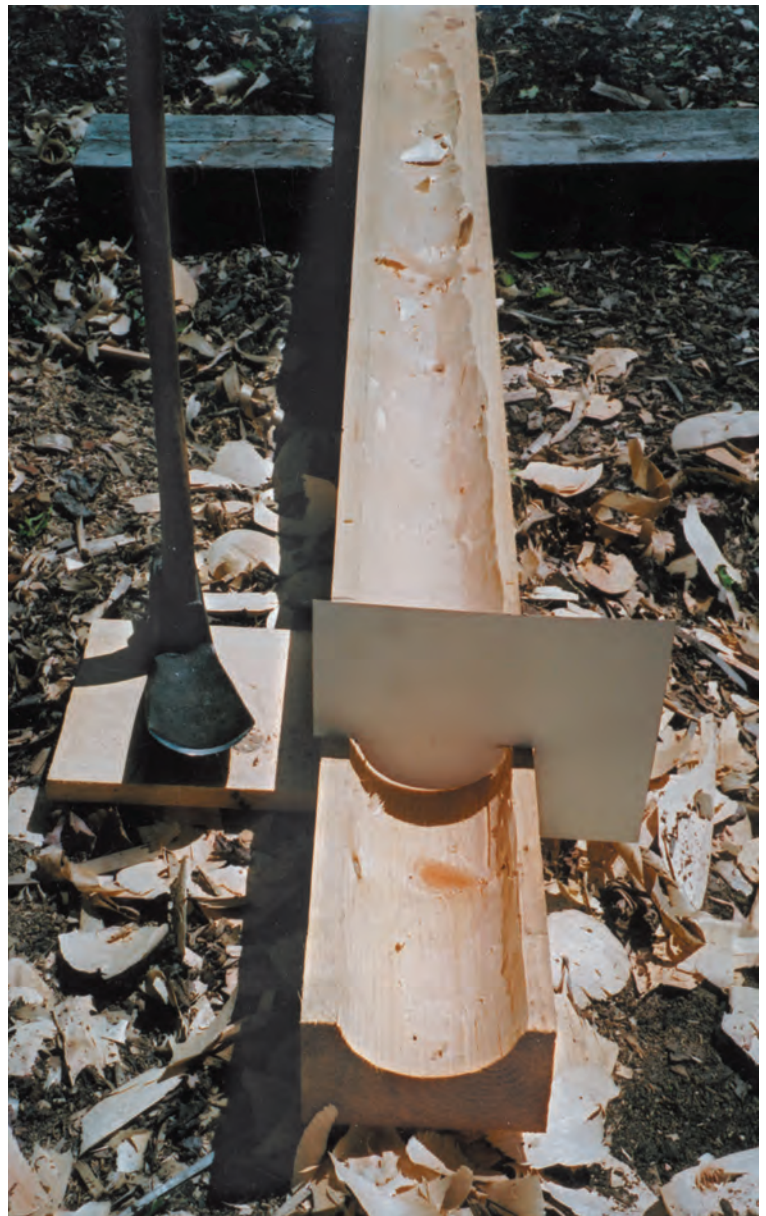
Fig. 14. Gutters are hewn from white pine heartwood with an old gutter adze. A simple template is used to maintain a consistent profile in the 4x6 workpiece.

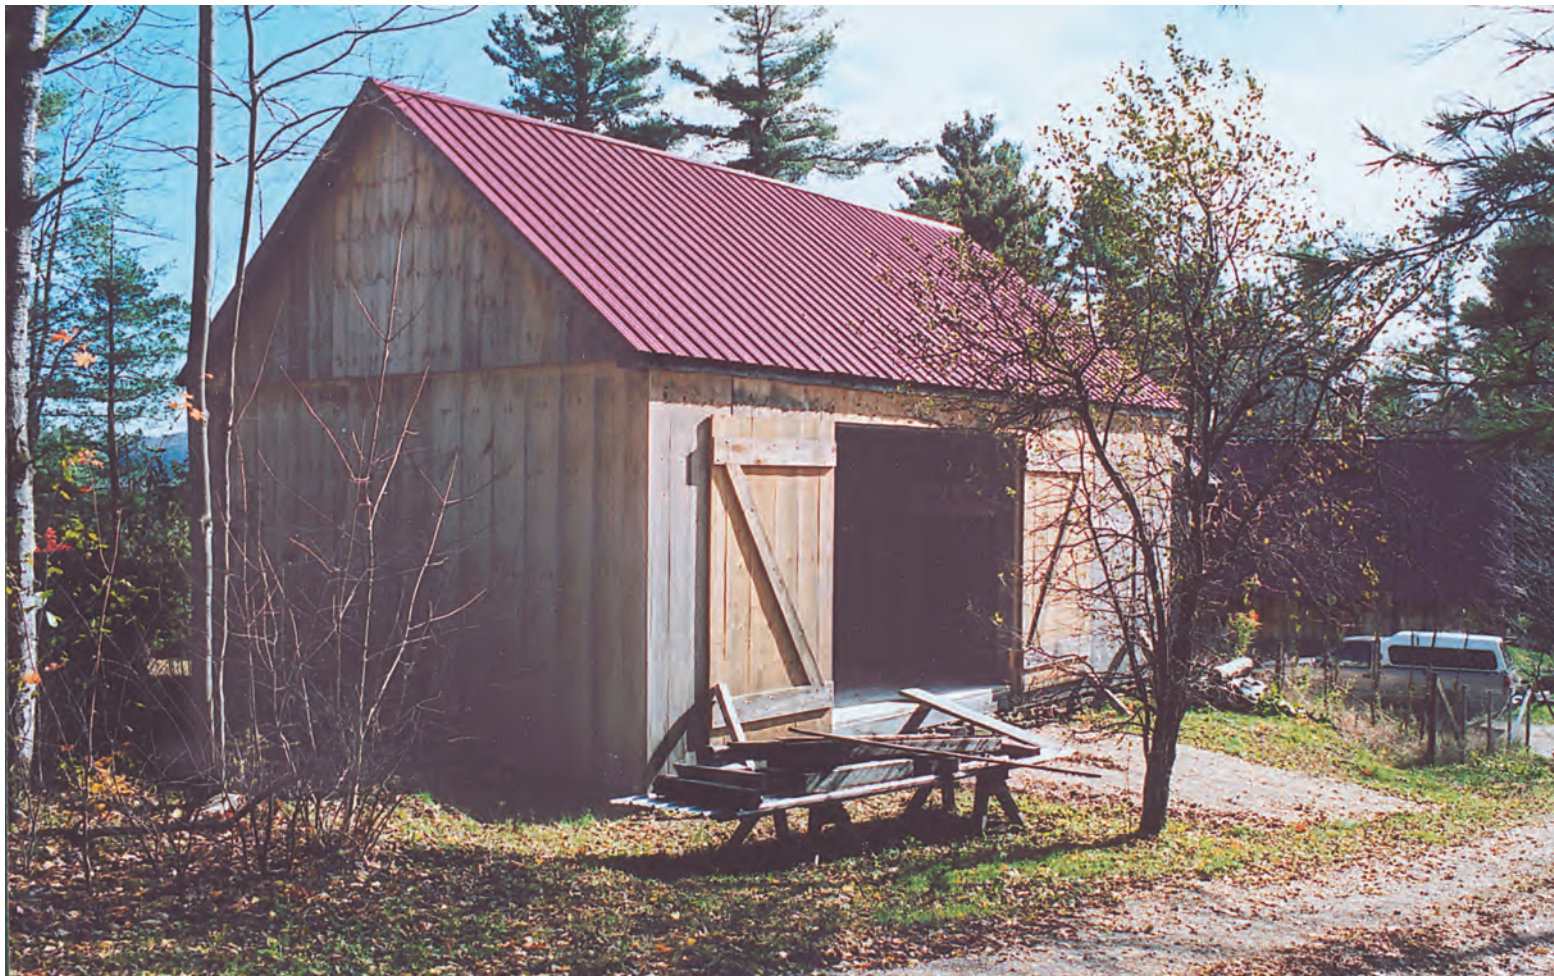
Upper side of author's completed barn, the built-in-place doors open to a warm autumnal sun. Below, pre-1893 view of English barn, with gutter plainly visible at right, in the then-pastured hills between North Adams and Adams, Massachusetts.

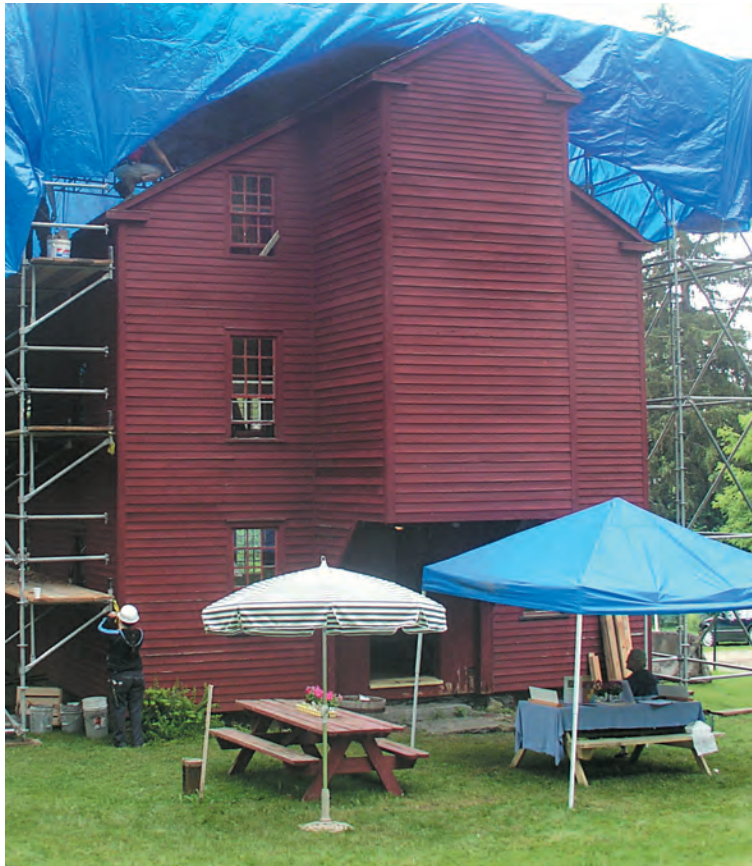
Fig. 3. Granary was fully staged and, with the roof wide open, tarped to protect interior surfaces and time-consuming frame repairs. Lunch was taken in style.

at the Washington Monument), located only 45 minutes from Mount Lebanon. The design they suggested included working platforms at each floor level with safety rails, which eliminated the need for safety harnesses and tying off. The enclosure worked extremely well and kept the project from being slowed by the two weeks of rain that came immediately after the roof deck of the scaffold enclosure was tarped (Fig. 3).

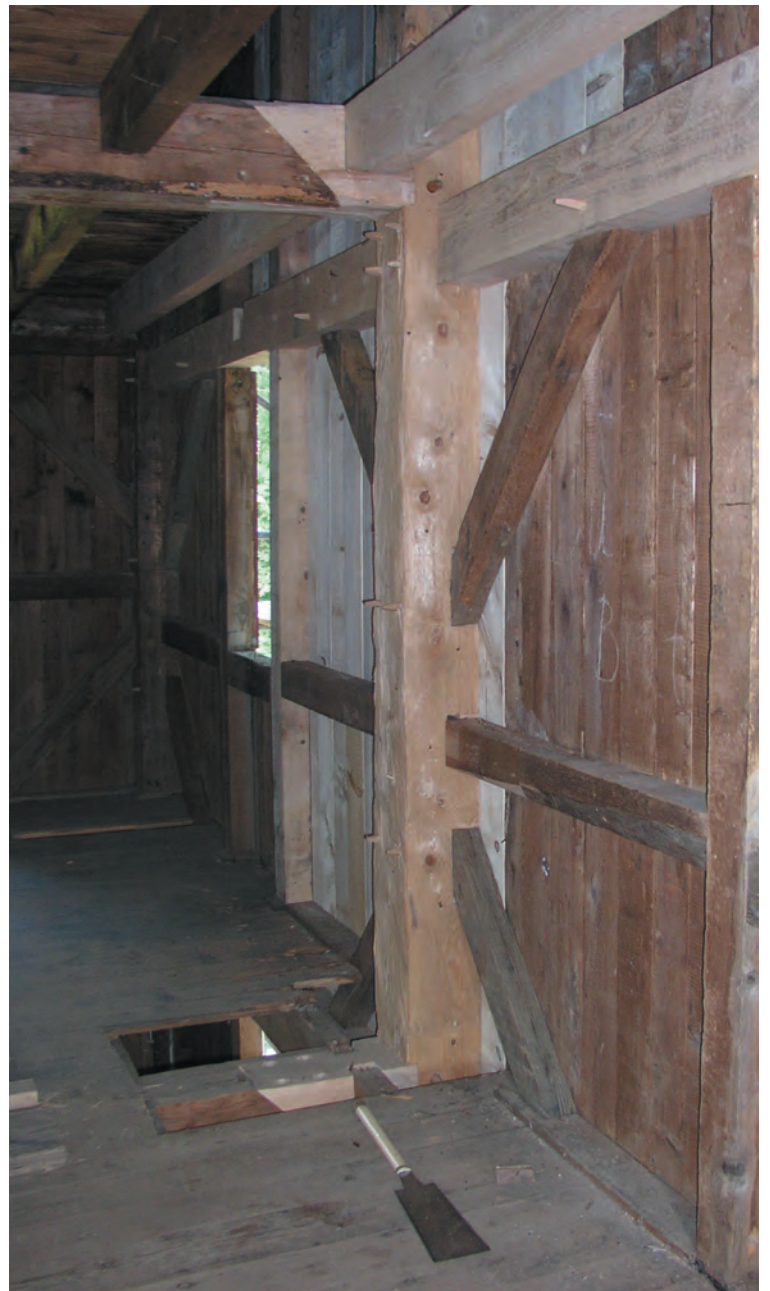
Fig. 4. Wall repairs shown above included new posts, girts and sheathing as well as carefully scarfed tie beam ends. Some braces, apparently original, were recycled from a demolished Shaker structure.

Once the extremely damaged timber frame was exposed, documented and dismantled, we began the process of restoration (Fig. 4).

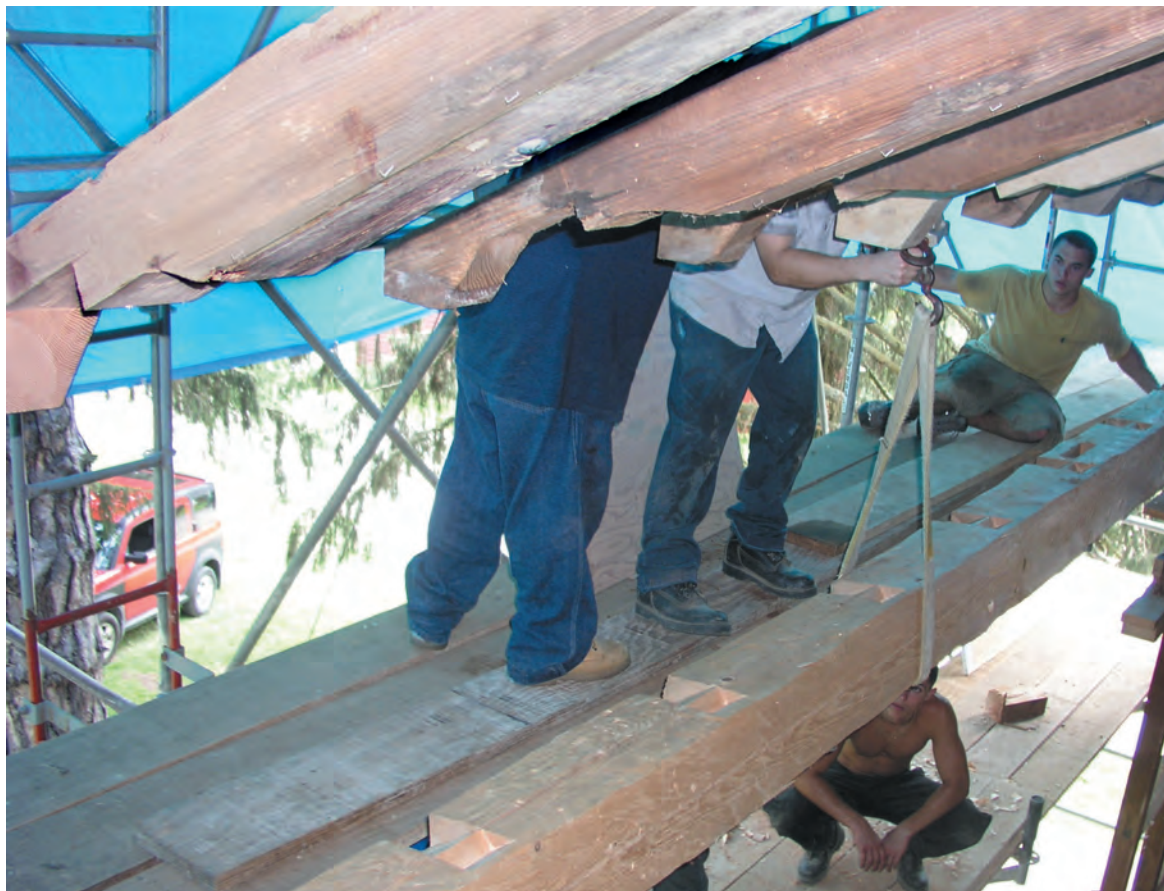
Fig. 5. After scarfing-on of new rafter ends, the repair sequence called for insertion of the new step-lapped plate from below. Plate will be hoisted further and blocked up on cribbing spanning from the attic floor to the staging, then slid outward to engage the rafter feet.

Laying out and cutting the repair joinery was very enjoyable for the students and apprentices as the rainy weather had given way to beautiful sunny days and the sawhorses were staged in the open yard in front of the granary (Fig. 2). All of the work was completed during a four-week period. Maneuvering the repair parts into place was the next challenge. The structural scaffolding again turned out to be a significant asset: it allowed for hoisting and rigging of the timber without a crane. The assembly sequence started at the top where the new 26-ft. scarfed repair section of plate came in under the repaired rafter tailpieces. Once the plate had been hoisted up and staged on stacks of blocking that bridged from the attic floor to the scaffold platform, the plate was slowly pushed out until the step-lapped rafter seats were engaged. The halved and bladed scarf joints, chosen because of examples found in other Shaker buildings at the site, allowed the plate to be slid horizontally as the joinery was aligned (Fig. 5).

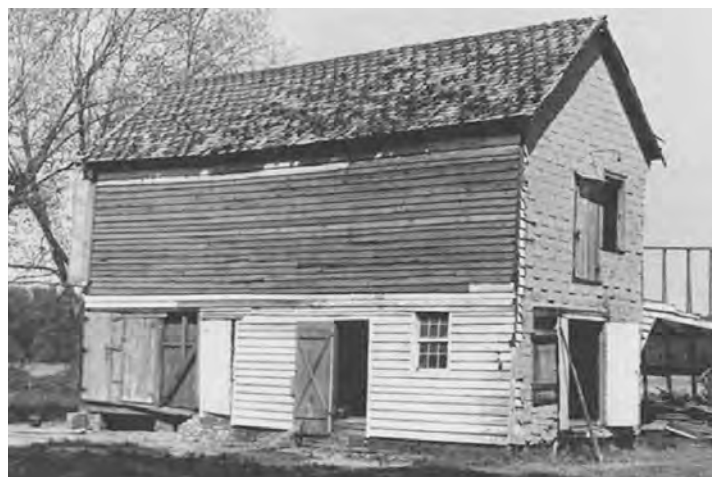
Fig. 1. The Robson House, Pitt County, N.C., 1742. One-room house enlarged to two and later converted to tobacco packing barn.

During 17 years working in the eastern division of the N.C. State Historic Preservation Office, I have visited dozens of one-room houses dating to as late as the mid-19th century. Some of these have survived largely unaltered while others are hardly recognizable. Most of these early dwellings were converted to kitchens or slave quarters, were overbuilt into a larger house or became an appendage to a new and larger dwelling. One of the most intriguing survivors is the 1742 Robson House in Pitt County (Fig. 1).

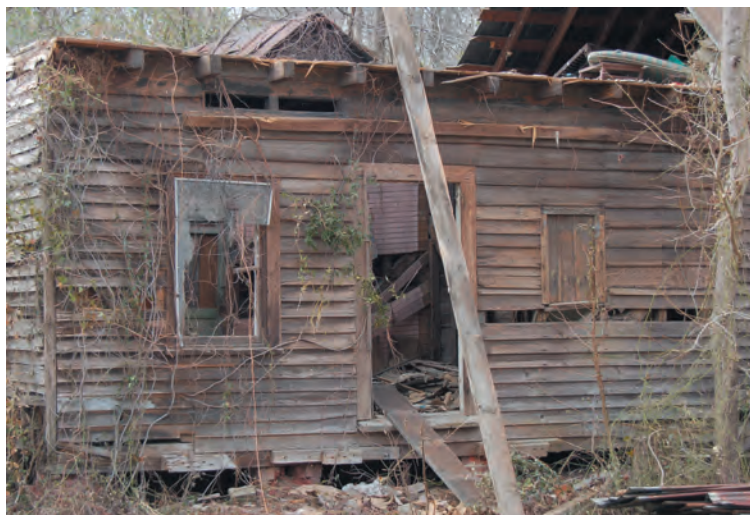
Fig. 2. The ruinous Brown House, Pitt County, ca. 1780.

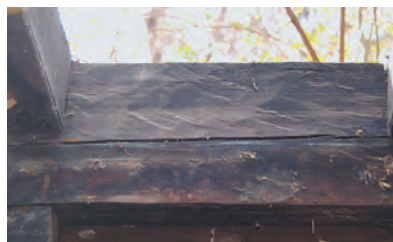
Fig. 3. Dressed and beaded joists in Brown House.

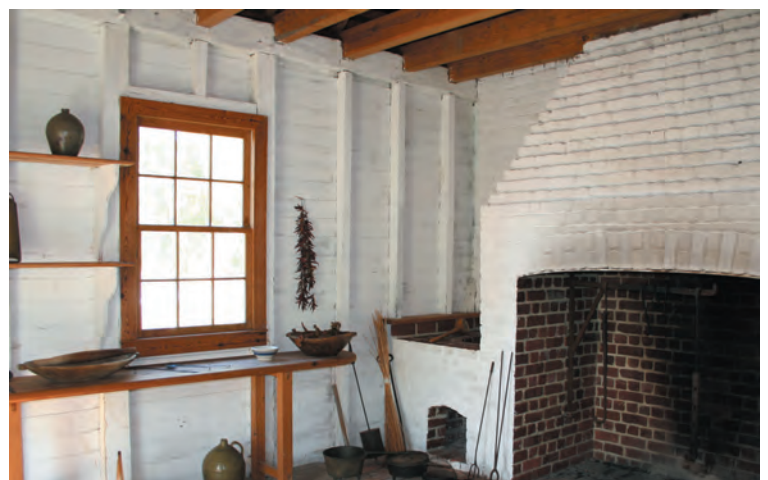
Fig. 7. Detail of Hope Plantation, Windsor, N.C., ca. 1800, where sills average 10½ x 14 in.

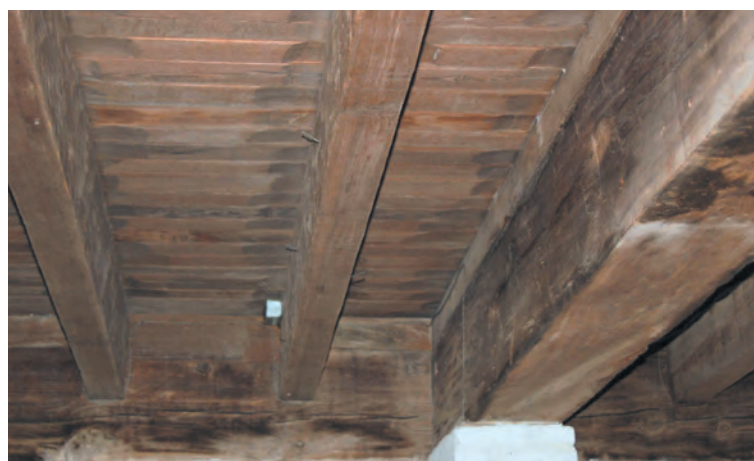
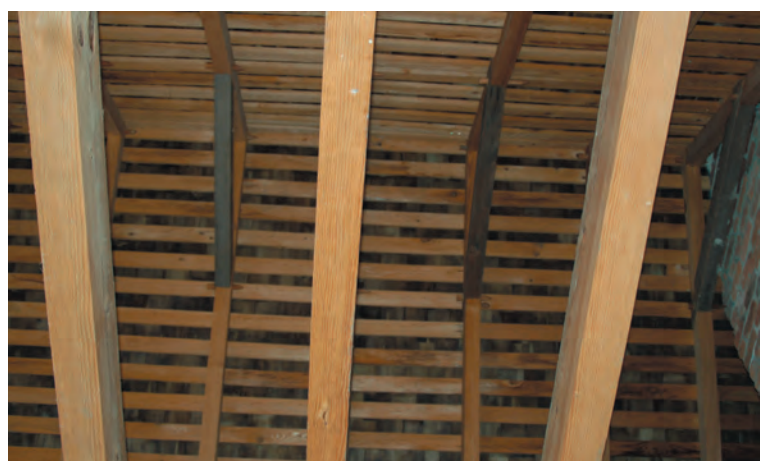
Figs. 8–9. Reconstructed open-ceiling kitchen at Hope Plantation. Ventilation overhead relieved heat of a wood-fired southern kitchen.

and open ceilings. (The attic flooring we found in a few kitchens was added later.) This open space allowed for needed ventilation, especially in a hot and humid climate (Figs. 7–8).

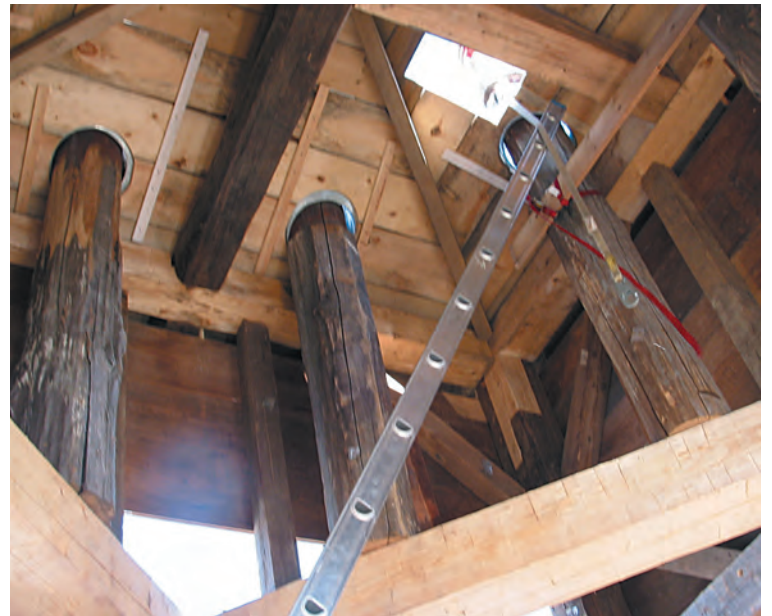
Fig. 1. Steeple columns are turned where they emerge to view, left merely debarked where they remain concealed.

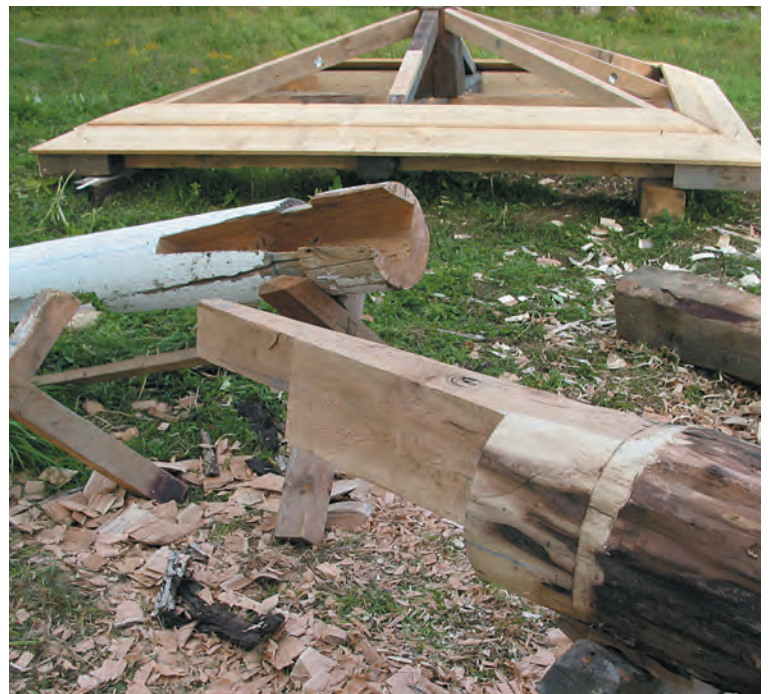
Fig. 2. Scarfing painted remnant column to new base. Newly re-framed tower roof, partly boarded, in the background.

of the various elements and reassembling them. The tower that stayed on the church required extensive free and slotted tenoning since it couldn't be fully pulled apart. With the second tower we were free to rebuild it as it was originally. The butternut columns were elaborately repaired and two were replaced, although finding halfway straight and sound 13-in.-dia., 18-ft. butternut logs was difficult because of the diseased state of the species today (Fig. 2).
