TIMBER FRAMING

JOURNAL OF THE TIMBER FRAMERS GUILD

Number 84, June 2007

| 1700s GERMANIC FRAMING IN MORAVIAN SALEM, N.C. John Larson | 4 |

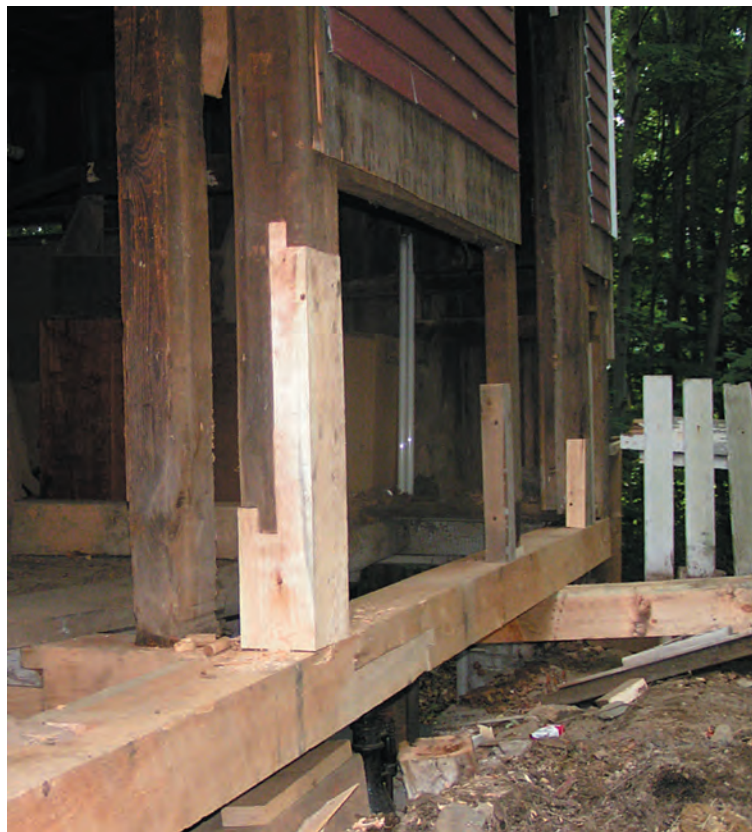
Fig. 2. Repair or replace? Here, one choice for sill, the other for posts.

When it comes time to repair the frame elements, the first big question is whether to repair or replace (Fig. 2). For the sake of preserving the historic fabric, I try to repair an element rather than replace it, but this is always a judgment call. Will a repaired piece function as well as a new piece? How was the original designed to function? Some pieces work in tension, some in compression, and where in that piece are the forces the greatest?

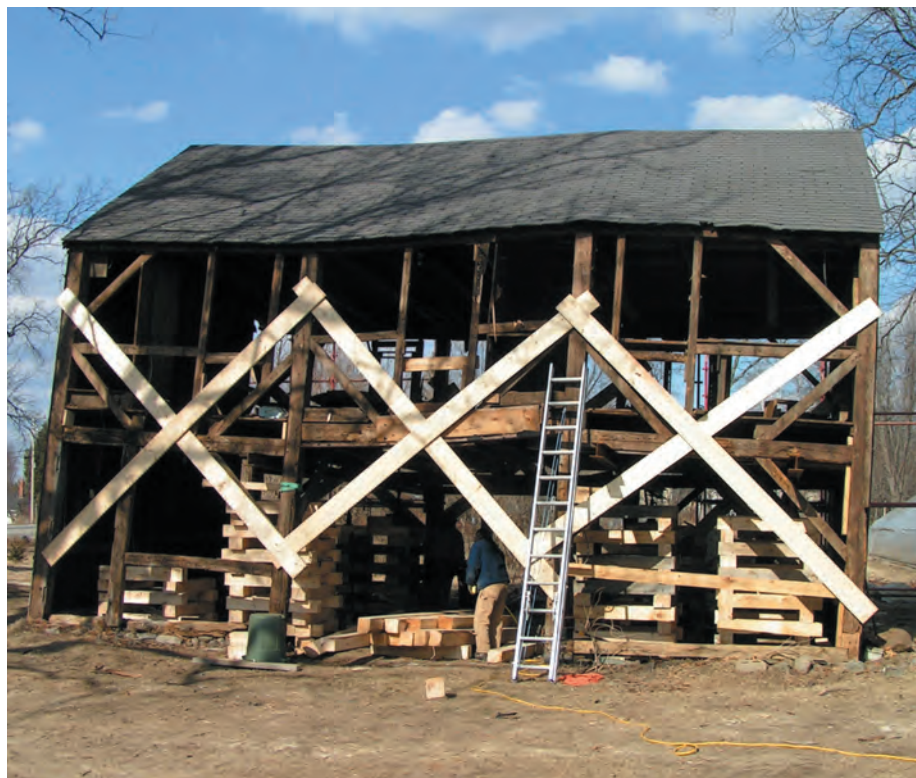
Fig. 1. Stabilizing a building can effectively replace its functional elements.

Before repairs can start, the building must be appropriately stabilized, by cribbing, cross-bracing and restraining the frame (Fig. 1). Stabilization systems can stand in as building elements—the cribbing as foundation, the cross-braces as wind braces and the restraints (chains and binders) as tension joinery. During this stage, it is necessary to identify the point loads in the building. If a post has a rotten bottom, the weight intended to travel along the post's path has been diverted. Where did that weight go? Frame elements that were never intended to carry weight now may have become structural elements by default. If the frame element has failed, the temporary stabilization needs to be at least as strong as the original piece. Also, if the cribbing system is built to hold up the weight,

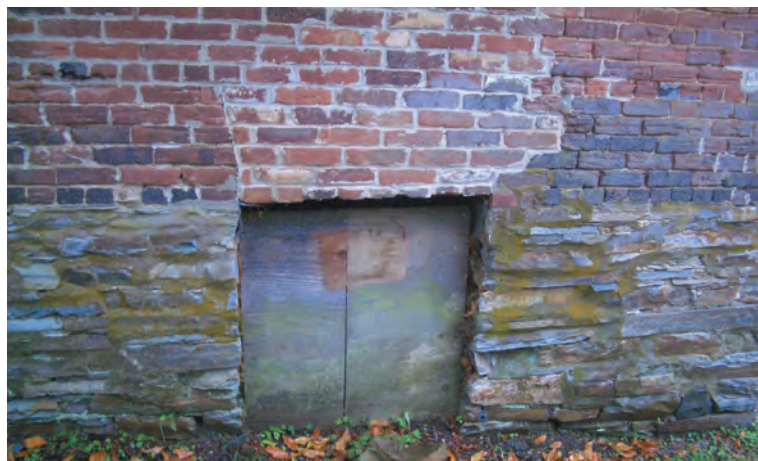
Spalling damage caused by 1970s Portland cement mortar used to point 1816 bricks.

Cement mortars also are bad for historic structures because of their hardness when cured. Portland mortars do not expand and contract the same as lime. Thus when brick or stone expands against the harder Portland, it may break and lose the faces of the masonry units, as shown below. Irreparable harm often occurs.

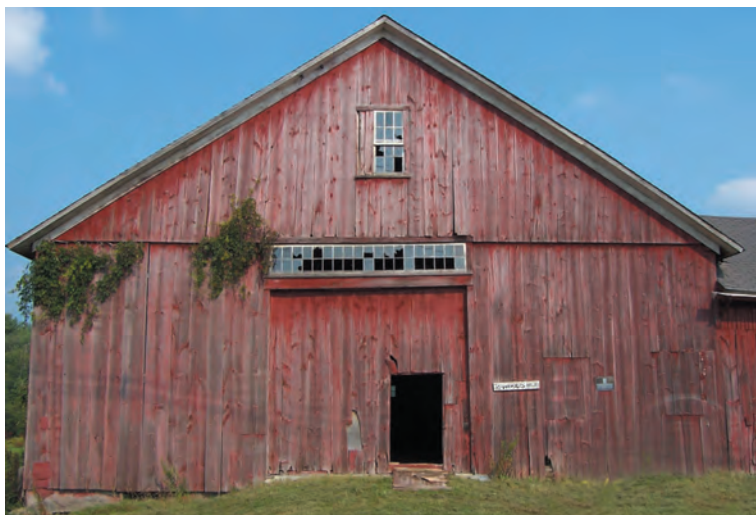
Fig. 1. The Chase barn as found, apparently 19th-century.

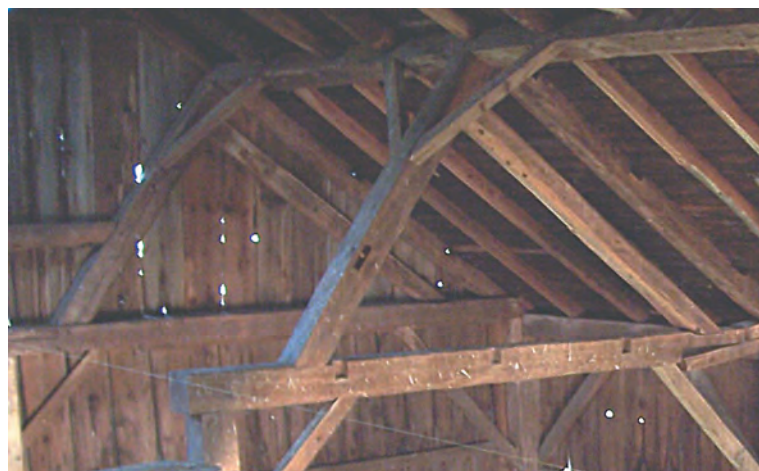
Fig. 2. English barn cut and spread apart, with new roof framing.

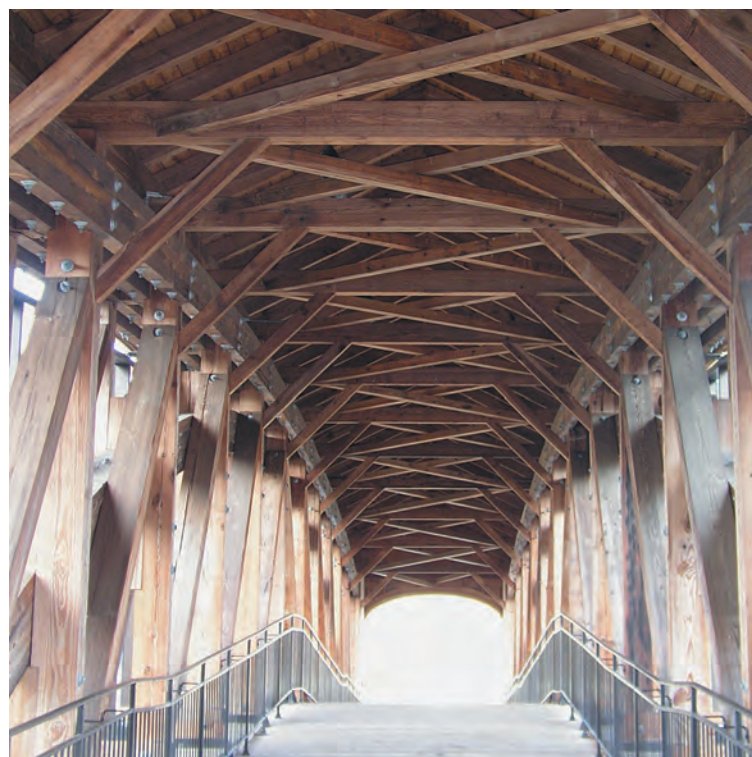
Fig. 1. Covered pedestrian bridge at Old Salem, N.C.

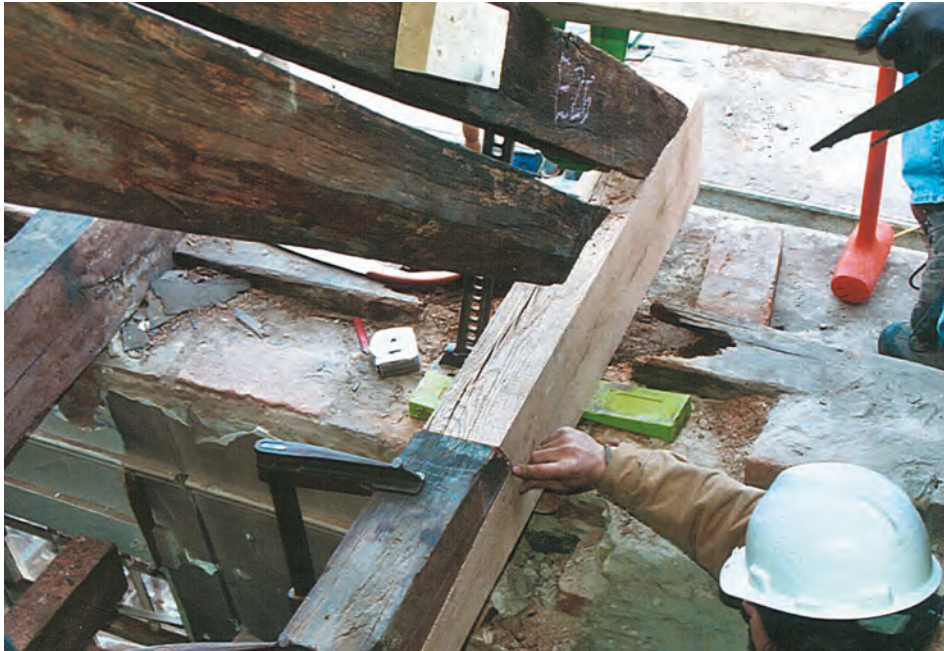
Fig. 2. Repairs to a principal frame at the Single Sisters' House, Old Salem.

THE roof structure of the ca.-1785 Single Sisters' House at Old Salem consists of principal and common A-frames with both collar

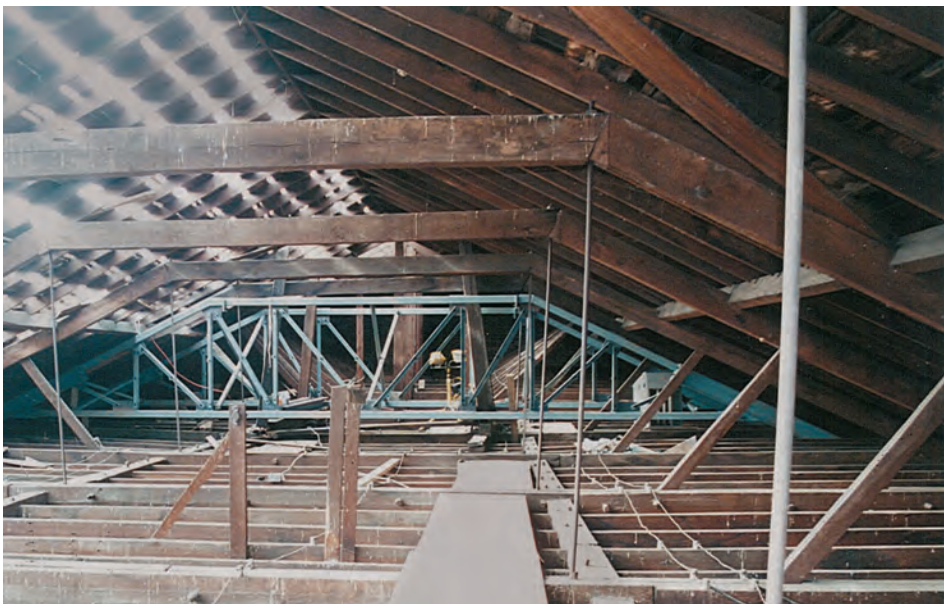
Fig. 3. A pair of light steel trusses now support the steeple in the attic of St. Philip's Moravian Church. Main roof trusses are composite vernacular queenrods.

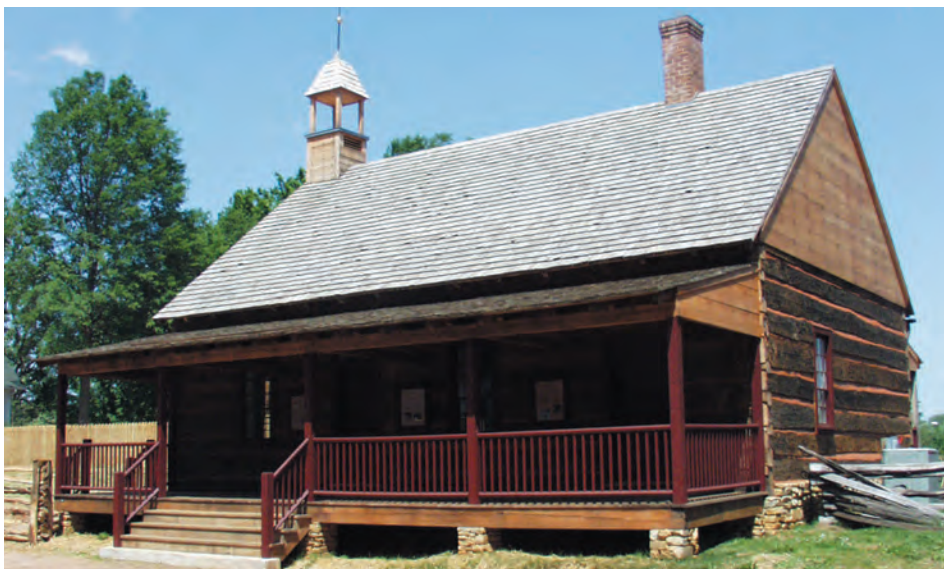
Fig. 4. Reconstruction of the 1823 Moravian Log Church.

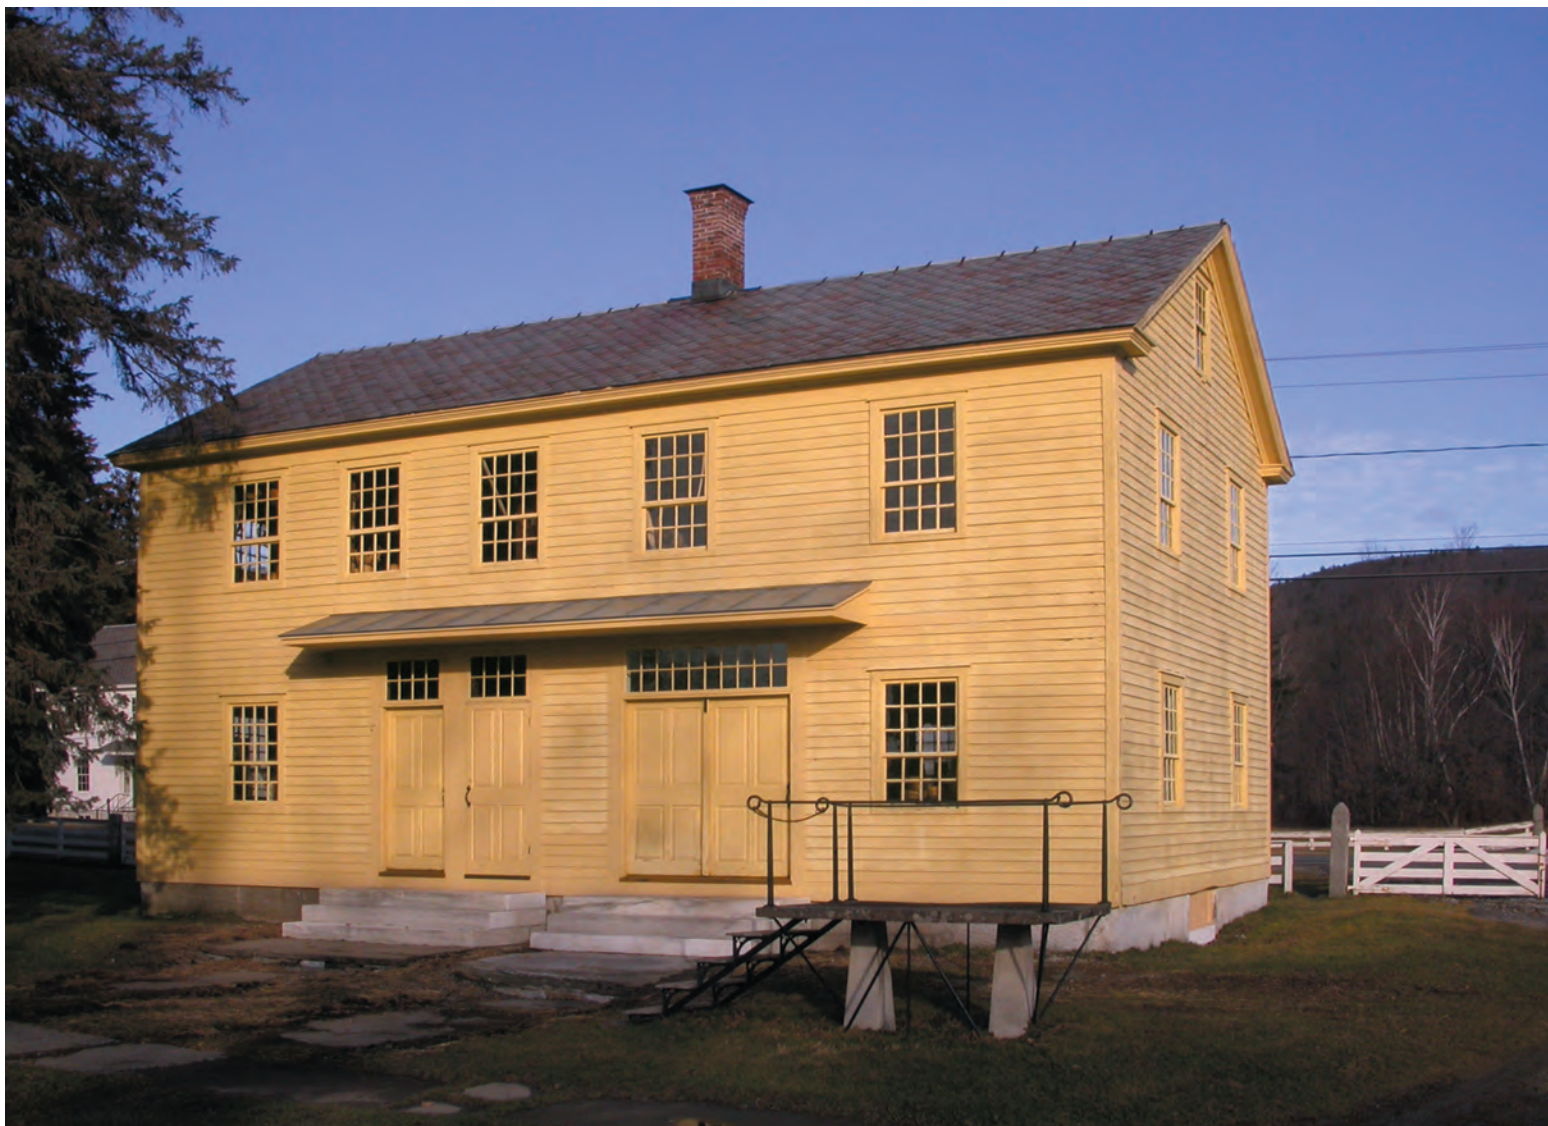
Fig. 1. The Brethren's Shop at Hancock Shaker Village repaired, with scarfed-in sills and posts, woven-in exterior finish and a new pentice roof to protect the entry. The iron platform on posts in the foreground is a carriage mount.

Sill and foundation problems as a result of roof runoff, poor surface drainage and backsplash from the entry steps led to door, sidewall trim and flooring disintegration as the structure settled (Fig. 2).

Careful documentation as the south side of the building was shored and disassembled provided new evidence of previous repair efforts, including old pentice-roof mortises. Traditional timber frame repairs were made and a new pentice roof was added for protection over the entry steps (Figs. 3–6 overleaf).

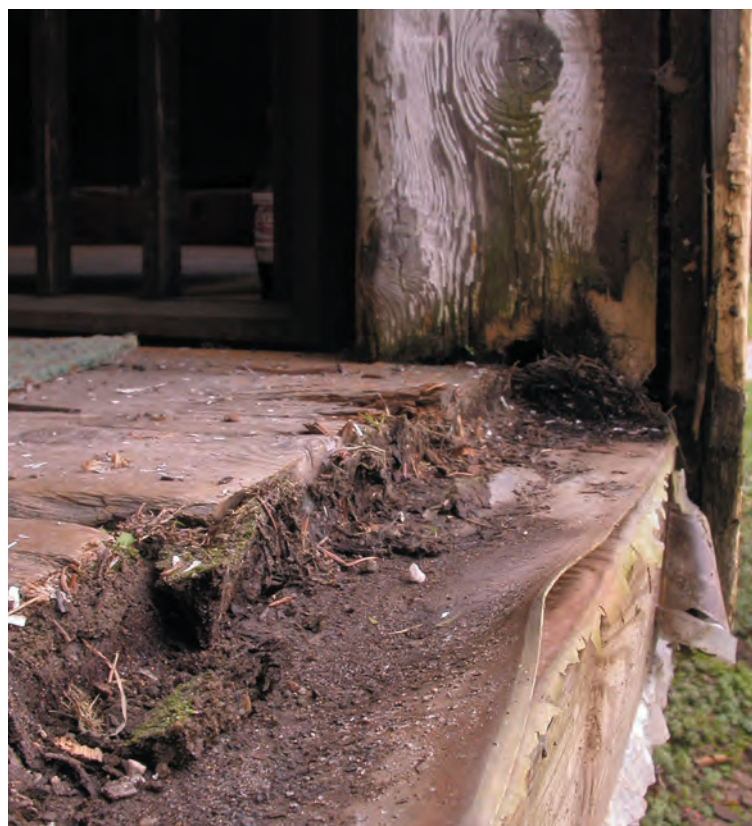
Fig. 2. Years of backsplash from broad unsheltered stone steps had led to significant decay in the doorways and the building's sill beneath.

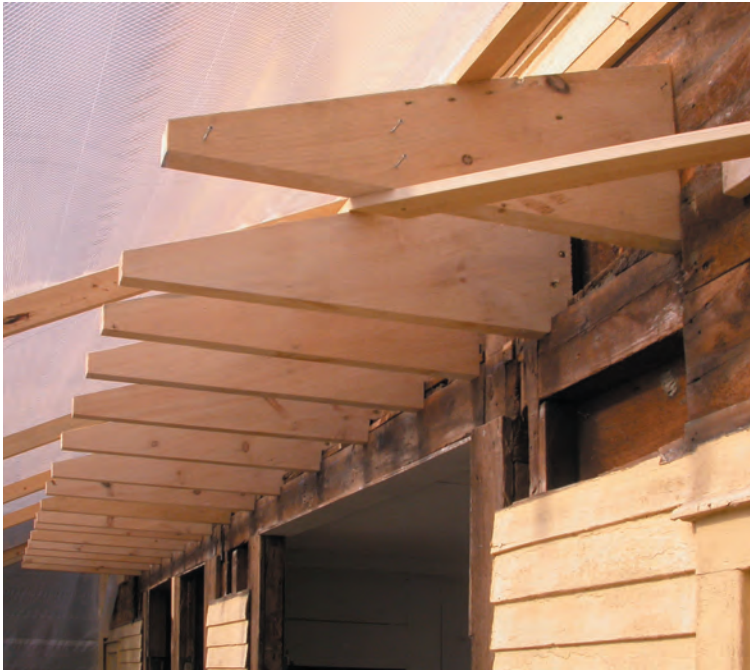
Fig. 3. Reconstruction of pentice roof followed discovery of telltale mortises in building. Temporary roof over work area allowed unhindered progress.

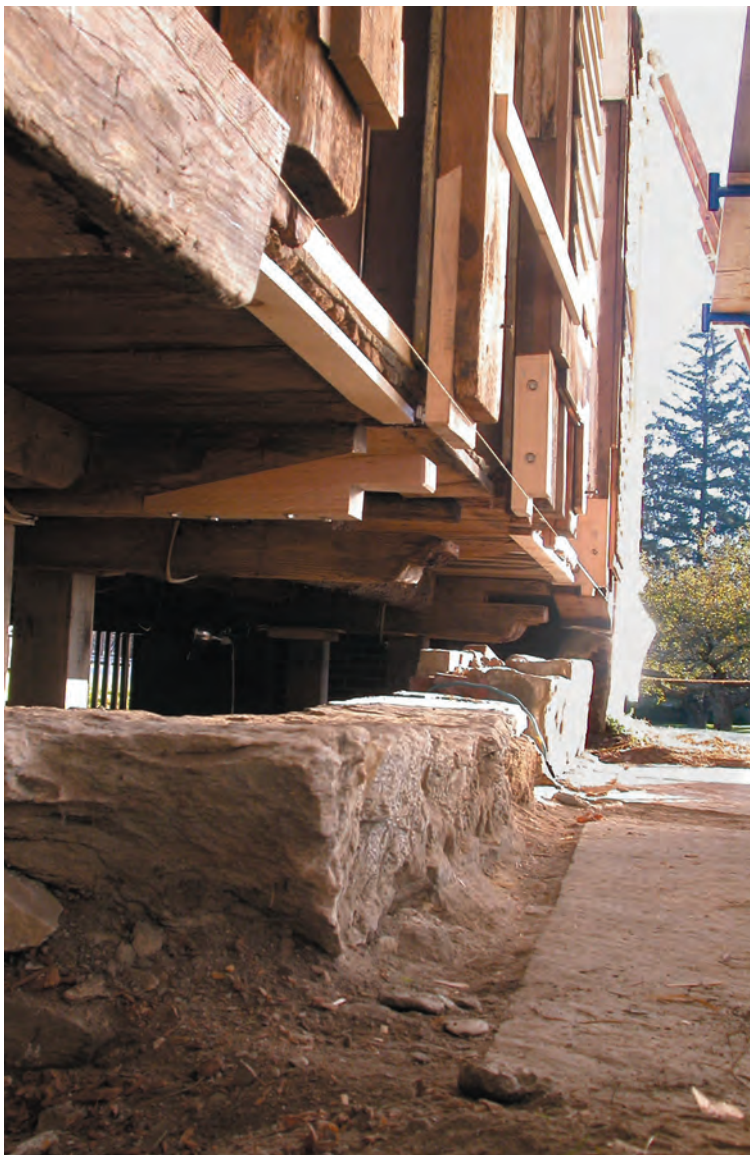
Fig. 4. Sill and foundation stone removed, repairs advanced on girder and post ends.

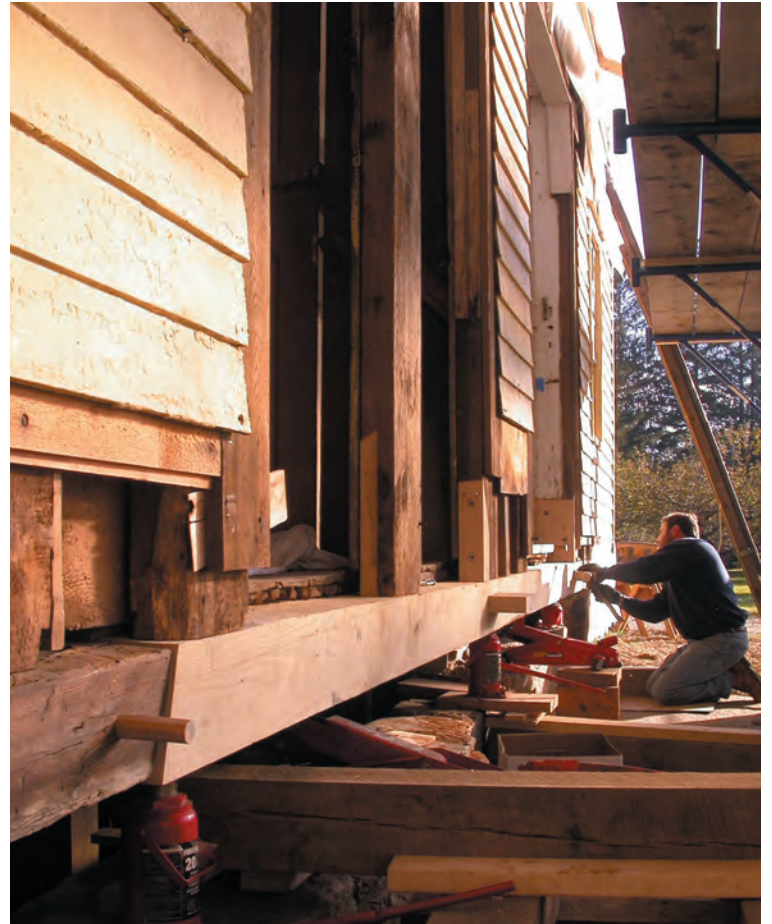
Fig. 5. Scarfed-in sill in place, Matt Duffin drives in free tenon to secure floor beam meeting sill. To his left, a second free tenon remains proud.

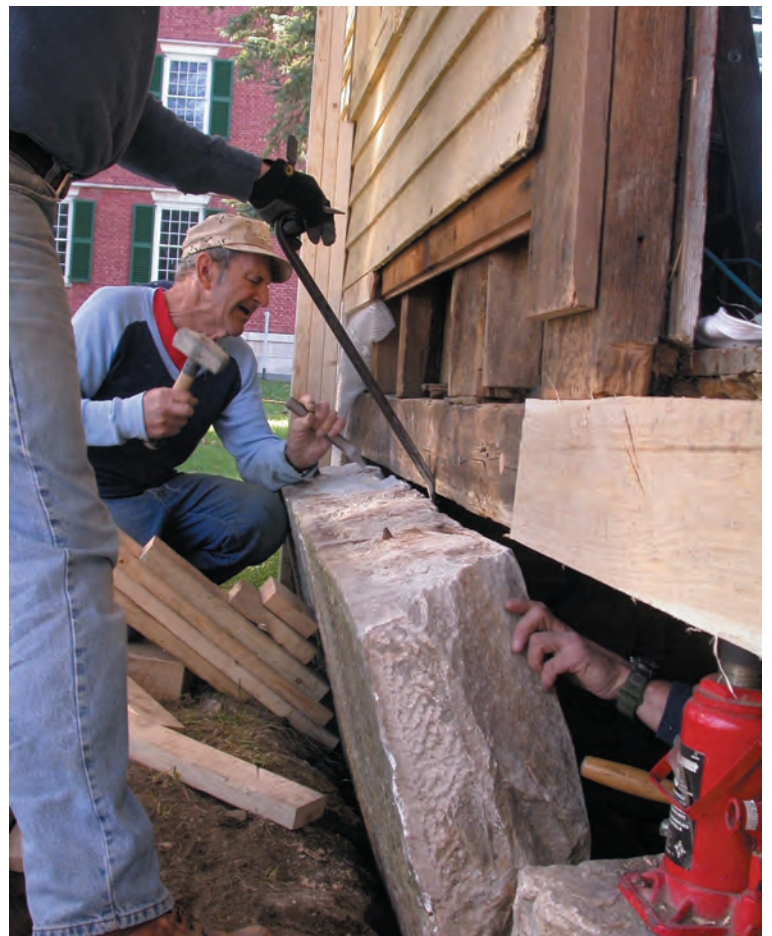
Fig. 6. Persuading a granite foundation stone to enter under the sill. The late Ed Mottarella chamfers the arris to ease the way.

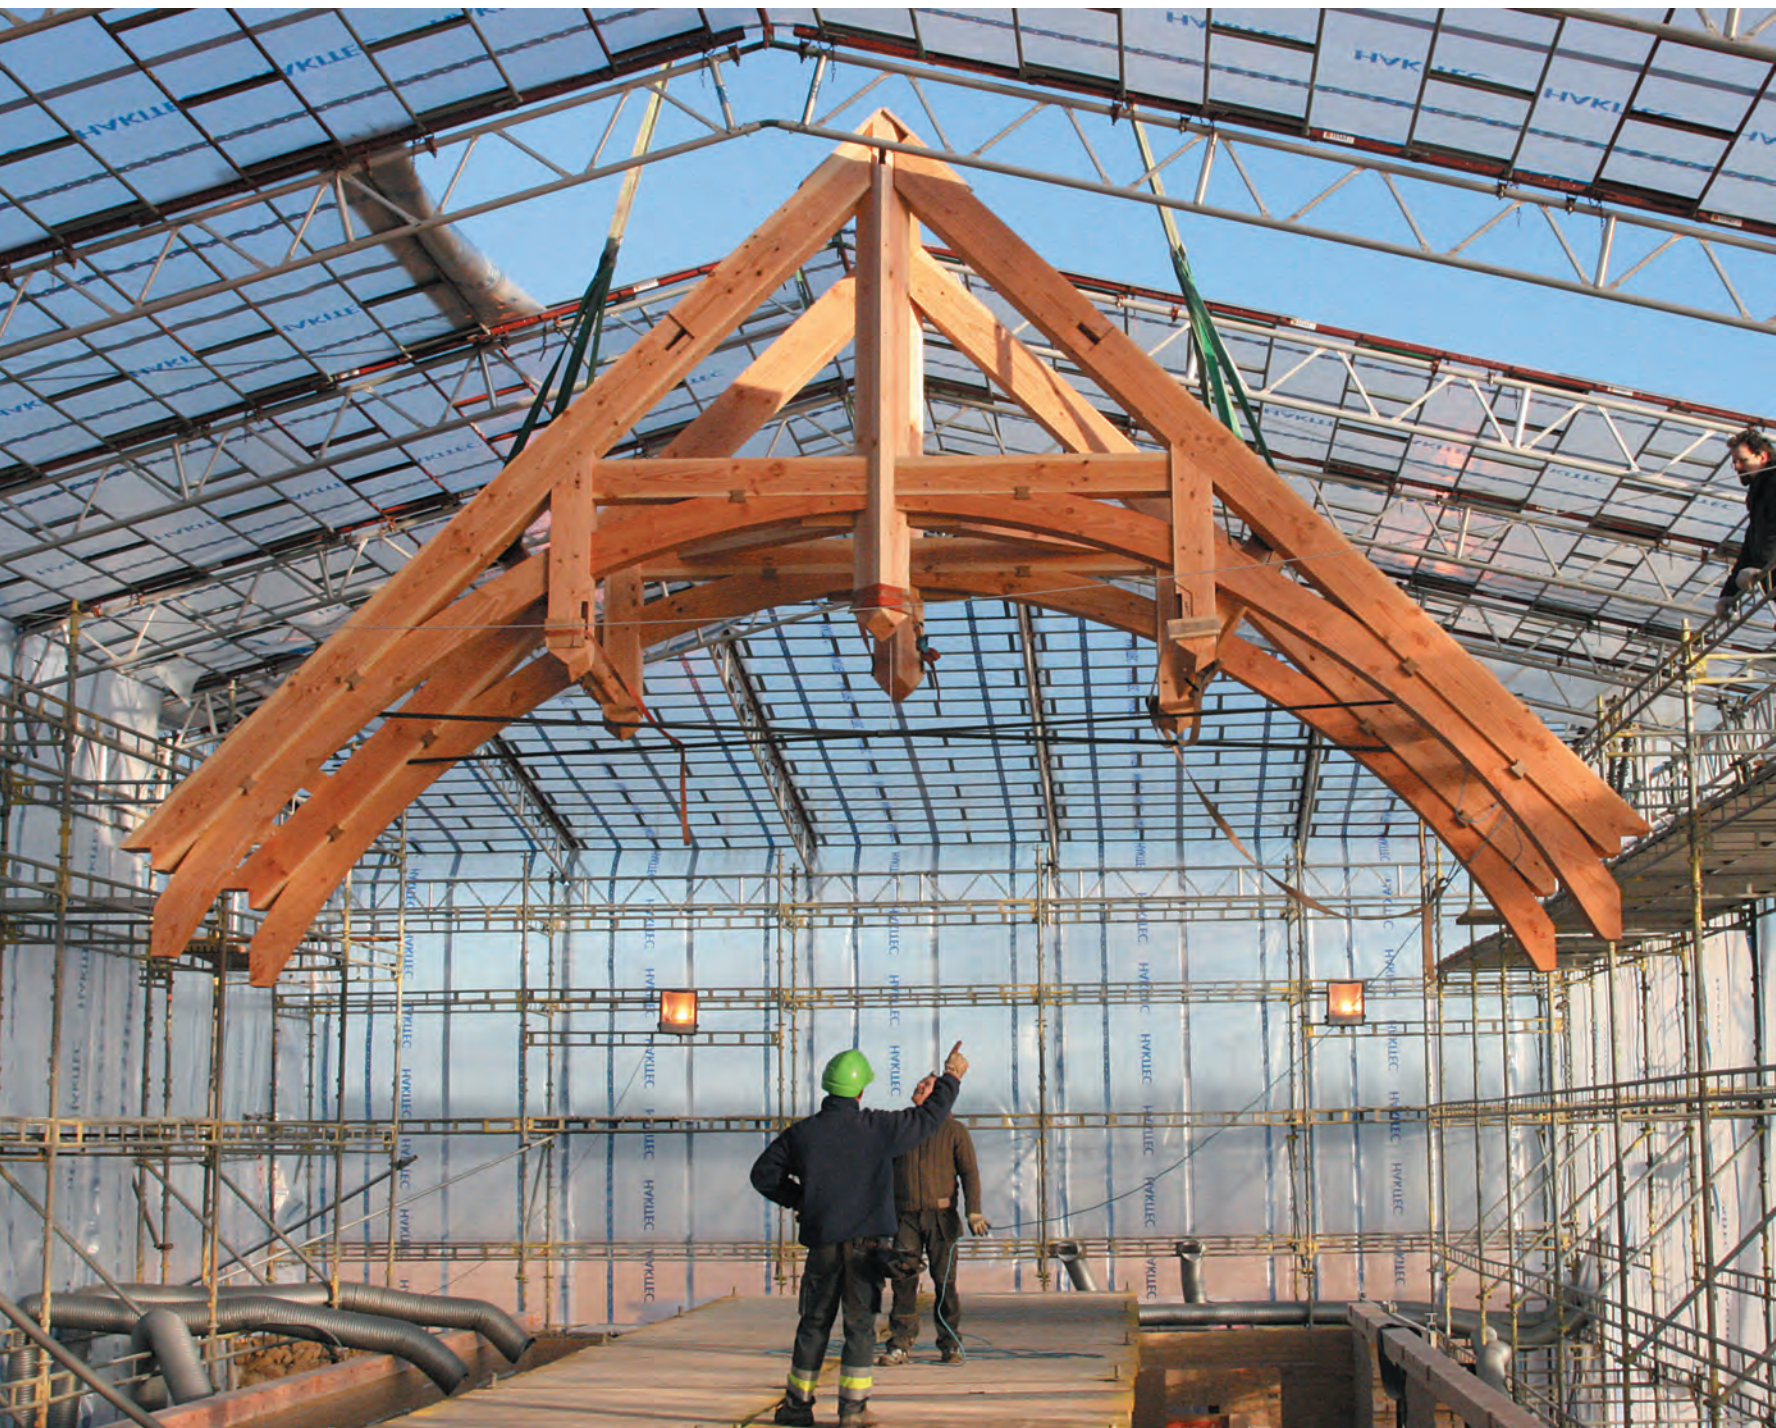
Flying in one of four decorative double roof trusses for a great room in Stubbegaarden, Denmark, in Northern Zealand about 40 miles from Copenhagen. Trusses were designed and built by Mikkel Johansen and Timber Solutions ApS in Græsted, of Danish-grown Douglas fir, and will sit on plates atop new lime-mortared brick walls.
