TIMBER FRAMING

JOURNAL OF THE TIMBER FRAMERS GUILD

Number 74, December 2004

TOPICS Rick Collins	2
HISTORIC AMERICAN ROOF TRUSSES IV. COMPOSITE AND RAISED BOTTOM CHORD TRUSSES Jan Lewandoski	4
COMPOSITE AND RAISED BOTTOM CHORD TRUSS ENGINEERING Ed Levin	20
D-I-Y DOWN UNDER II Rob Hadden	22

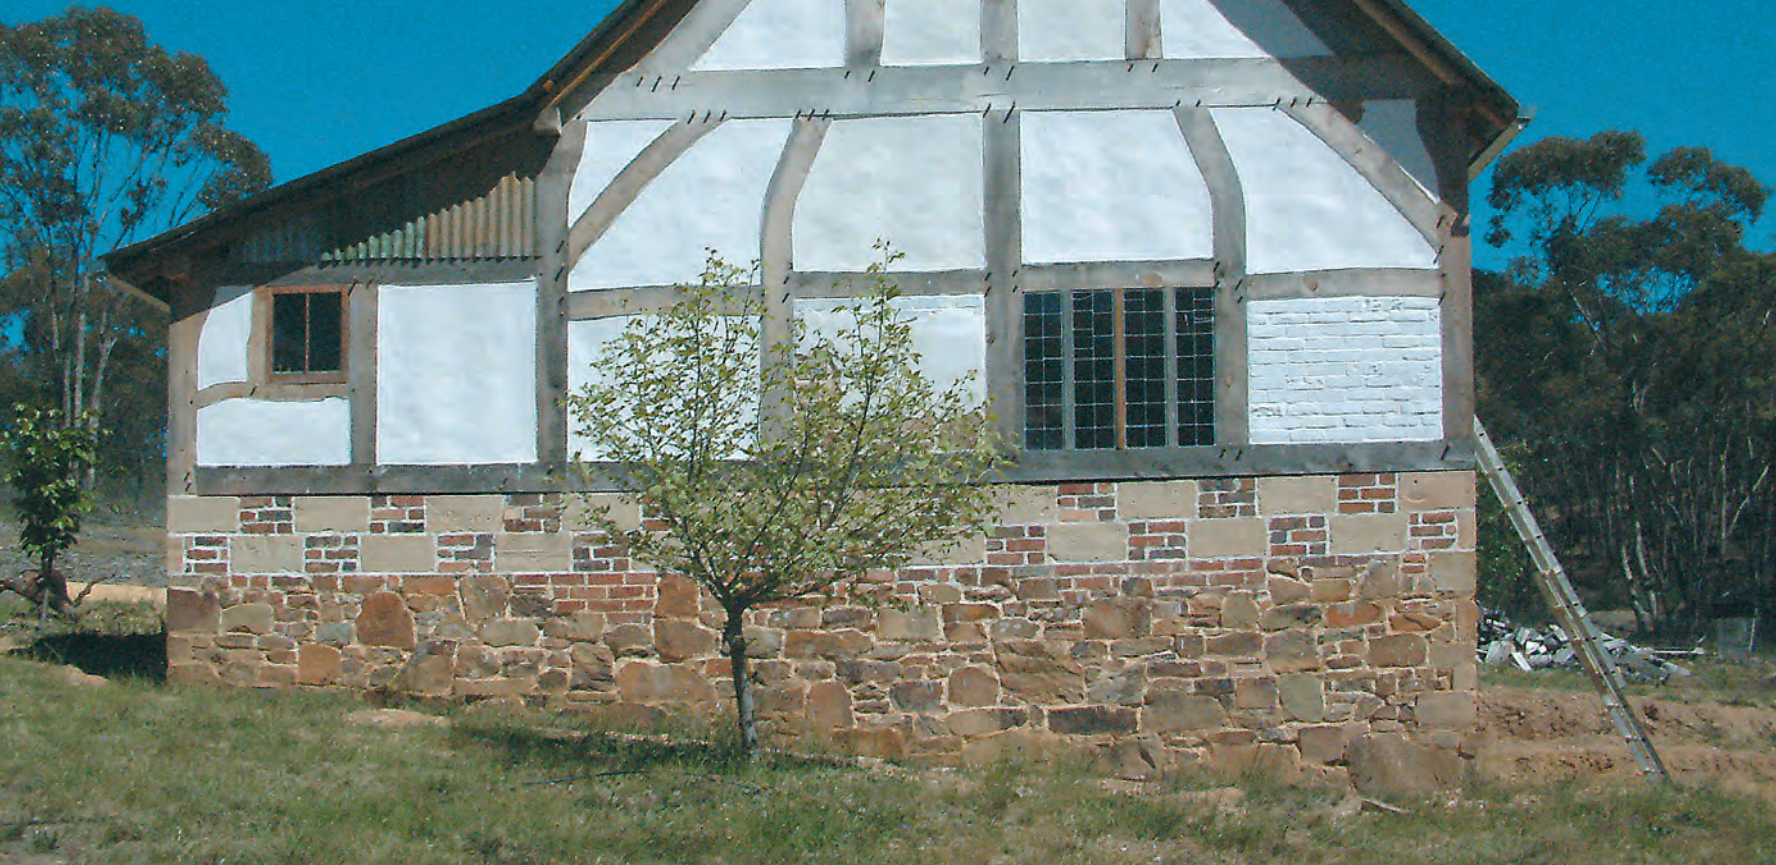
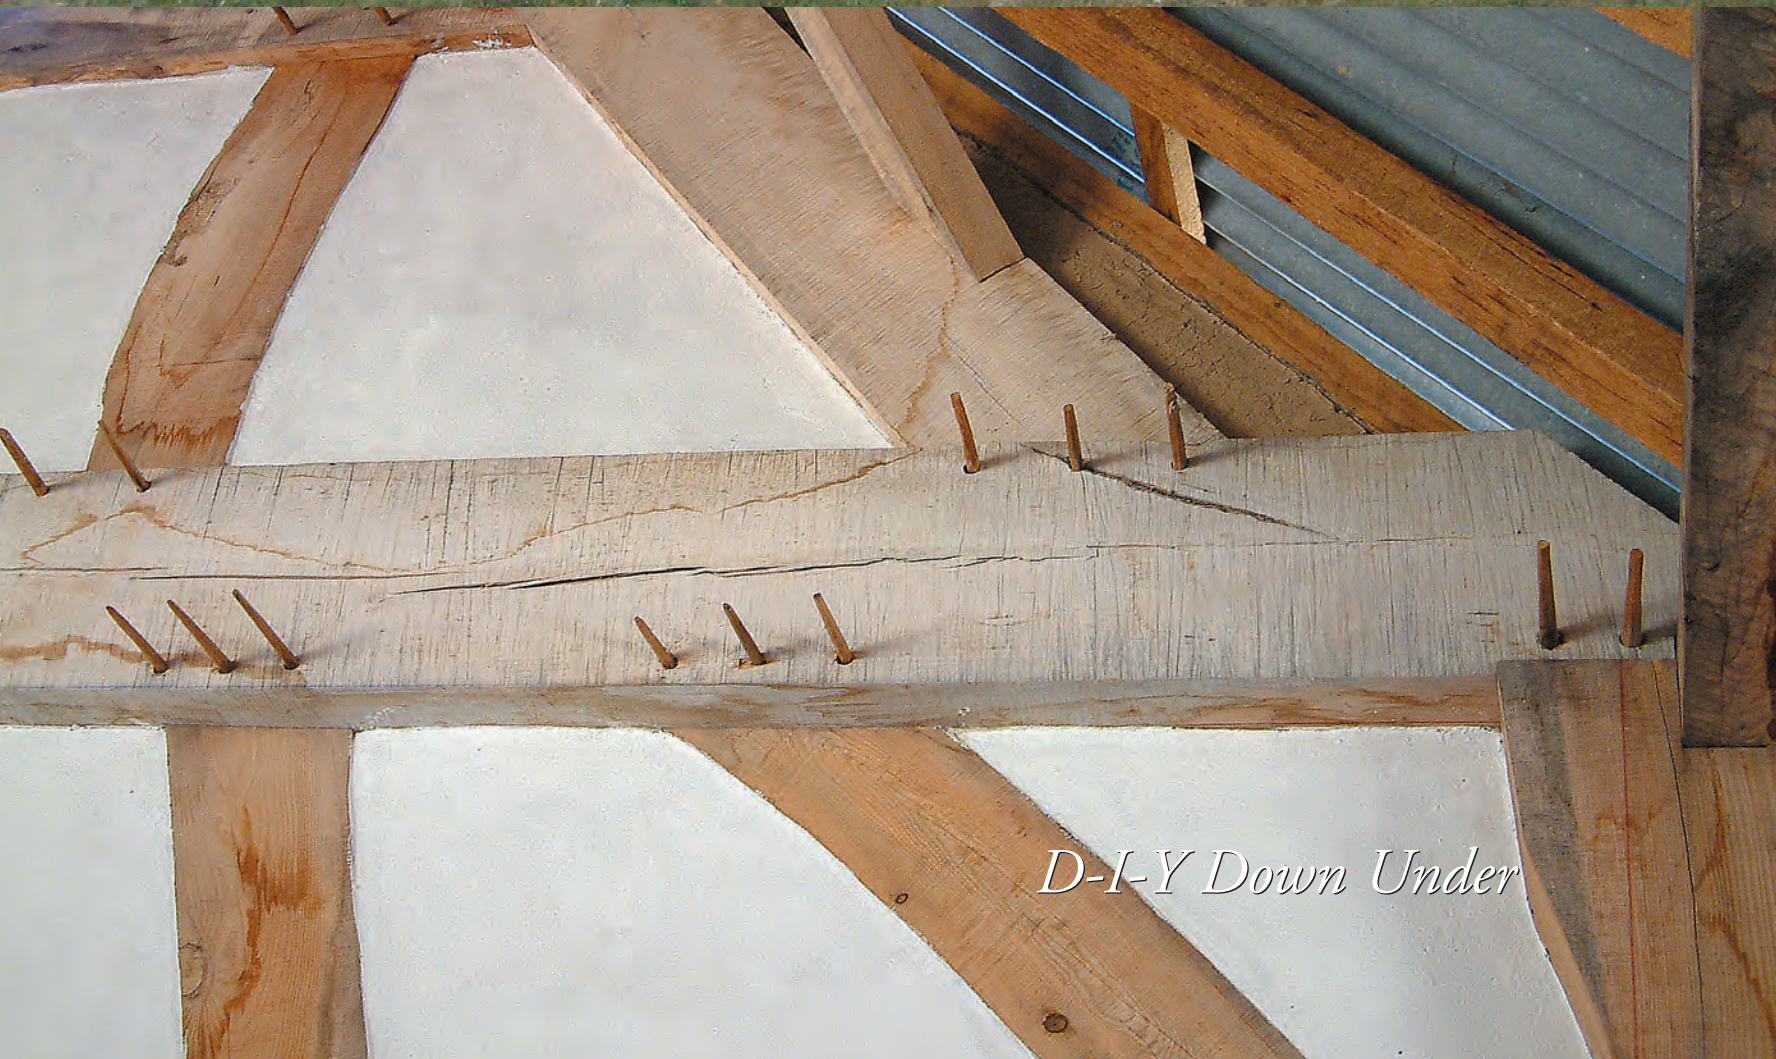
On the cover, end view and interior detail of newly made barn with guest quarters in Castlemaine, Victoria, Australia. The owner-builder, an artist and self-taught mason and timber framer, chainmilled most of the timber from salvage logs of many species and gathered and laid all the stones in the masonry foundation. Inspired by English design largely from the Welsh Marches, though not exclusively so, the frame was cut by English scribe rule and raised piece by piece using gin pole, shear legs and tackle. Pegs are cleft and shaved. Photos by Mandy Murphy. Story page 22.

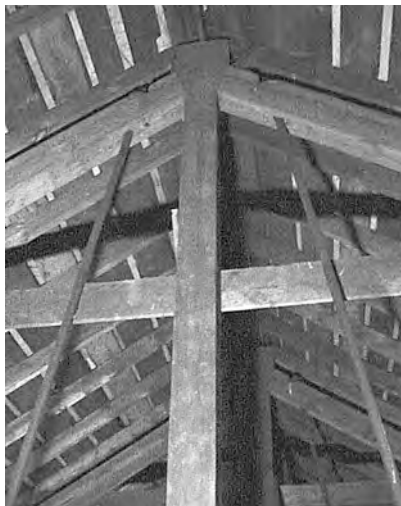
Iron rods support scarfed tie beam.

We dealt first with the attic-truss bottom-chord separations, by rigging with cables and turnbuckles to prevent further spreading. After several weeks of tightening the rigging we were able to draw the building together about $\frac{3}{8}$ in. We felt this would be enough to stabilize matters, and that any further action would damage the large plaster ceiling below. The most recent plaster job had certainly been completed after the bulk of the spreading had occurred in the bottom chord members.

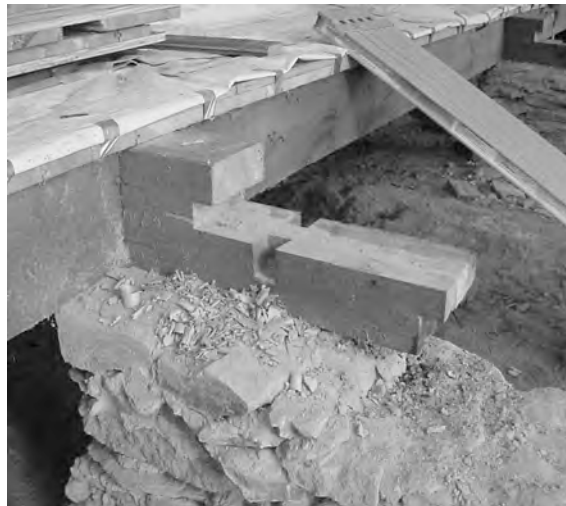
Edge-halved scarf in floor girder. Notch carries joist.

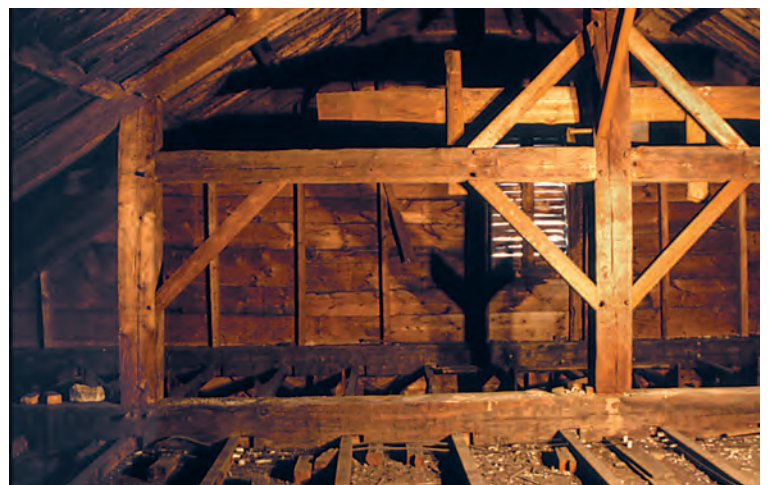
Fig. 3. Naïve truss at Newbury, Vermont, Methodist Church, 1829. Apparent queenpost merely adds unwanted load to truss chord.

The examination of church attics of notable span in eastern North America (qualified by the small percentage it is possible to see in one lifetime) generally reveals trusses so rationalized that we suspect the builders were very experienced and endowed with good structural instincts, or they were in possession of builders' guides that included sound truss designs. Exceptions exist. Puny raking struts or ties rising from tie beam to rafter in such roofs as at the Strafford, Vt., Town House (1799) or at the Windham, Vt., Congregational Church (1801), discussed in Part III of this series (see TF 72), are archaic holdovers that play no role or only a tiny one in the functioning of these otherwise completely realized trusses. Another puzzling example is the kingpost truss roof of the 1829 Newbury, Vt., Methodist Church, where 9x9 vertical members parallel the kingpost at the quarter points of the span, unsupported by struts or bracing, seemingly awaiting (nonexistent) gallery posts below to help them prop the midspan of the rafters. Without the gallery posts, these unsupported posts at Newbury serve merely to load and deflect the bottom chord at a point 10 ft. distant from the kingpost tension joint (Fig. 3).

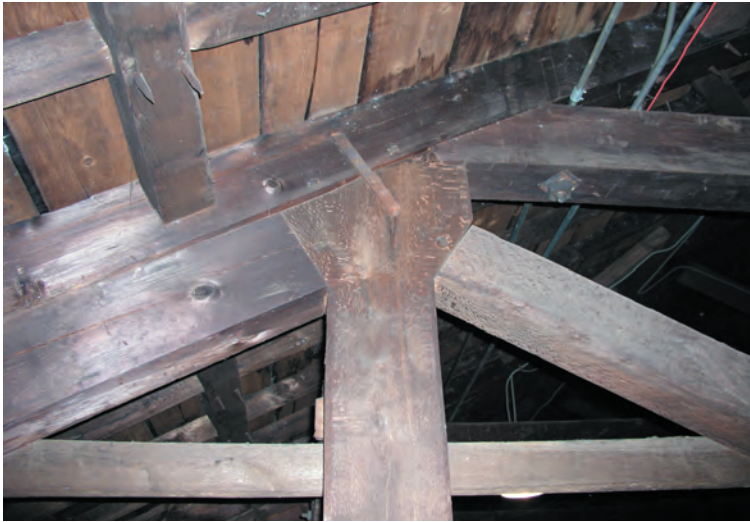
Fig. 8. Some queenpost heads at Central Moravian, obstructed by struts, cannot be bolted to the principal rafters and are stapled instead.

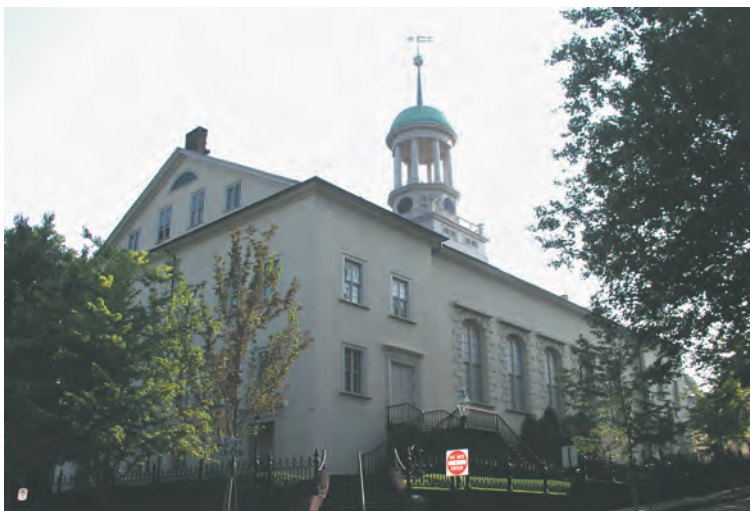
Fig. 9. Rubble stone walls at Central Moravian are targeted. Substantial cupola is placed centrally, supported ultimately by six trusses.

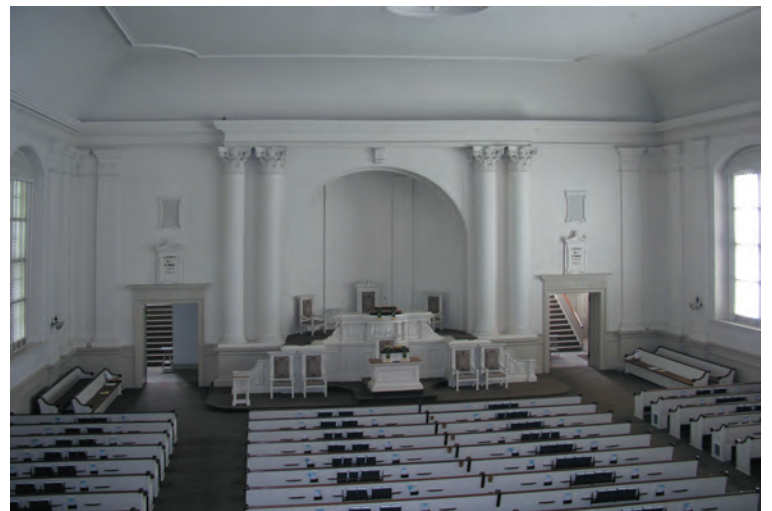
Fig. 11. Coved ceiling is formed entirely below the attic floor. Spacious, classically decorated interior is well maintained.

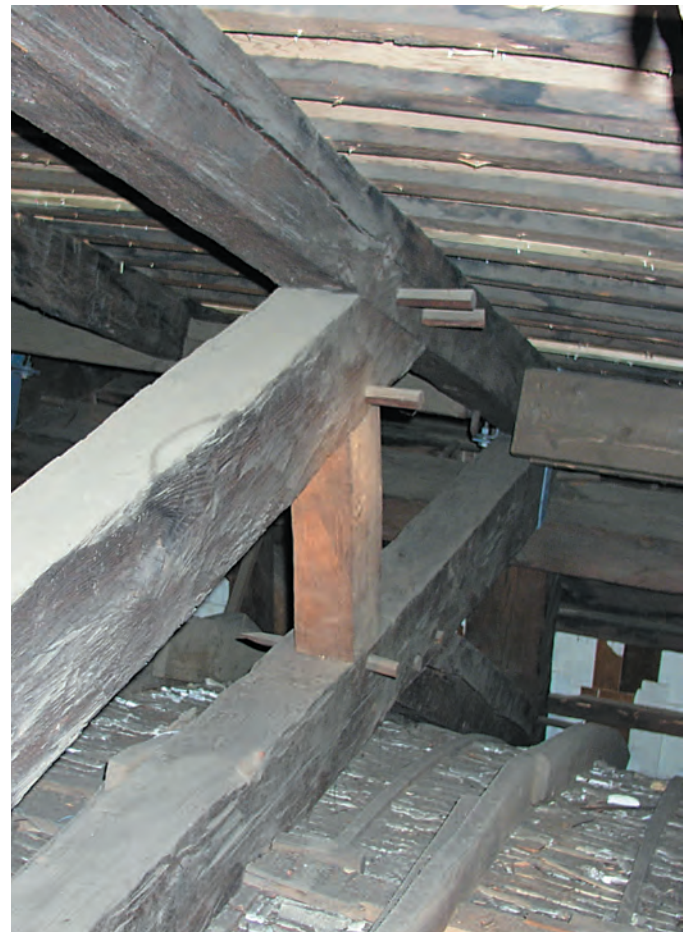
Fig. 22. Principal rafter at Shrewsbury descending past connection with raised chord to meet oblique tie over plate. Brace rises from post to oblique tie, and vertical strut connects latter and raised chord. Some back-primed shingles visible at wall.

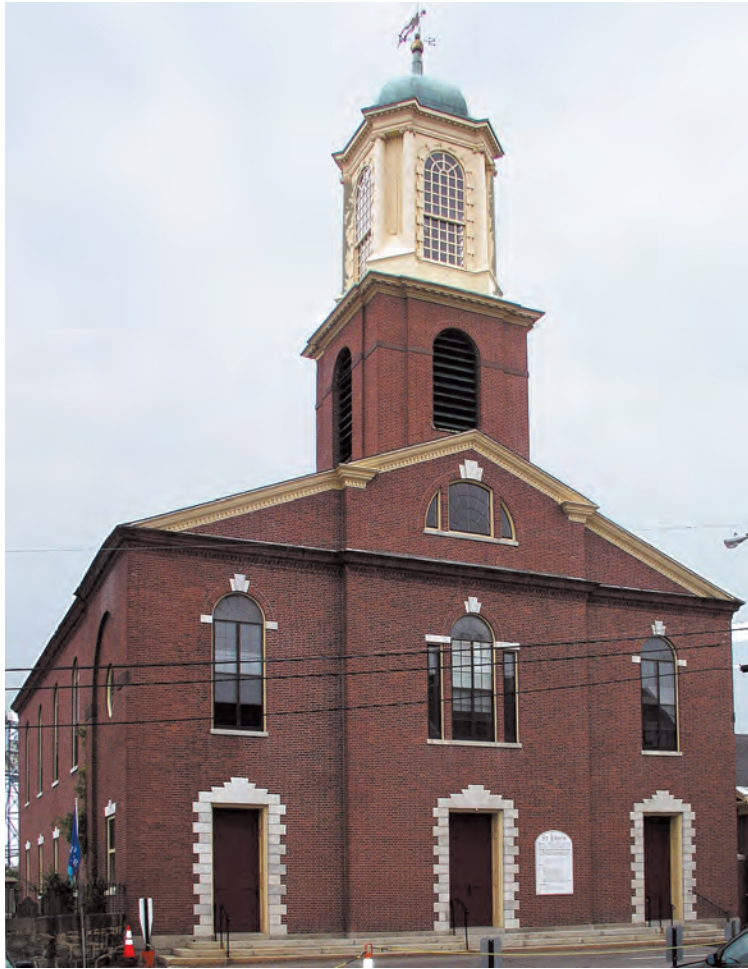
Figs. 26 and 27. St. John's Church, Portsmouth, N.H., 1807, rich in crisp neoclassical detail. The cornice and pediment base are made of molded brick. Below, tapered and carved gallery posts directly support short posts of truss hidden in attic. Researchers in background.

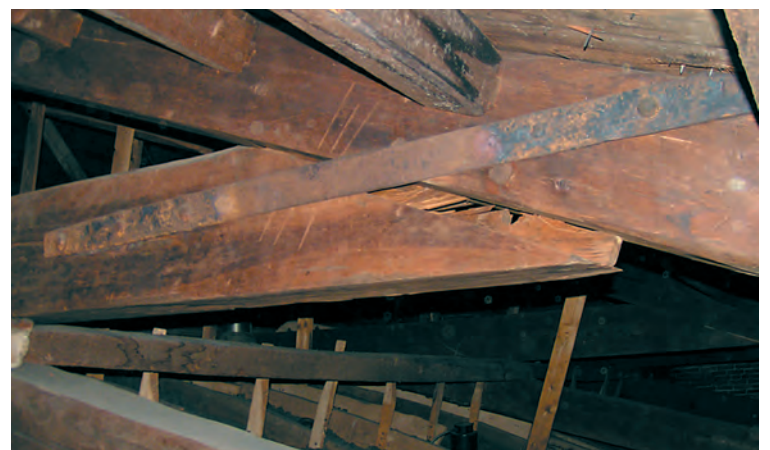
Fig. 29. Tenon destruction in raised chord withdrawn from principal rafter in St. John's truss. Strap may conceal shear failure in chord.

The problem at St. John's is that the gallery post extensions prop the principal rafters near midspan but do not directly or even closely support the raised bottom chord and its joints with the principal rafter. Perhaps consequent from this anomaly are the only failures we observed at St. John's: two separated junctions between raised bottom chords and principal rafters, one noteworthy and one resulting in complete destruction of the chord tenon at this pinned and strapped joint (Fig. 29 overleaf).

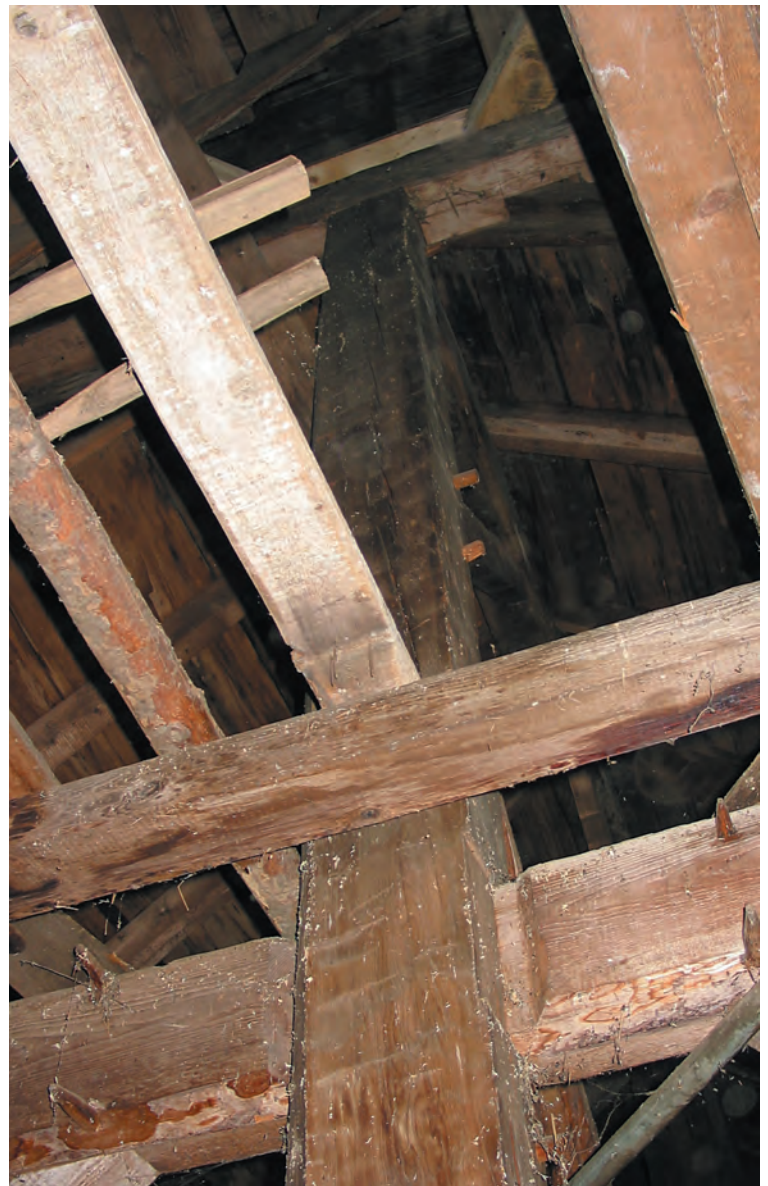
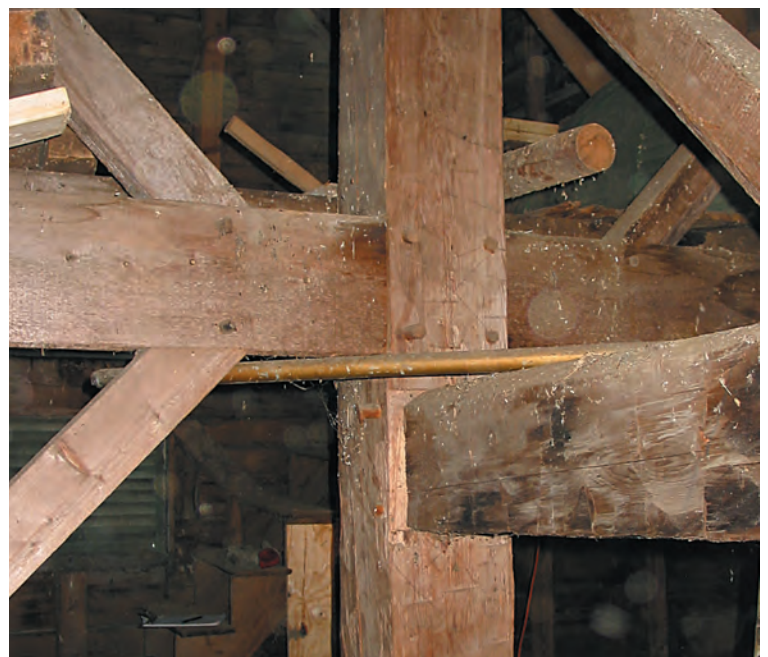
Figs. 33 and 34. Kingpost in tower truss at Sutton Baptist Church is supported by pins at the top and by the tenons of the braced beams seen near bottom of photo and also seen passing from left to right in the photo below. Below, the kingpost is linked and braced back to the bottom of the next kingpost truss via the lowest beam seen on the right.

The tower truss kingpost at Sutton now bears back heavily on its longitudinal brace and connector, and the thrust is carried through the connector and its lower diagonal brace to the foot of the next interior kingpost. The latter is through-tenoned to a tie beam carrying joists and a finished ceiling and thus quite capable of resisting the partly horizontal thrust. The longitudinal braces that rise toward the tower truss kingpost are very heavily compressed on their bearing shoulders, whereas the braces rising away are loose in their mortises.

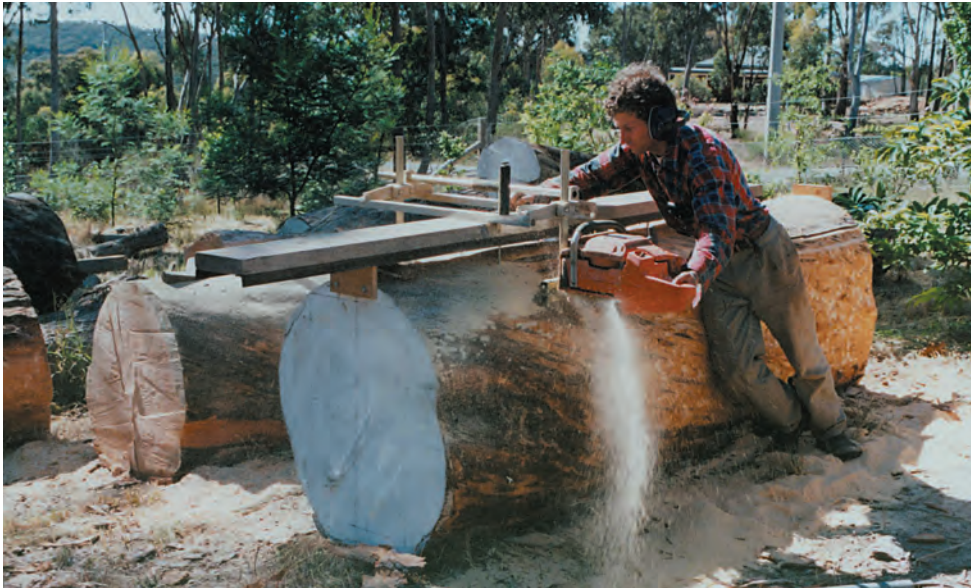
Author converts stone pine log into four matching posts. Husqvarna 3120 runs in Westford mill, made in Western Australia. Timber conversion took three months.

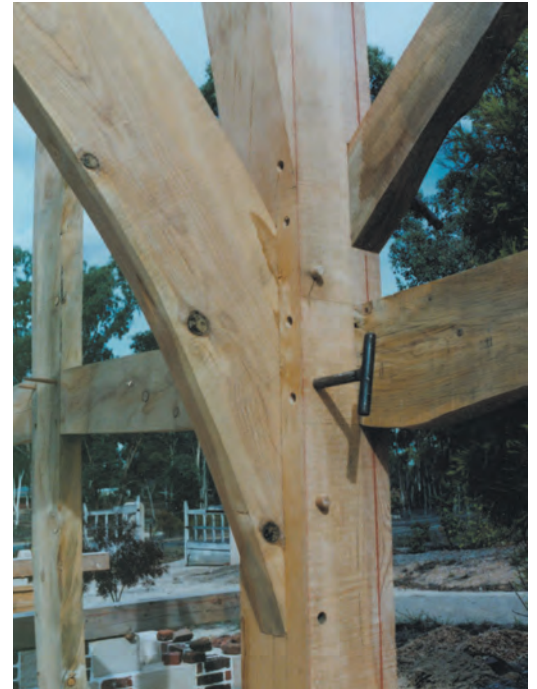
Inch-and-a-half reference line plainly visible on side of post aligns mortises for rail and brace, plus tenons for plate above and sill below.

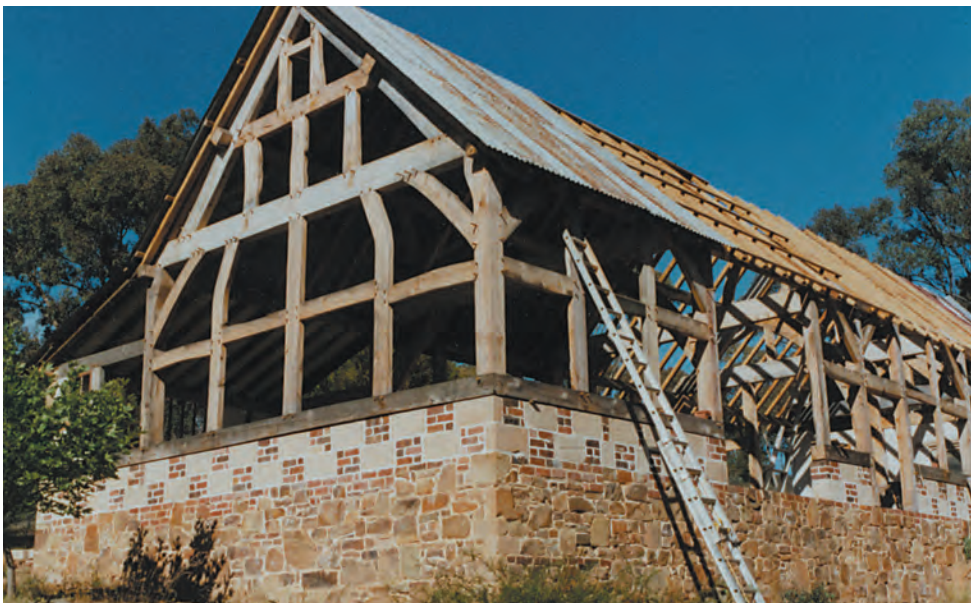
Finished frame is 19x75 ft. with an 8-ft. outshot (at left above) about 13 ft. long. Checker-board plinth surmounts sandstone walls 15 in. thick, double-skinned with rubble infill.

AS each long top plate run was 75 ft., a number of scarfs were required, which I placed over each of three cross-frame posts and made long enough to be supported by a brace. These joints were stop-splayed and undersquinted with folding wedges and four face pegs. Where the last run of a plate ran over the solid earth wall of the guest quarters (the end bay of the building), offering continuous support, I used a simpler edge-halved and bridled joint. Instead of laying out the scarfs with individual lines, I used a template made from thin plywood. By using the inch-and-a-half reference lines on both sides of a timber, I could locate the template with great accuracy and scribe the shape with a Japanese marking knife. The templates were cut with a knife as well, so there was no kerf and both parts of the template matched precisely. This system worked extremely well and saved a

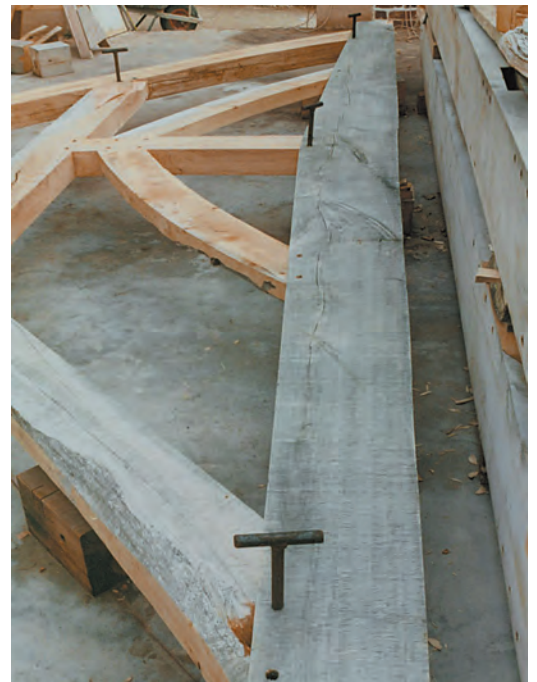
Completed layout assembly of Kentish-style truss. Note struck chalk line on layout floor. Iron drift pins are indispensable in scribe rule layout.

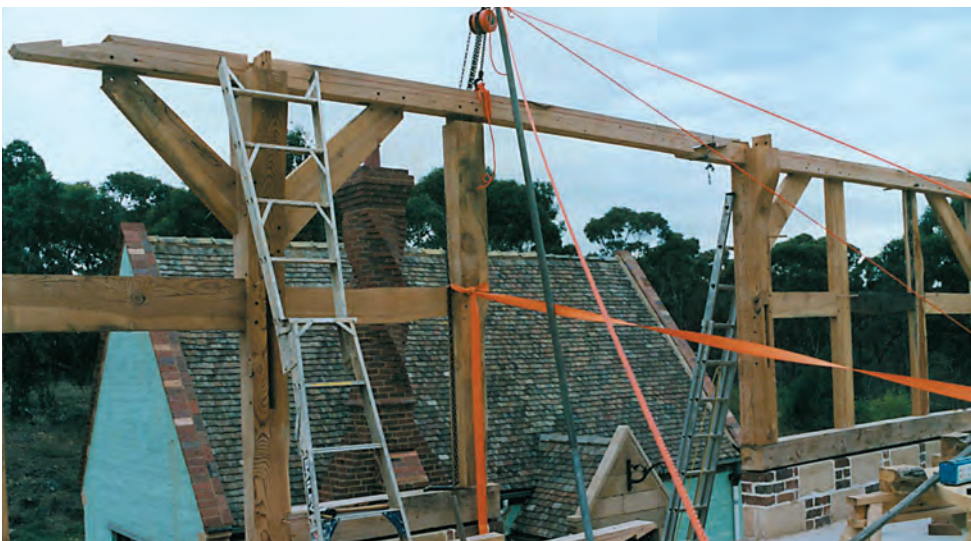
Setting the 5-piece scarfed 75-ft. plates. Post jowls are uniquely shaped. In the background, the author's first effort (1994-2000), a masonry building with timber-framed roof.

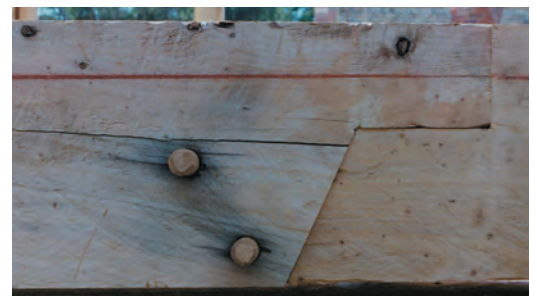
Bridled scarfs join sills or plates where continuously supported. Elsewhere scarfs are stop-splayed.

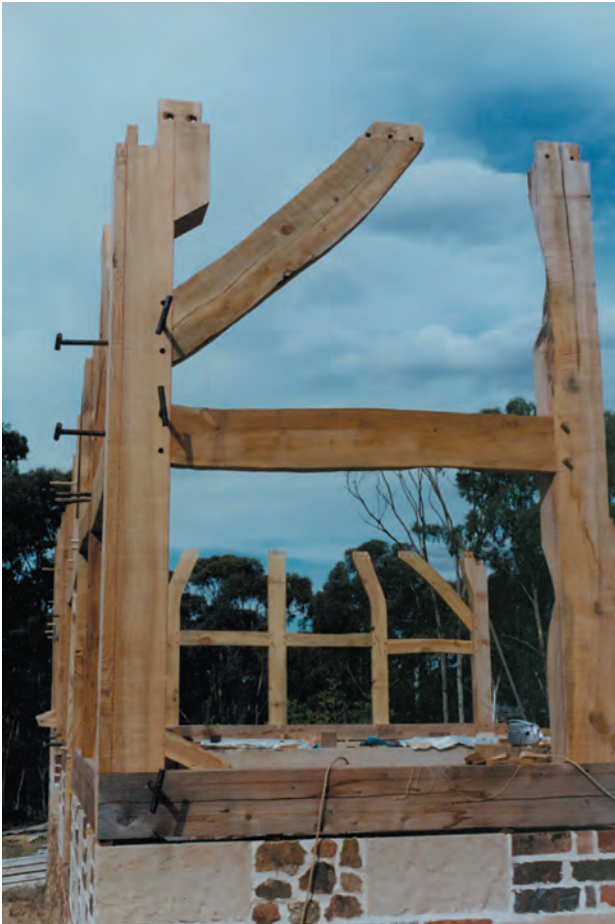
Early in raising, posts, rails and braces for one cross-frame and one wall are up. Once all are up, long plates, tie beams, truss elements, principal rafters and purlins follow in that order.

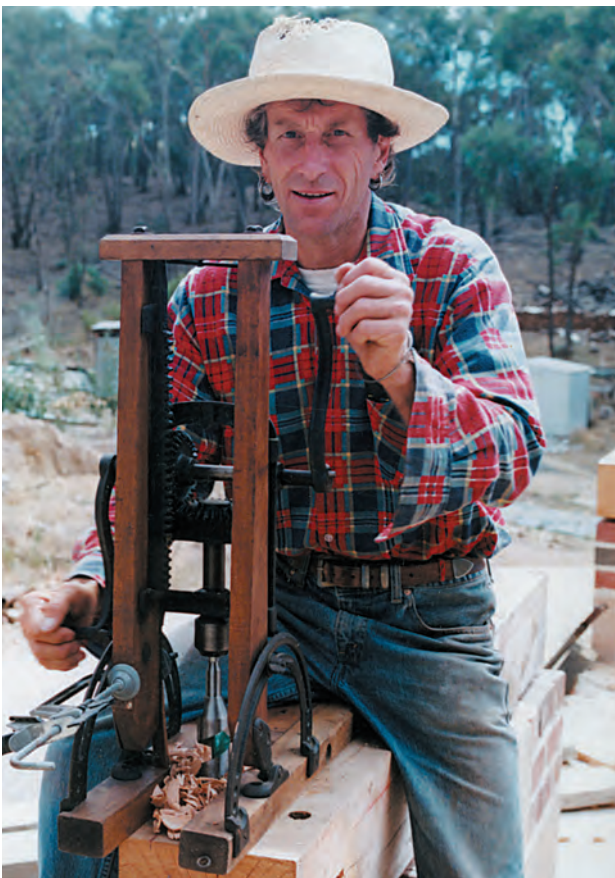
The author seated at the boring machine roughing out a mortise. Depth stop is not original equipment.

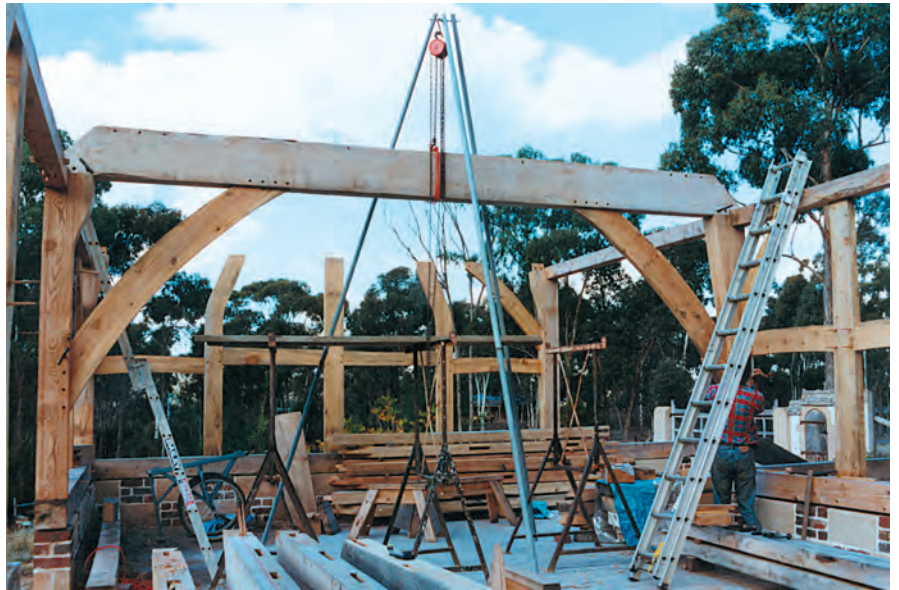
Setting collar with tripod and tackle. Using a plumb bob dropped from the hook, tripod rigging is centered over building midline for lift of tie beam at its midpoint.

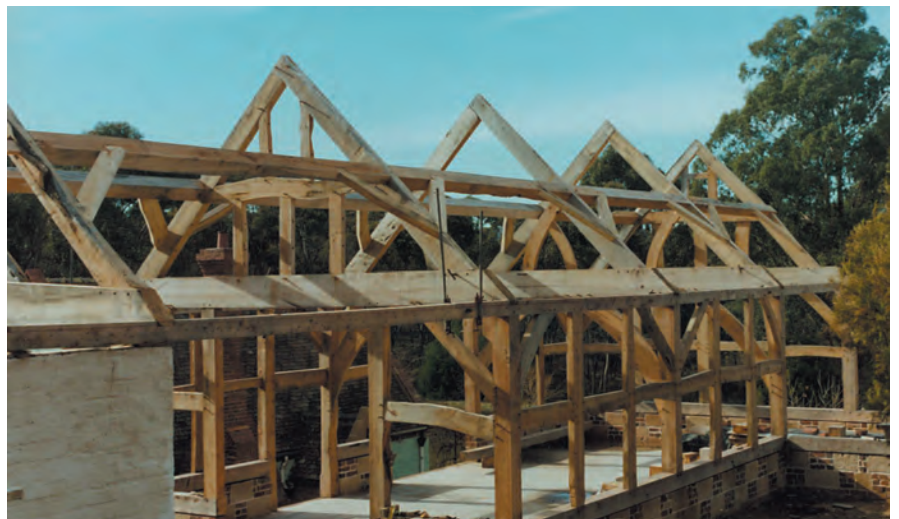
*Plates (shown before cutting common rafter steplap seats) are 6x6 Monterey cypress (*C. macrocarpa*), 7x14 tie beams are poplar, 8x7 purlins are cypress pine as are 5x15 principal rafters. Wind braces are lap-jointed to principals and purlins.*

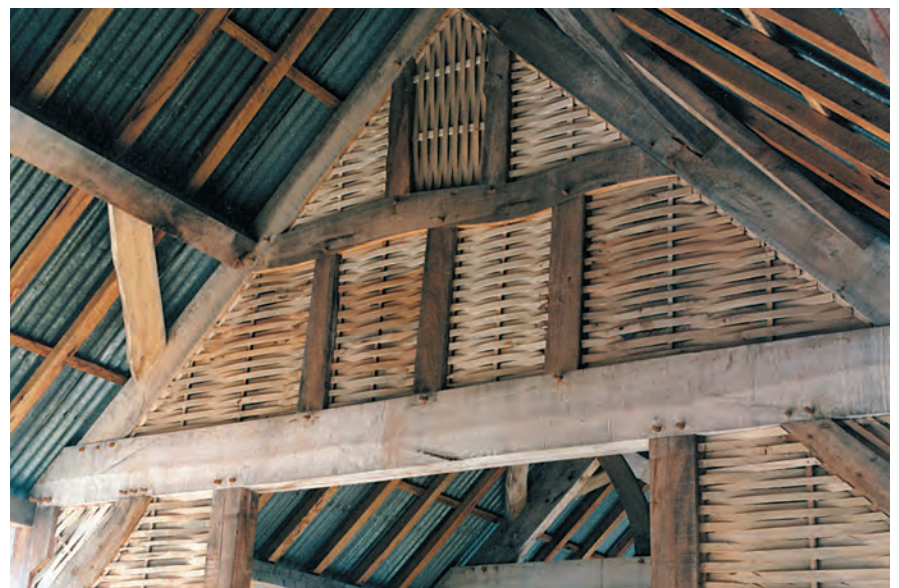
Sawn and resawn wattle woven laboriously over the staves in preparation for the clay-and-sand daub infill to be applied from both sides and coated with lime.

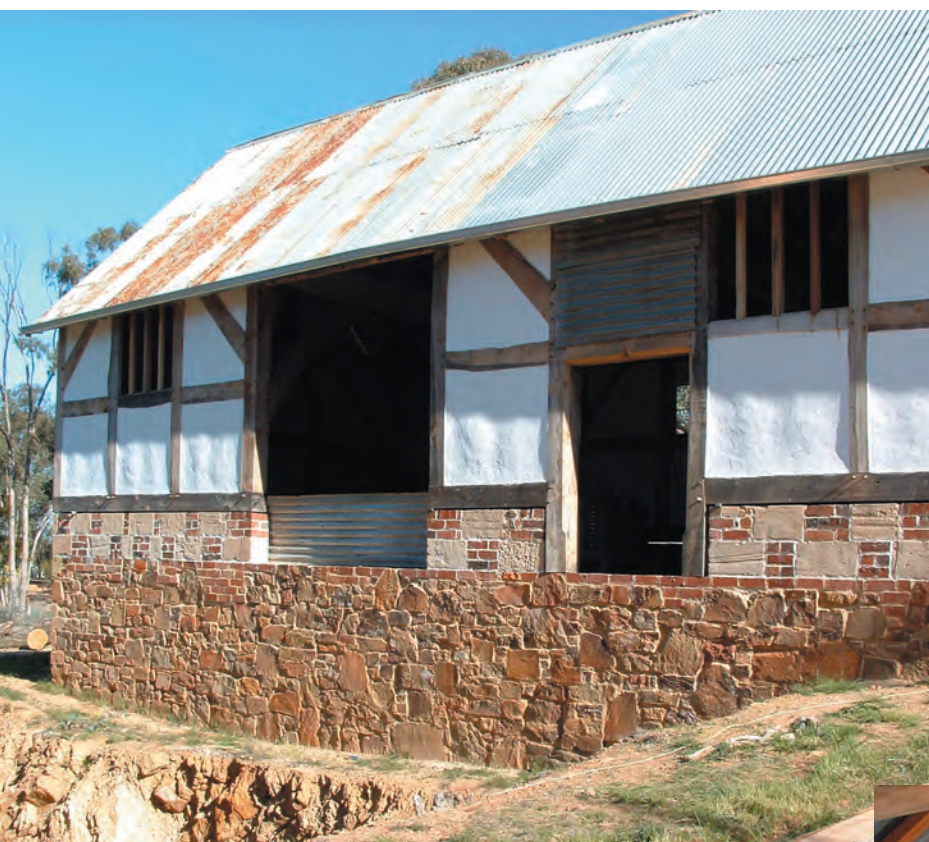
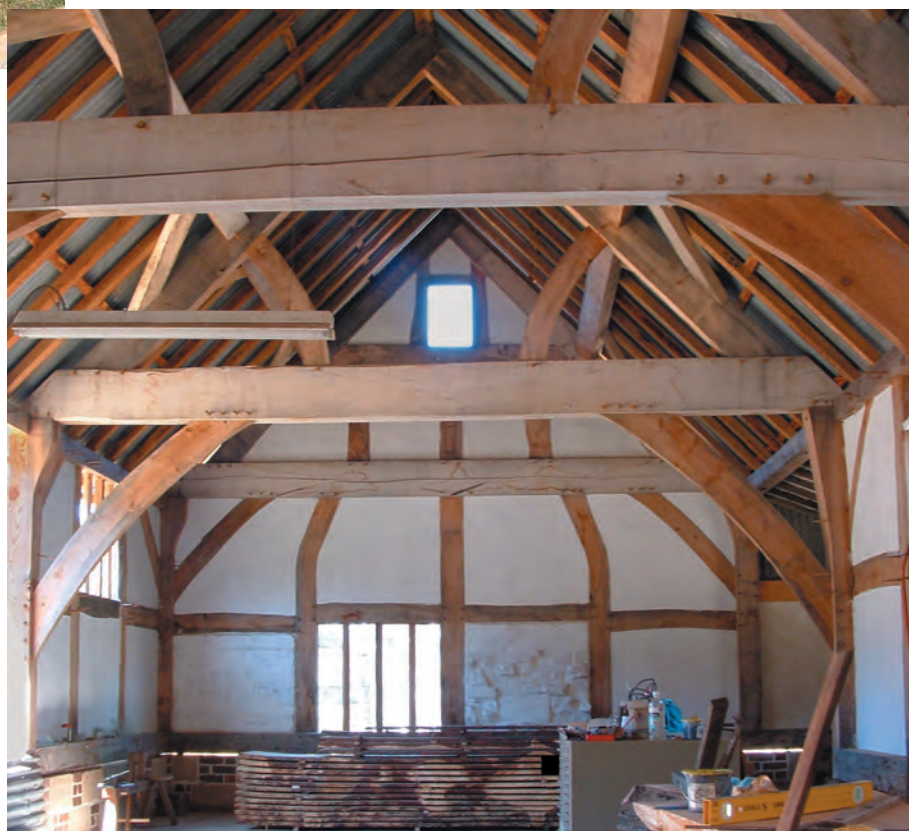
Above, exterior detail of new barn in Victoria, Australia, built using mostly salvaged materials and sandstone found on the property. Timbers were chainmilled from a variety of unwanted pine, poplar and cypress logs. Underneath the fresh limewash is clay-sand daub applied to poplar wattles. The large empty wall bay gives onto the interior space shown at right. Story page 22.
