# TIMBER FRAMING

JOURNAL OF THE TIMBER FRAMERS GUILD

Number 89, September 2008

*The Wemple Barn*

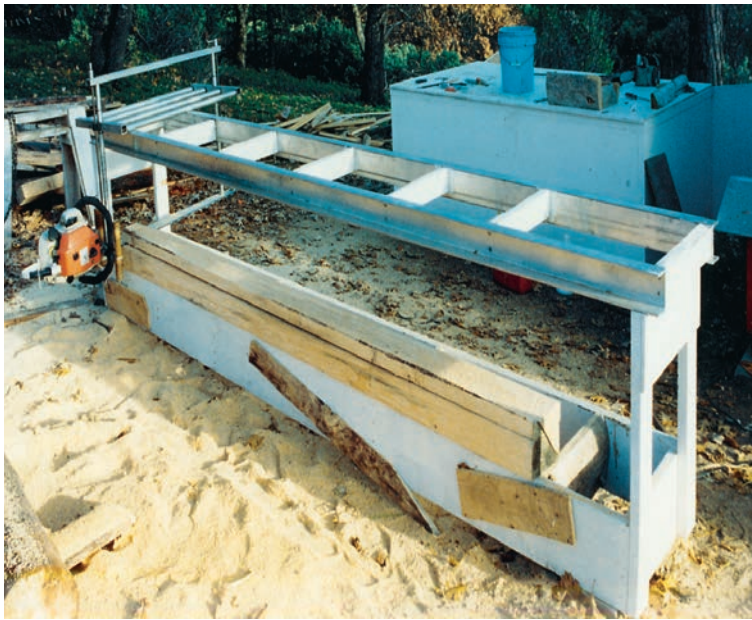
**Fig. 1.** Table-mounted portable sawmill, here shown taking 2-in. plank, can true up one face of a twisted timber preparatory to layout and joinery. Longer beams fit through ends of fixed table.

IN the last issue of this journal, Whit Holder gave a good account of laying out twisted or otherwise distorted timber ("Snap-Line Square Rule Layout," TF 88). I've used the layout method he describes, but only on timbers that are to be exposed on four sides, such as the kingposts in his roof frame. In an alternative approach, all other timbers can first be milled or planed true on an outside or upper face to provide a reference surface, which in the long run should be done anyway to make a clean fit with the cladding applied later. Most reclaimed timber dealers will recut stock on one face. If not, then a portable sawmill will do the job nicely (Fig. 1).

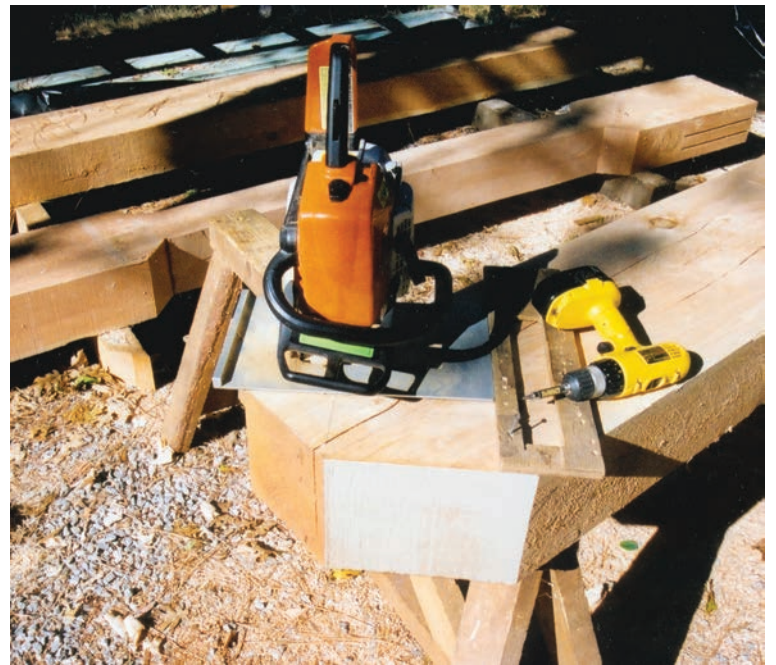
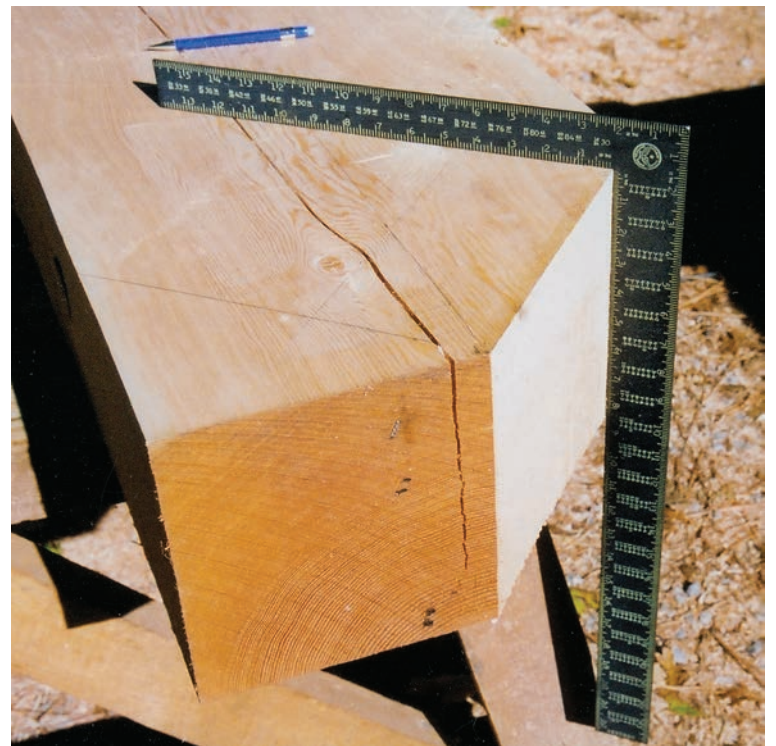
**Figs. 2–3.** Small chainsaw mounted on Big Foot base run against fence will make accurate square cuts from reference face. Fence must be screwed down as clamps will shake loose from saw vibration.

With one true face, an out-of-square timber takes little more time to work than an accurately squared timber. A saw that cuts 12 in. deep (which means a chainsaw) will handle most timbers from one side. For a number of years I have used a 75-degree adjustable chainsaw base made by Big Foot Tools that works nicely for end cuts and compound angles (Figs. 2–3).

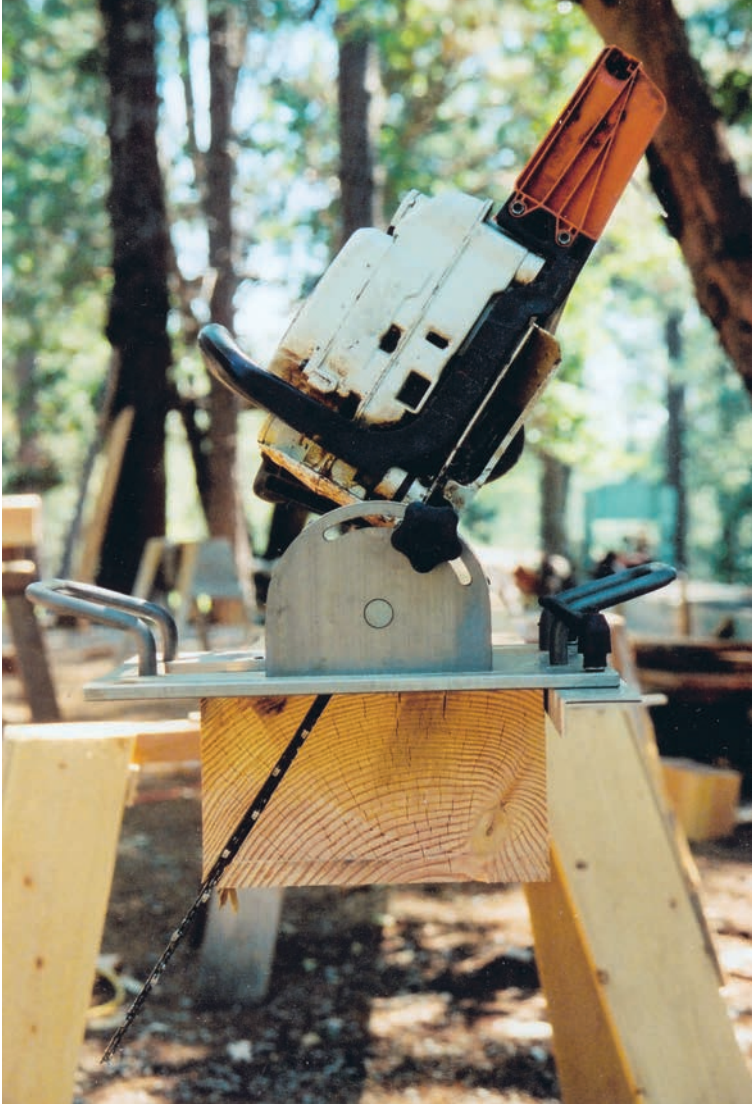
Fig. 4. Accutech base adjusted for bevel cut at fixed distance from timber edge. Chain is filed for ripping.

More recently I have been using Accutech's chainsaw miter mill (again you supply the chainsaw), which also does bevel and compound angle cuts. In addition, the Accutech has a built-in rip guide, allowing you to cut tenon cheeks right away, without the preliminary end cuts necessary for drop-cutting cheeks with a circular saw or with the Big Foot-based chainsaw. This rig also will do shaping and grooving (Figs. 4–5).

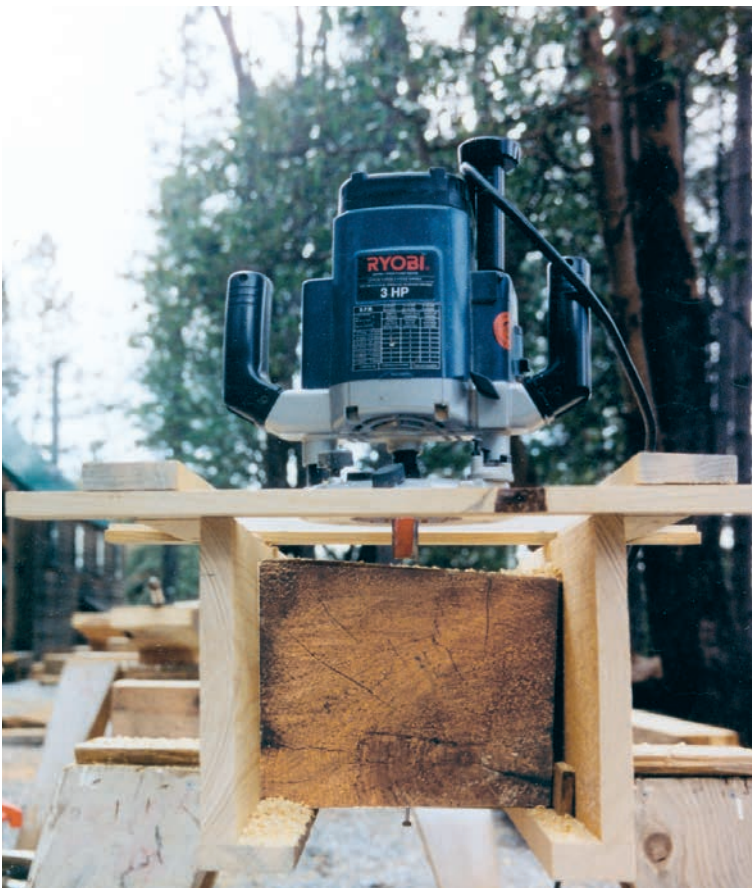
Fig. 6. Router mounted on jig ready to produce housing parallel to reference surface (underside of timber in photo).

As for joinery operations, the necessary jigs don't have to be complicated or pretty. With these simple appliances, housings and mortises can be worked from the reference face (Figs. 6–7).

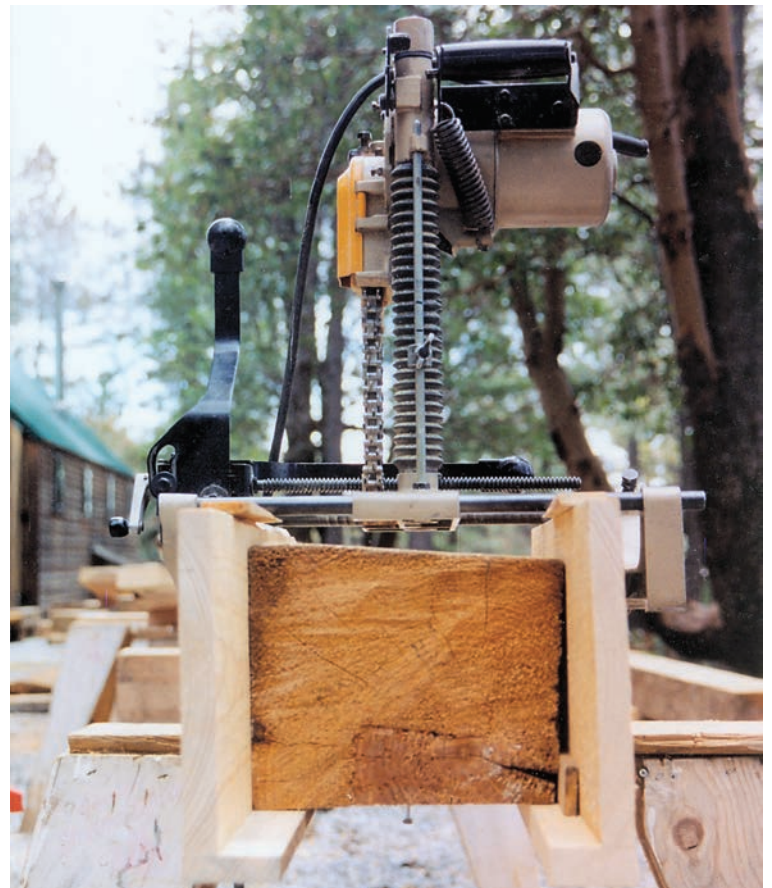
Fig. 7. Chain mortiser mounted on jig ready to cut mortise perpendicular to reference surface.

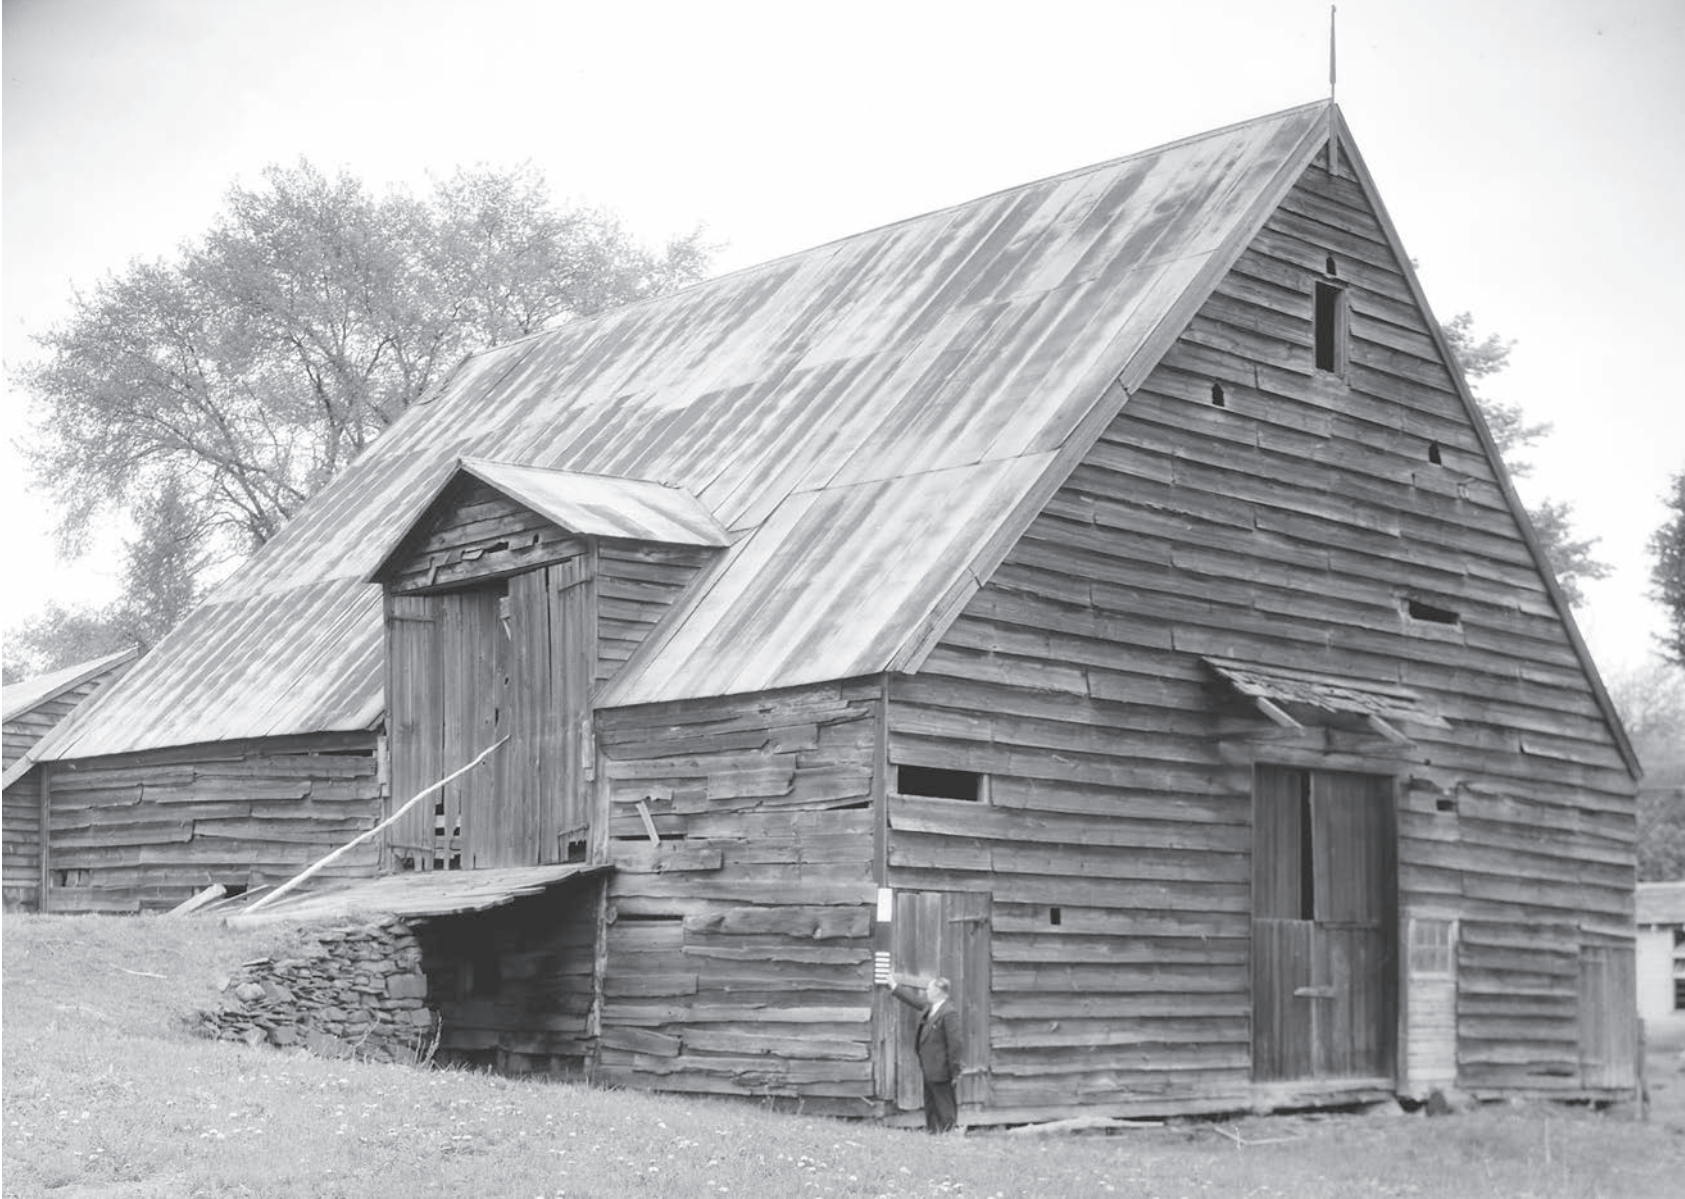
Figs. 1–2. The Wemple barn, above, and brick farmhouse, below, ca. 1760, Rotterdam (earlier Dunnsville), Albany County, N.Y. Historic American Buildings Survey photographs by Nelson E. Baldwin, after 1933. Three-ft. scale of researcher is partly subdivided in 2-in. intervals.

**Wagon Doors.** The gable walls retain their wagon or threshing-floor double-doors about 12 ft. high and more than 9 ft. wide, with original wooden hinges (Fig. 1). All such doors found so far swing inward, presumably to avoid seasonal snow accumulation. The Wemple barn doors pivot on wood pintles set into grooves (Fig. 3 overleaf). The  $11\frac{1}{2} \times 9\frac{1}{2}$  door posts stand about 9 ft. 6 in. apart. Originally one leaf of each double door was divided into roughly equal upper and lower parts, perhaps to obtain light and ventilation without having to manage a 12-ft. door. Later at one gable wall the facing leaves were cut in two and, later still, fastened back together. All door sections swing on full-width oak strap hinges, 3 in. wide and tapered in thickness from 4 in. at the hinge edge to about 2 in. at the lock edge. The doors are braced inside by wide diagonal battens (Fig. 4 overleaf). The face boards, about 10 to 13 in.

**Pentices.** In areas of the Hudson, Schoharie and Mohawk river valleys in New York, distinctive short roof projections or pentices were built to protect the wagon doorways from the weather. Original pentices or even pentice remnants are rare. (One survives on the Bogart barn, ca. 1790, and another on the Mahoney barn, ca. 1760, both in Ulster County. Variations on the form occur elsewhere.) Typical pentices appear on both ends of the Wemple barn, although none of their wood elements is now original. Each pentice extends nearly 4 ft. out from the gable wall, supported by three medium-pitched rafters, the outer ends of which join horizontal pentice arms emerging from original mortises in the gable wall anchorbeams (Fig. 1).

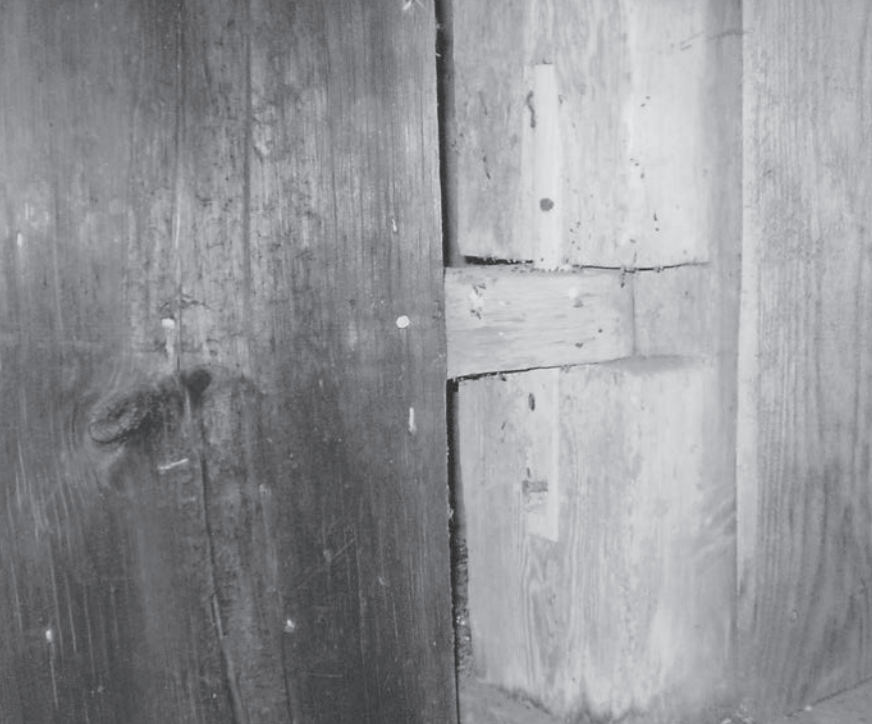
Fig. 3. Detail of oak lower door hinge, seen from outside, showing wood pintle let in and nailed to doorpost. Hinge strap measures 3x4 at the pintle. Door has been opened about 120 degrees.

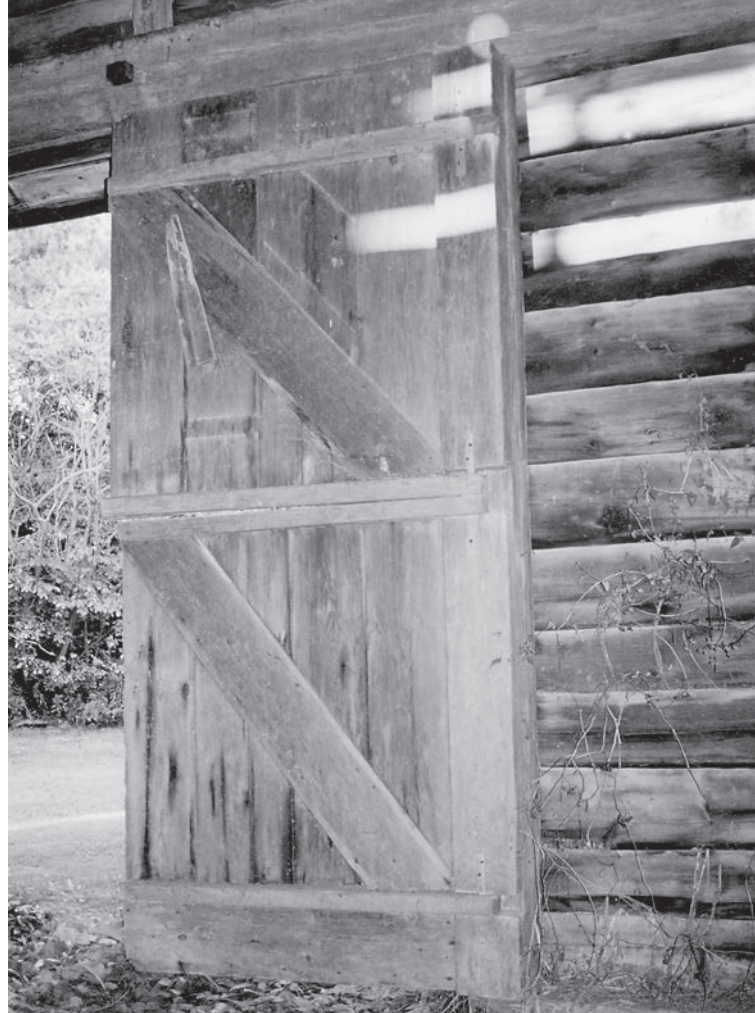
Fig. 4. Complete 12-ft. wagon door leaf in original divided condition. Battens are fastened from the inside.

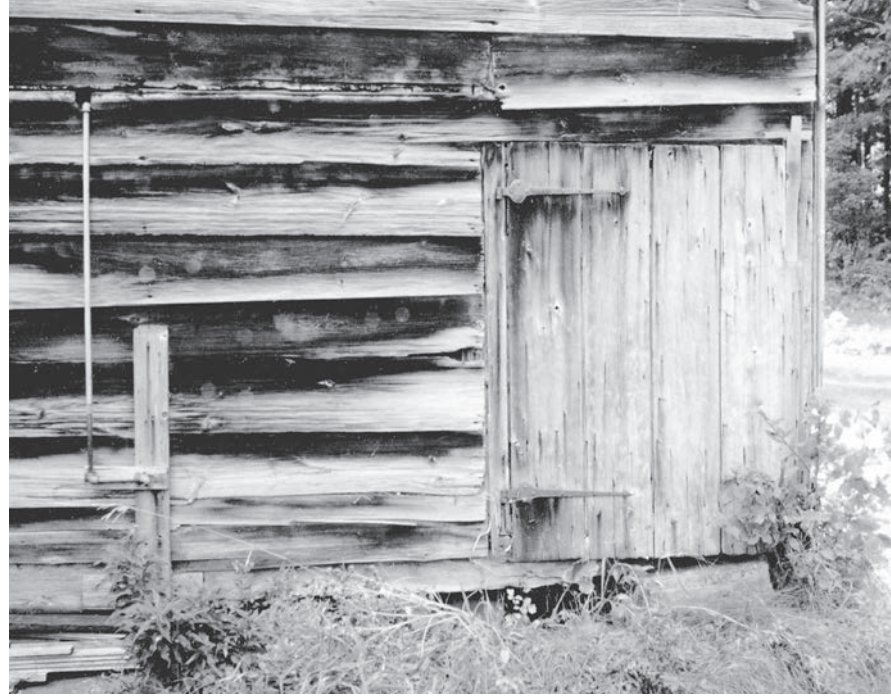
Fig 5. Animal doors on wrought hinges served horses and cows at respective corners of one gable end.

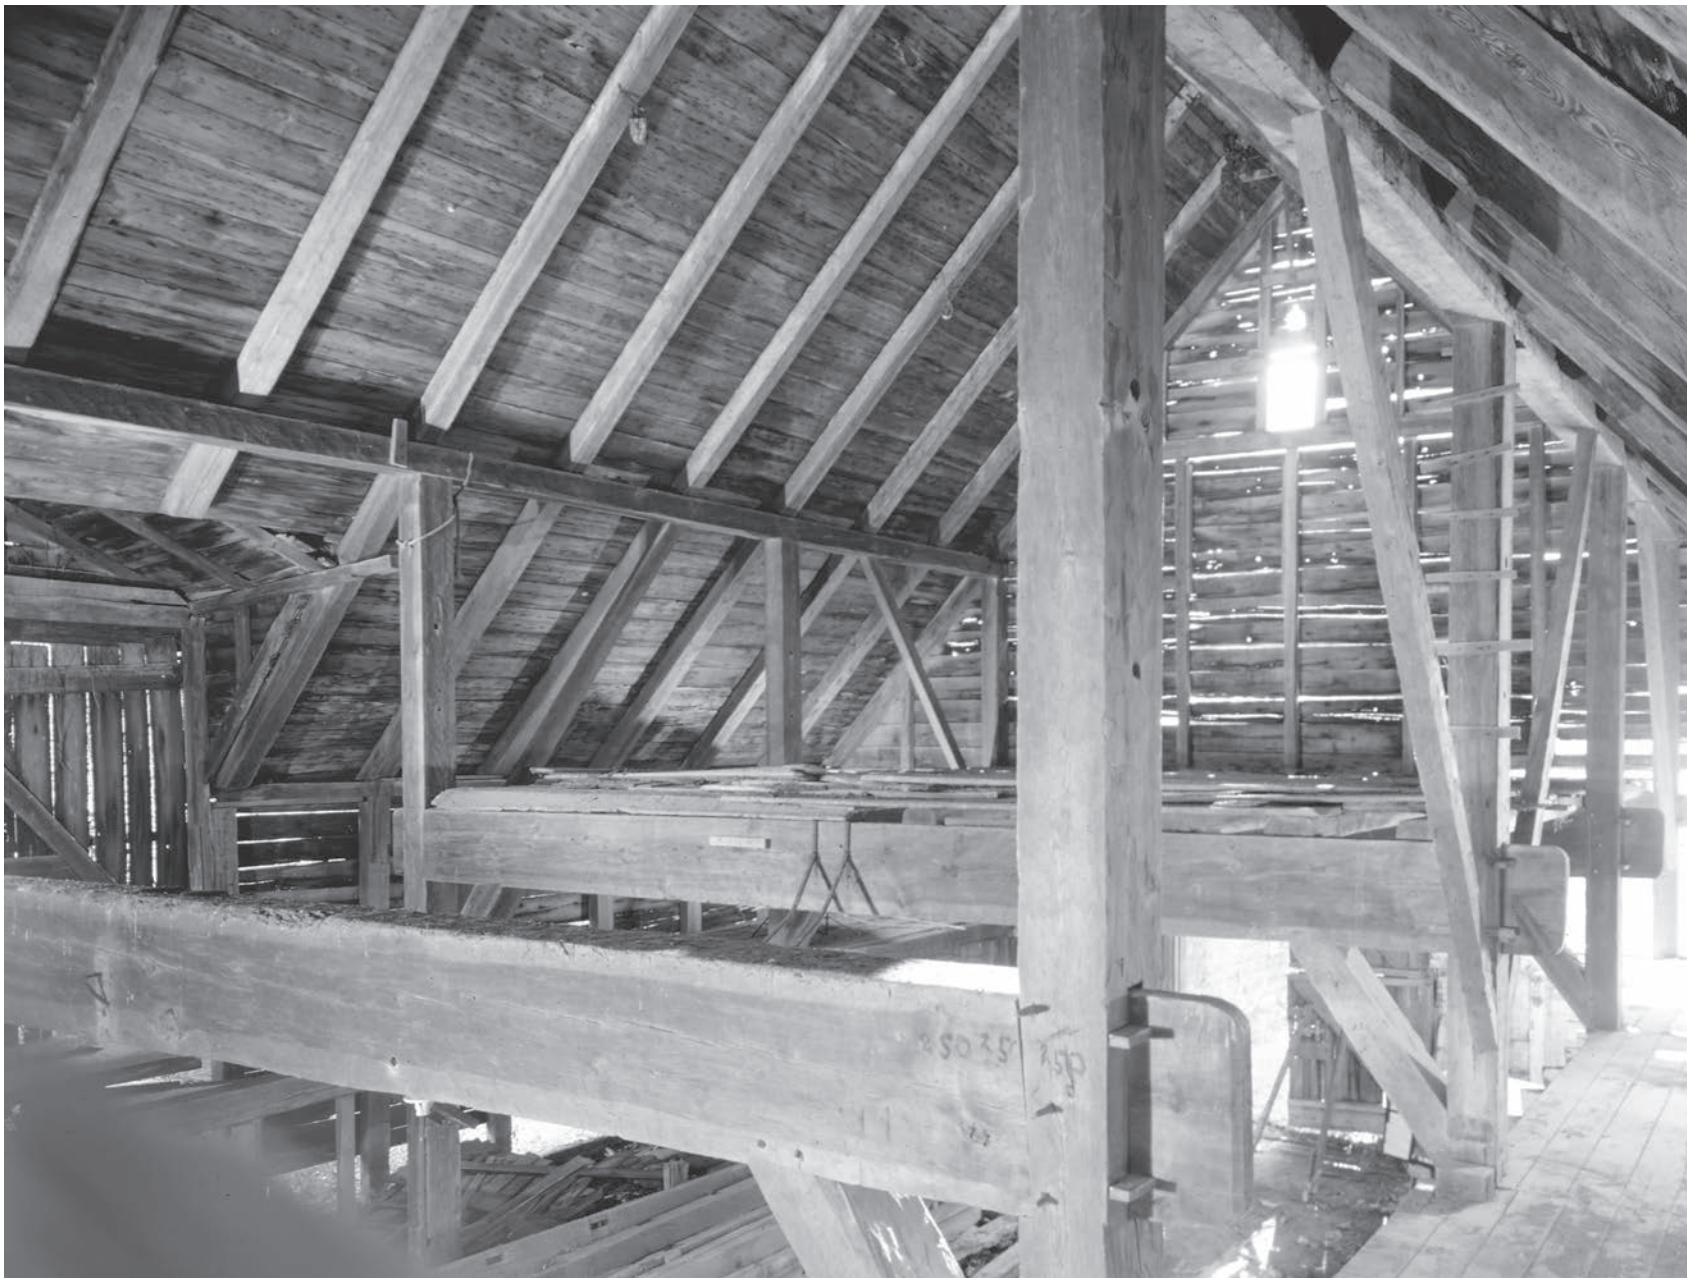
Fig. 6. Recent general view of Wemple barn interior, showing three central H-frames, long purlin braces and roof framing. Purlins run 56 ft. unscarfed, rafters 30 ft. Anchorbeams, 30 ft. tip to tip, measure about 12x22. At left, sidewall wagon entrance cut in 19th century.

usually appear in the upper half of post extensions, but they can appear almost anywhere along the posts. The upper holes in the Wemple barn's posts appear consistently 3 ft. 11 in. below the soffits of the purlin plates, the lower 6 ft. 1 in. (see foreground post in Fig. 6). All upper holes are 2 in. dia., the lower 1¼ in. In addition to its H-frame raising holes, the corner posts on both sides have 1¼-in. raising holes 24½ in. below the wall plate soffits that presumably assisted in raising the sidewall frames onto their sills.

**Purlin Plates and Braces.** The five H-frames in the Wemple barn are longitudinally connected and stabilized by purlin plates, each a single 56-ft. length of timber 10¼x9 (Fig. 6). Most barns of pre-1800 vintage have single-length purlin plates, especially in three-bay barns and those four-bay barns less than 45 ft. long. (With the single outstanding exception of the dated-1766 three-bay Nieuwkirk classic barn near Kingston in Ulster County, almost all three-bay barns of any era have single-length plates. But a number of four-bay barns after about 1810 and definitely after 1820 have

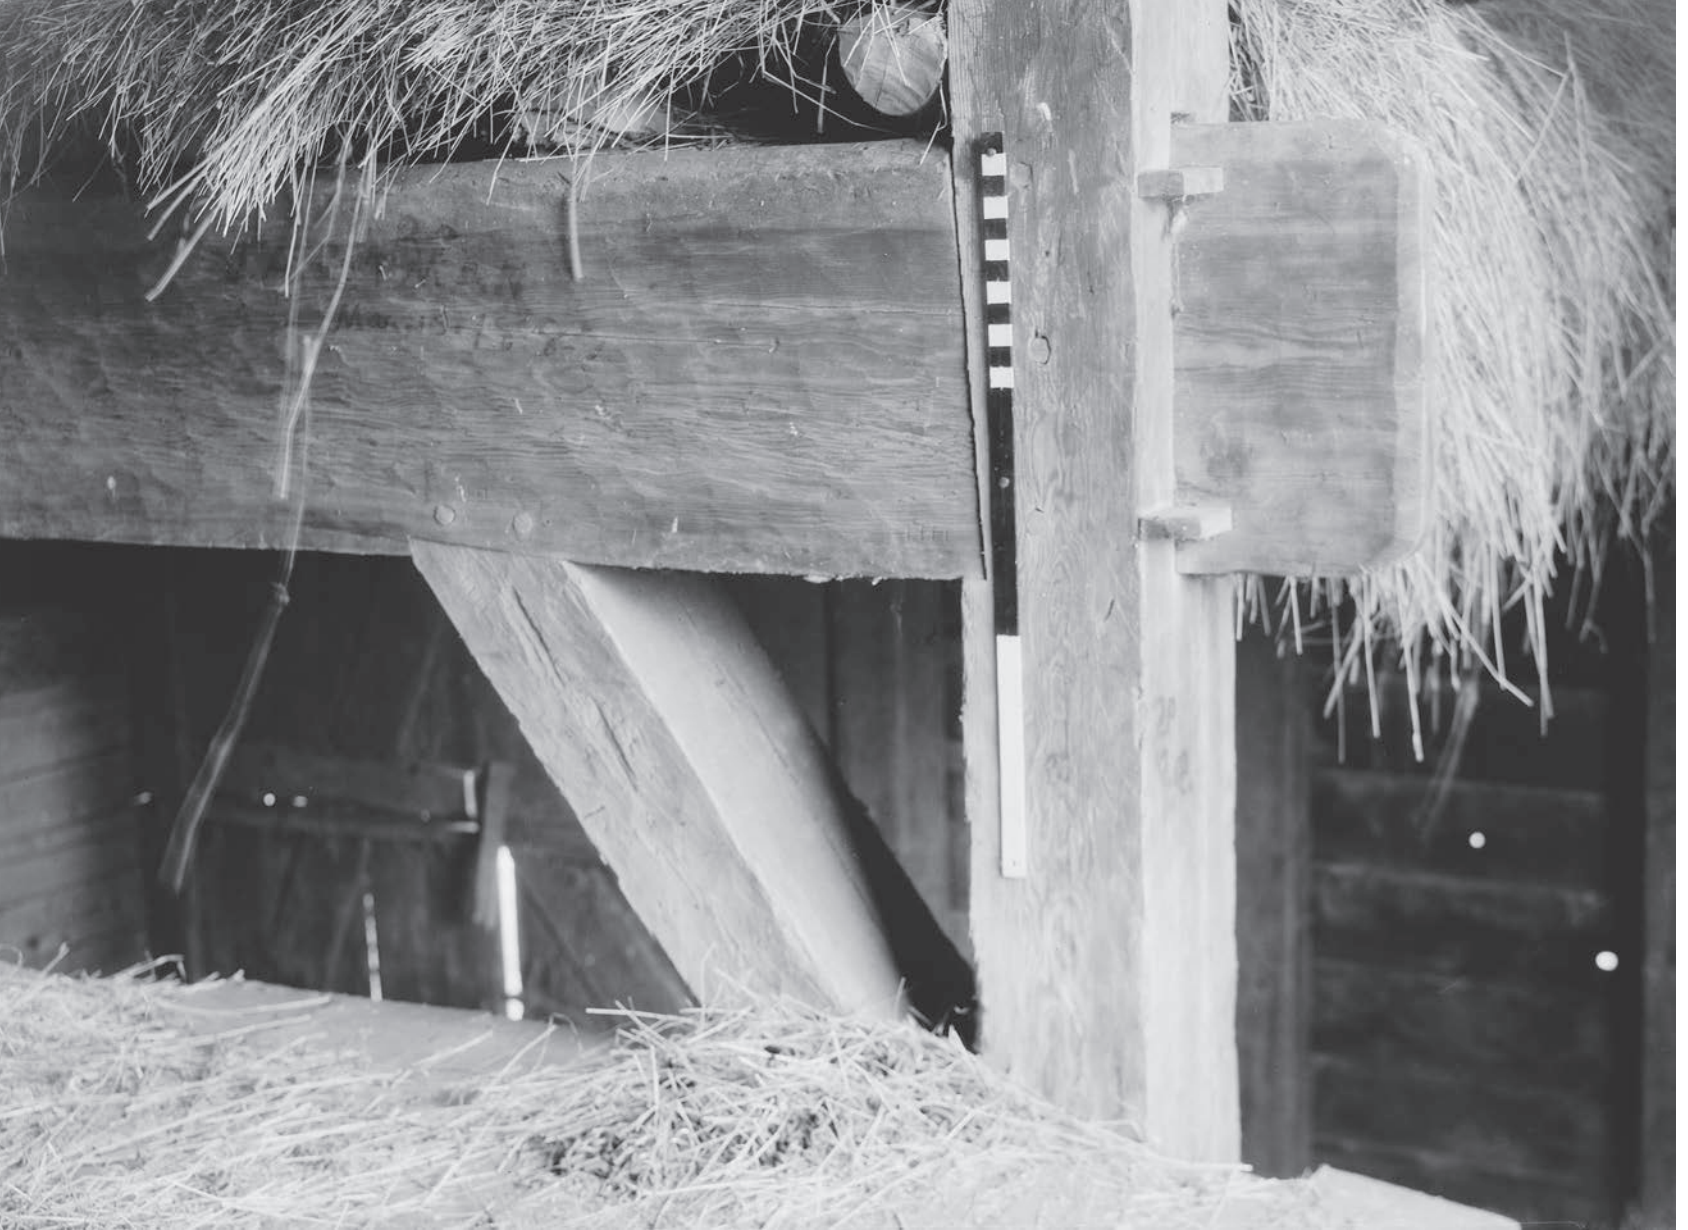
Fig. 7. Diminished shoulder anchorbeam, extended tenon with outside wedges and partial view of H-frame endpost and diminished shoulder kneebrace, all pitch pine except for the oak wedges. Three 1-in. pins secure the connection as well. Hewing and joinery are exemplary. The scale is 3 ft. long, partially subdivided into inches. Historic American Buildings Survey photograph by Nelson E. Baldwin, after 1933.

**Anchorbeam Joints and Extended Tenons.** The housing for the diminished shoulder on the Wemple barn anchorbeam tenon is nearly 1½ in. deep (such housings in other Dutch barns are 1 to 2 in. deep). Three 1-in. pegs transfix the joint in a typical triangular arrangement (post-1800 barns often used two). Peg diameters at the anchorbeam joints are good dating tools. After about 1800, such pegs often were increased to 1½ in. Before 1790 the joints consistently had 1-in. or smaller pegs. The layout or reference faces of the inner H-frames, to which all elements are held flush, relegating irregularities to the opposite or "back" face, are oriented toward the house end of the barn. Typical marriage marks cut by chisels are seen at the anchorbeam joints. (In the majority of cases where three-aisle barns occupy their original locations, the layout faces of inner bents face the house. This orientation may have been

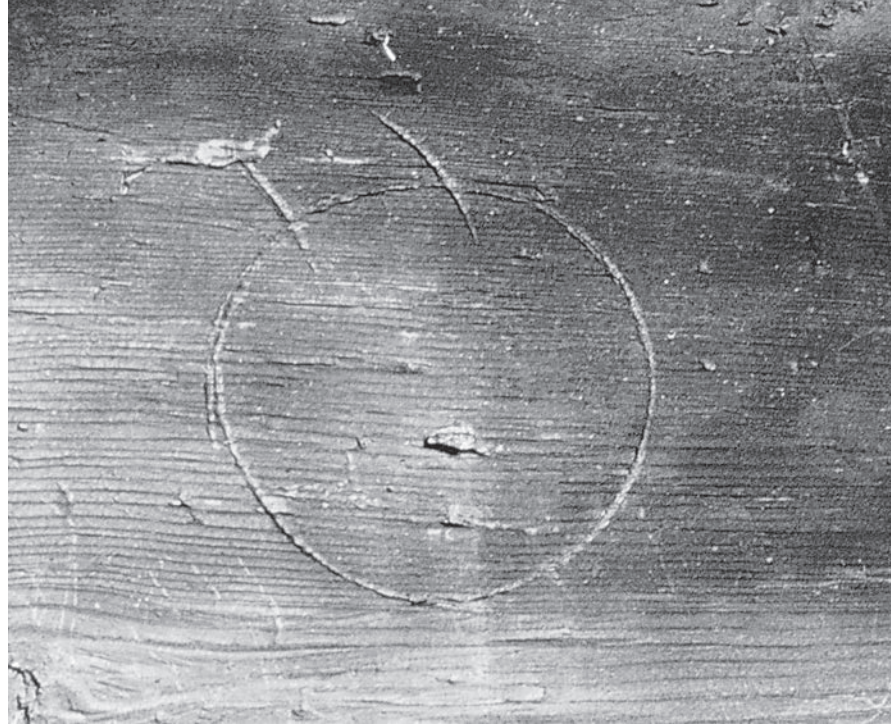
Fig. 8. Carpenter's mark about 3½ in. across, of uncertain meaning, scratched in one anchorbeam of the Wemple barn.

**Rare Carpenter's Mark.** Close to one end of the middle anchorbeam, a curious mark is scratched on the nonlayout face, a near-circle about 3½ in. across, intersected by two short arcs (Fig. 8). No similar marks appear elsewhere in the barn, so it cannot indicate H-frame number. It has some resemblance to a medieval mason's mark, extracted from a guild's master pattern of multiple circles and assigned to an individual craftsmen. I know of no other such marks on the Dutch barns I have seen in the last 35 years.

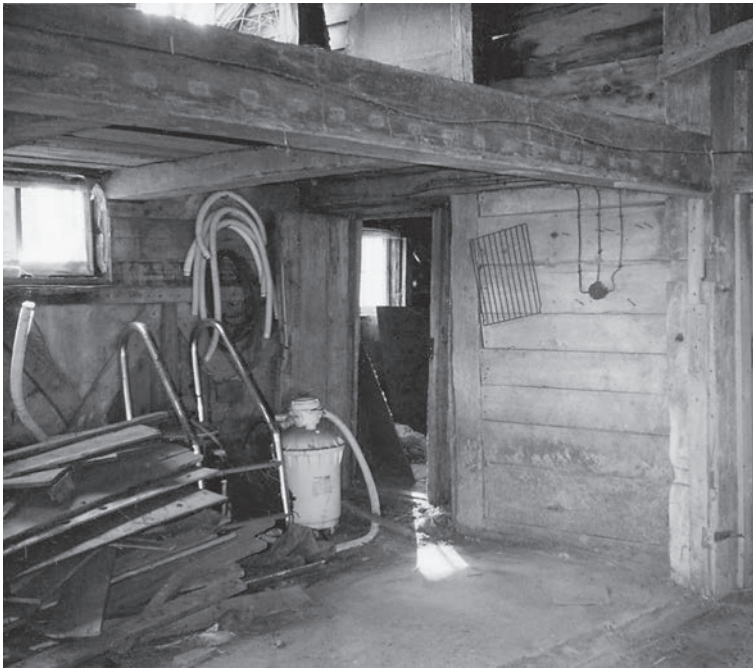
Fig. 9. Manger beam (running left to right in upper part of photo) shows ghosts of manger stakes that held feed above and ahead of the animals. The stakes ran down at an angle a short distance into the central aisle, terminating in a rail above the floor. H-frame post at right.

**Manger Beams.** The H-frame posts are connected lengthwise in the Wemple barn by beams about 6 ft. above the threshing floor, offering attachment points for mangers over the heads of the farm animals (Fig. 9). Beams 10x9¾ are placed 5 ft. 5 in. above the threshing floor along the cow aisle and 6 ft. 2 in. high along the horse aisle. (There are no such elements in one end bay.) The beams on the horse aisle show ghosts indicating attachment of angled manger stakes 2¼ in. wide, spaced about 6½ in. on center and 2 in. above the bottom of the beam. There are about 25 ghosts per beam, with small nail holes in the middle of each ghost indicating the method of attachment. (In many three-aisle barns in both New York and New Jersey, the manger stakes were notched into the upper corners of the beams. Intact manger stakes in barns are almost nonexistent, the only clear exception being those in the rare six-bay Deertz barn, ca. 1815, originally in Middleburgh, Schoharie County.) Crops were placed such that the animals could draw the food down between the stakes.

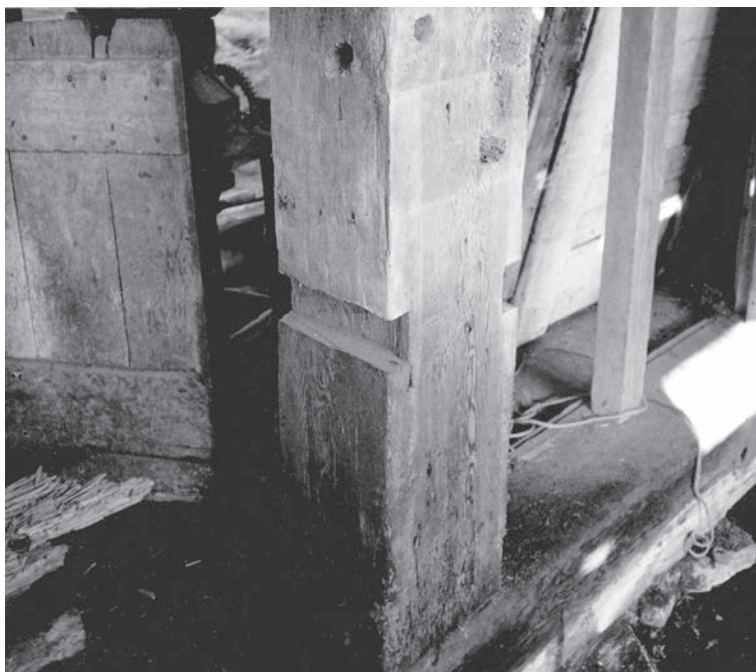
Fig. 10. Trench in H-frame post for edge of manger board to carry grain for animals. The Wemple barn had such boards at two levels.

In addition, manger boards were placed a few feet below the stakes, trenched into the H-frame posts, to hold grain (Fig. 10 overleaf). Some of the Wemple barn's H-frame posts are double slotted (upper and lower) for the purpose.

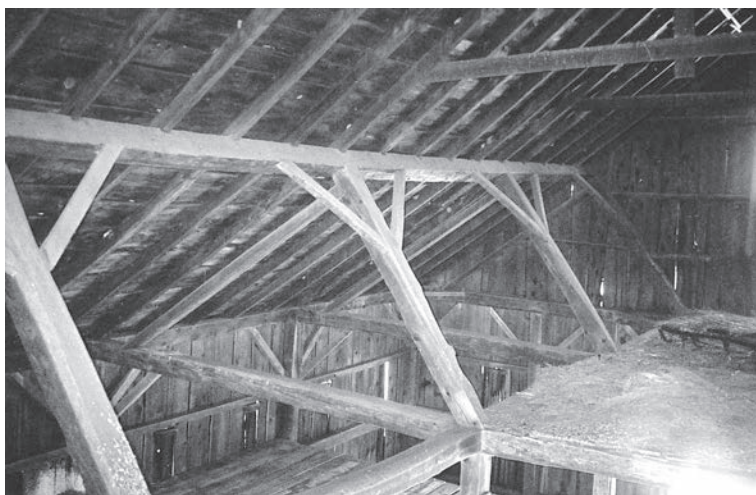
Fig. 2. Purlin on canted posts supports discontinuous rafters. Note ties at plate level.

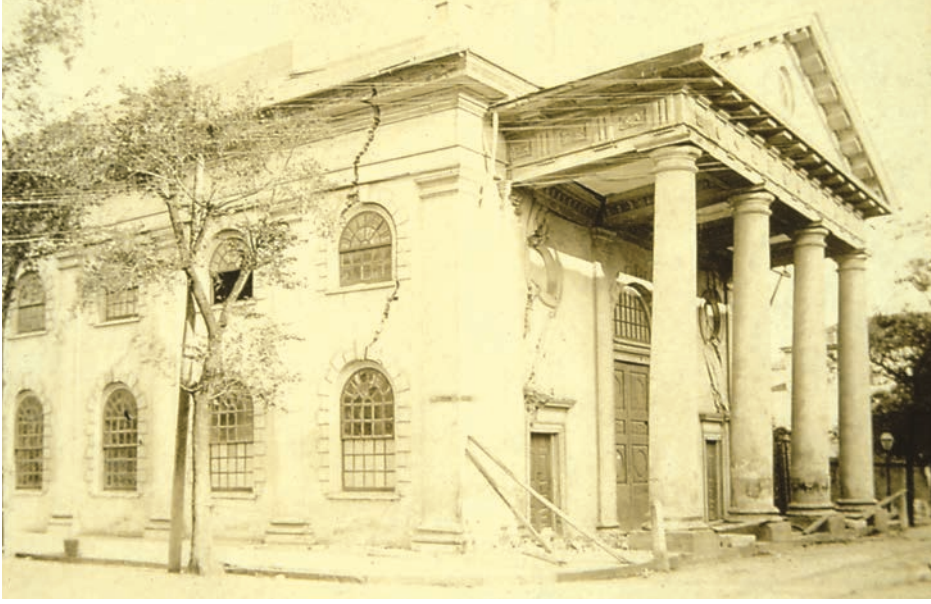
Fig. 1. St. Michael's after the 1886 earthquake. Portico leaning toward Meeting Street was rebuilt and large cracks in first bay repaired.

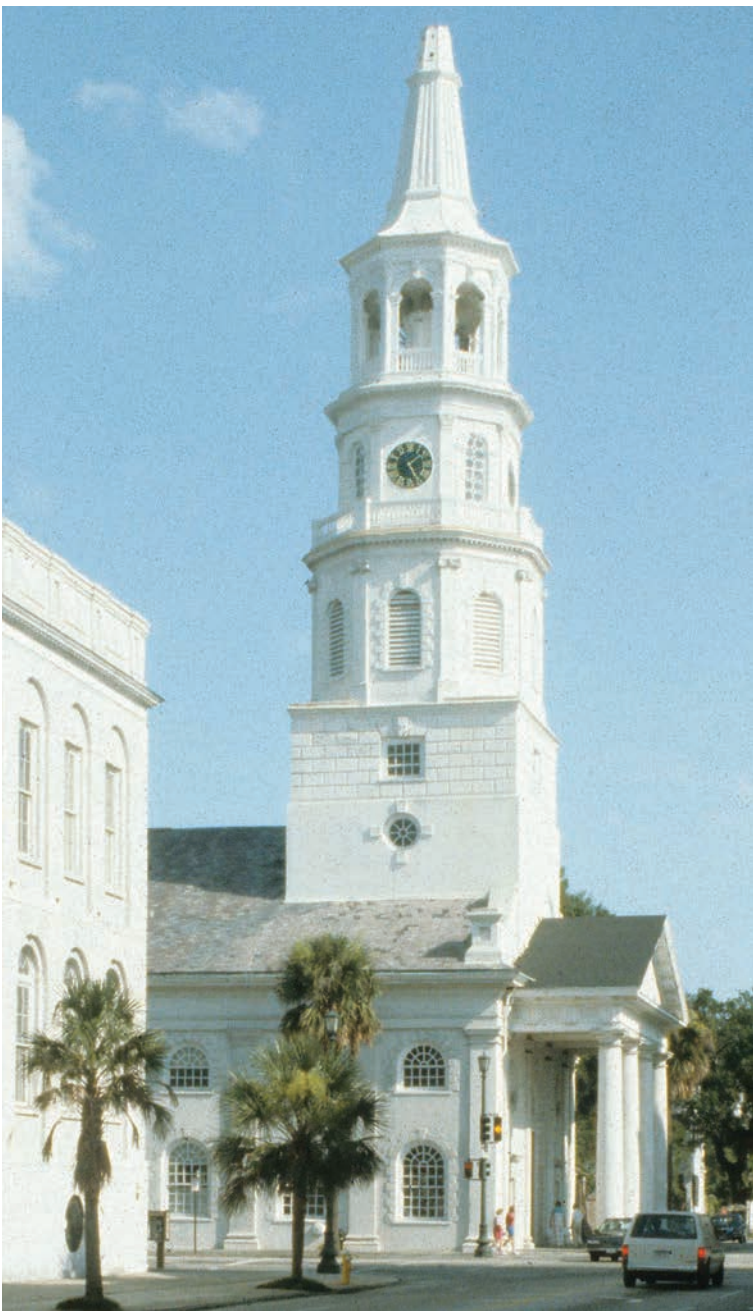
Fig. 2. St. Michael's in 1996, steeple 186 ft. tall, of which 111 ft. are masonry. Open lantern and spire are wood framed. Ball and weather vane not yet restored to spire.

The steeple comprises five stages above the roof. The first stage, a square tower pierced by small circular and square windows and partly rusticated in its exterior finish, extends down through the body of the church to form the center portion of the vestibule. Its brick walls vary in thickness from 4 ft. 9½ in. to 5 ft. 3 in. The masonry box, translating from square to octagon, rises through two more stages, the bell stage and the clock stage, to the underside of the open lantern stage. This fourth stage is timber framed, as is the spire, the fifth stage that completes the steeple (Figs. 2–3).

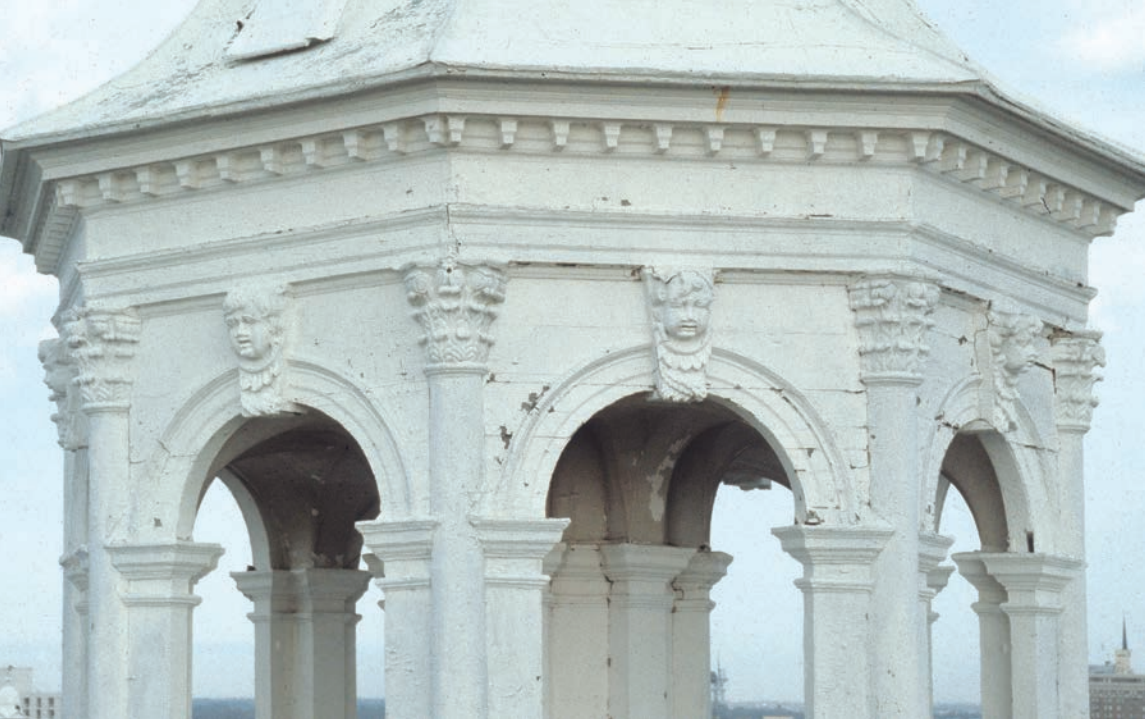
Fig. 4. Decorated lantern conceals perimeter posts, portal framing and core of timbers extending down to clock stage.

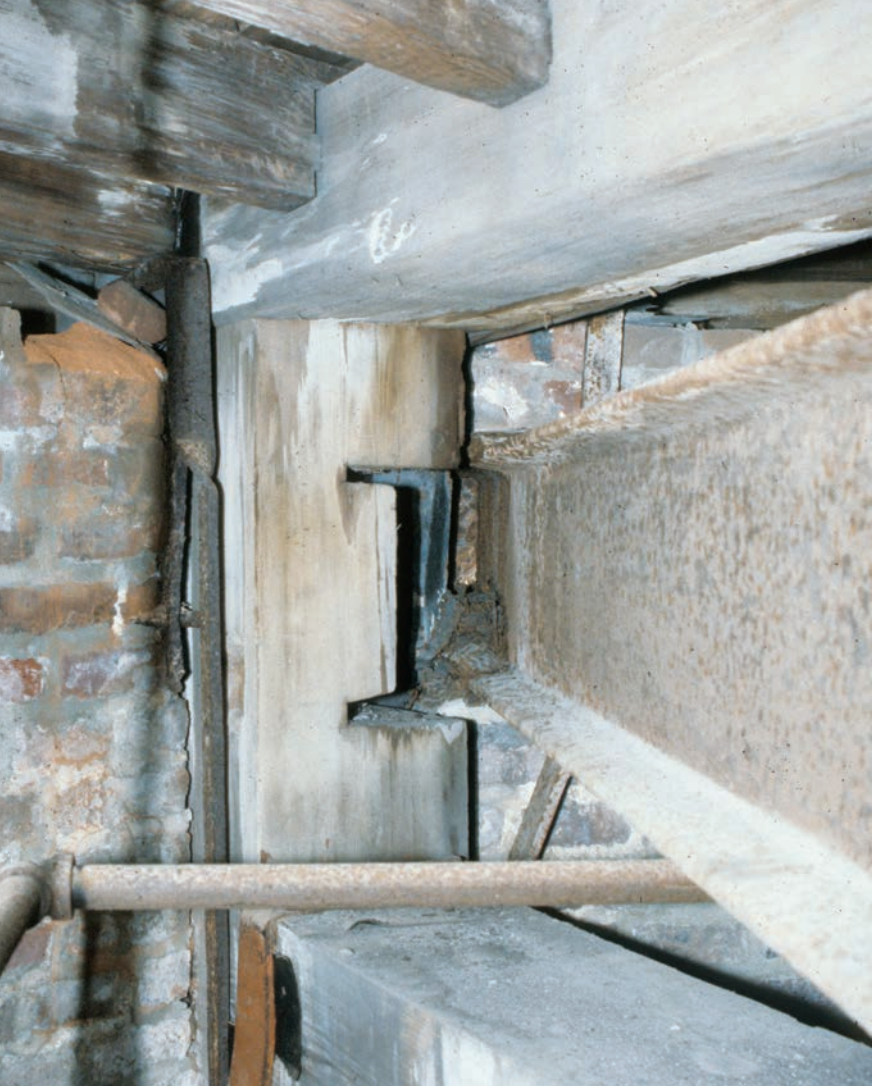
Fig. 9. Stub post in framing just below the lantern floor, cut by steel beam inserted in 1938. Pendant center posts descending from spire were similarly cut, with significant structural effect.

Of prime concern to all of us were the horizontal steel beams introduced into the steeple in 1938, apparently to provide additional vertical support to the steeple frame (Figs. 9–11). The eight original 8x8 pendant core posts descending from the spire to the masonry clock stage were severed two-thirds through to accommodate these struts. In September 1990 we produced a preliminary structural evaluation report including these observations:

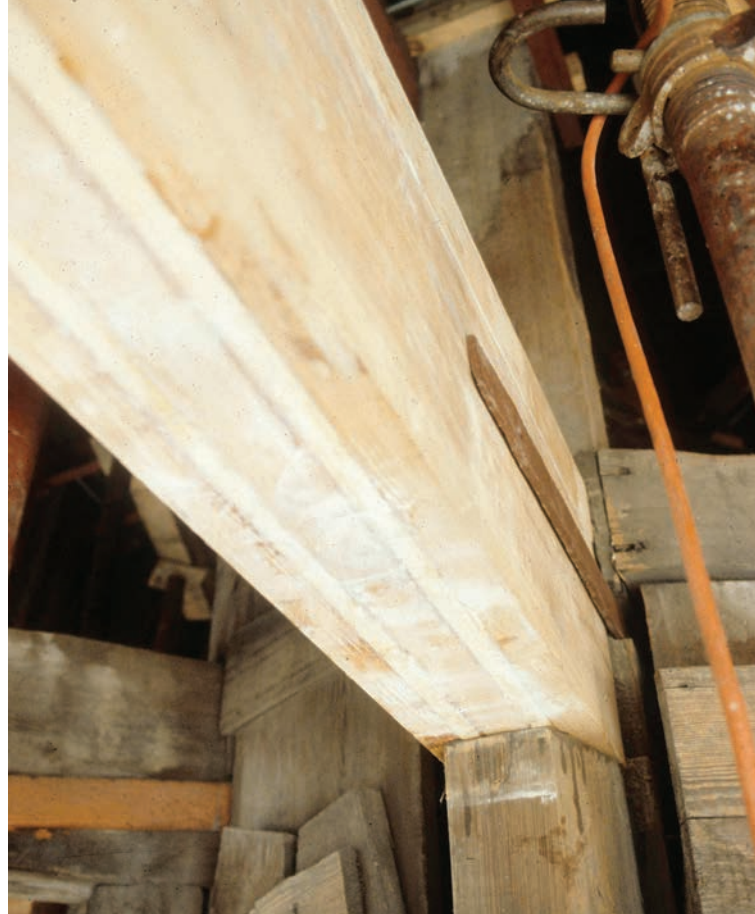
Fig. 14. Vertically laminated cypress beam replaced horizontal strut judged beyond usefulness.

We applied a factor of safety of four to the average value obtained by the testing program and used the result to design moment splices between the original wood and rebuilt ends of several of the spider beams. In one case, we discovered a horizontal strut that was totally deteriorated. To replace it, we laminated five cypress boards together on edge (Fig. 14).

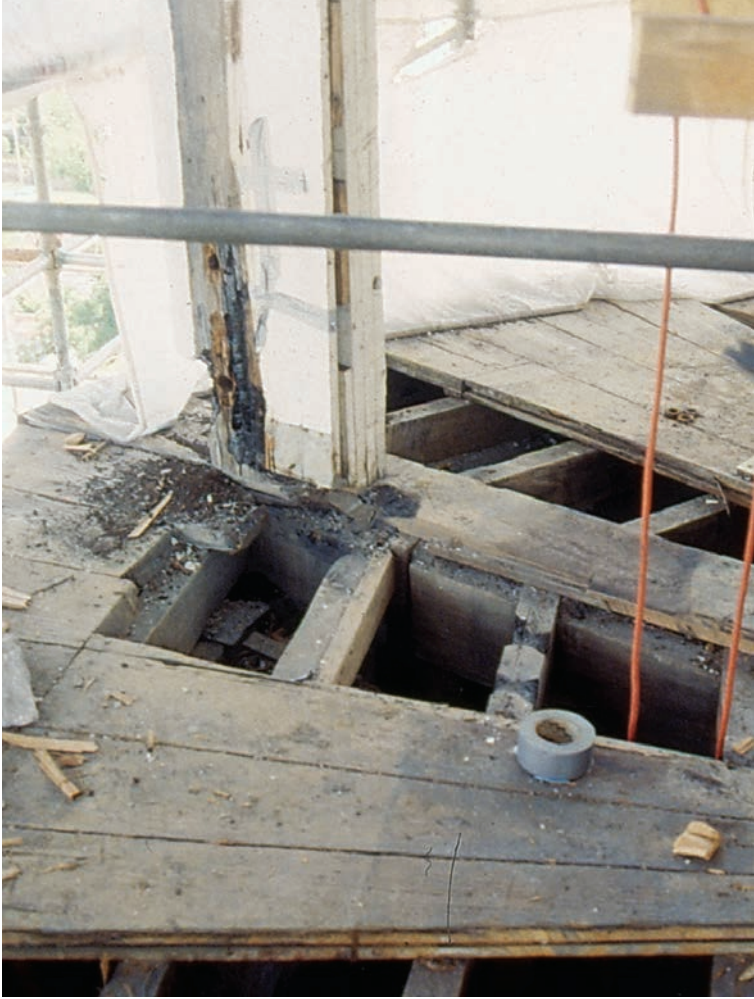
Fig. 15. Decayed perimeter post to spider beam connection under lantern floor.

New bottom tenons or tenoned ends as necessary for those perimeter posts that had deteriorated at the lantern floor were fabricated from dense cypress with a moisture content of 14 to 16 percent, close to the 11 to 14 percent moisture content of the original frame (Figs. 15-16).
