# TIMBER FRAMING

JOURNAL OF THE TIMBER FRAMERS GUILD

Number 89, September 2008

*The Wemple Barn*

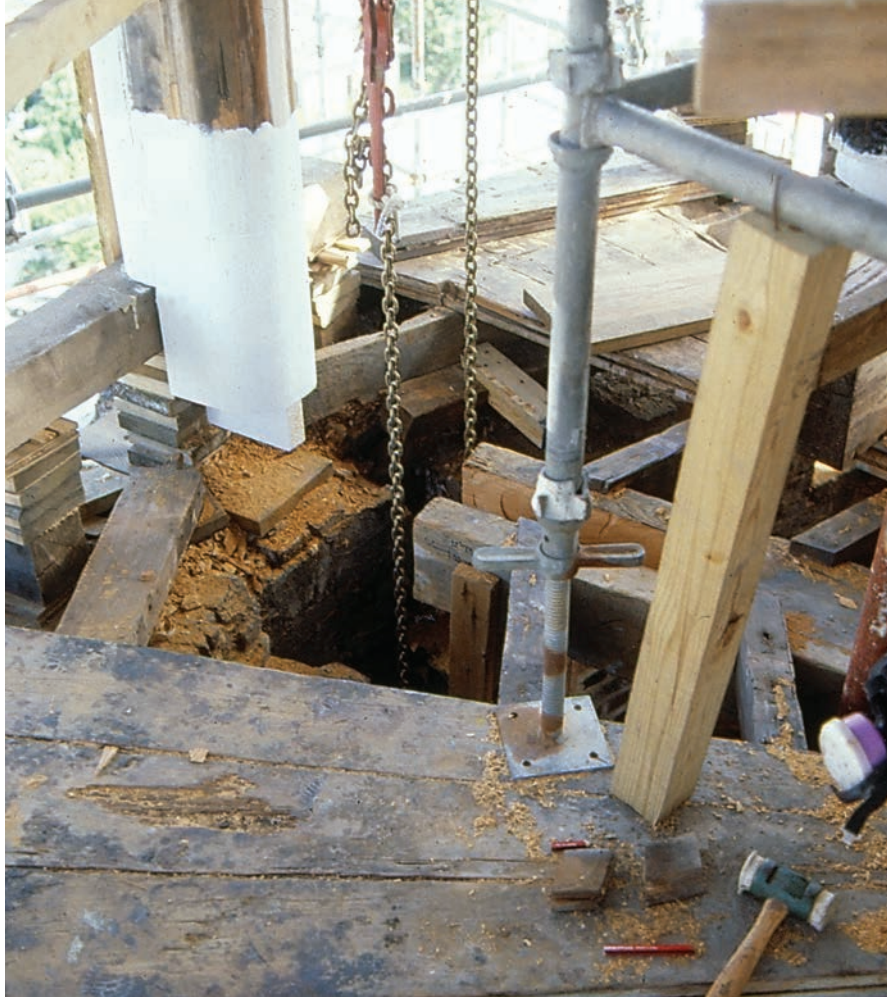
Fig. 16. New post end with tenon completed, bridled beam repair to be fitted and secured.

New bottom tenons or tenoned ends as necessary for those perimeter posts that had deteriorated at the lantern floor were fabricated from dense cypress with a moisture content of 14 to 16 percent, close to the 11 to 14 percent moisture content of the original frame (Figs. 15-16).

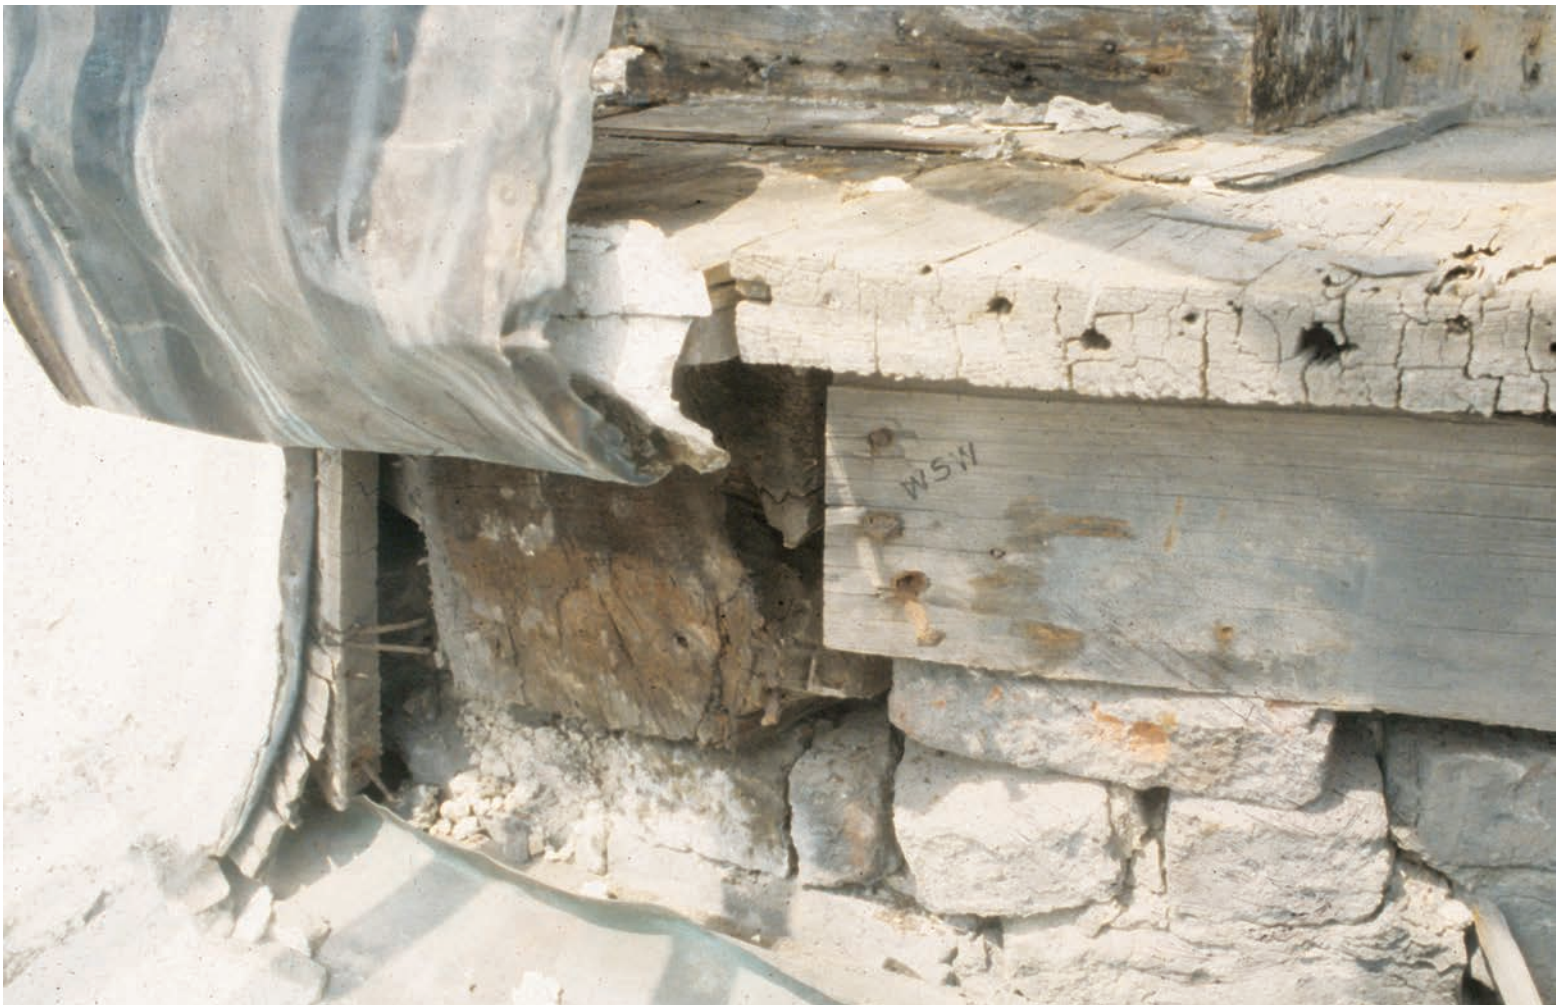
Fig. 17. Lantern floor peeled of its lead skin reveals splined and caulked floorboards and WSW end of one of the eight radial spider beams.
